SUNLIGHT INSPECTION SERVICE

123 Great Street Nice Town, Pennsylvania 19000
Sewer Scope # 2206000D

Sewer Line Scope

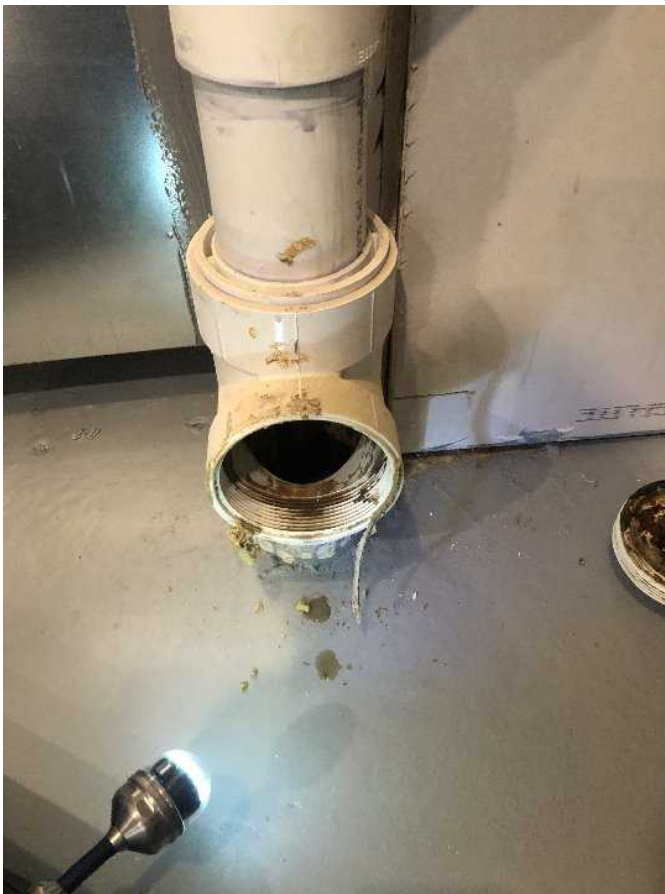
The sewer line was access from the clean-out fitting in the basement.

Camera access through interior clean out

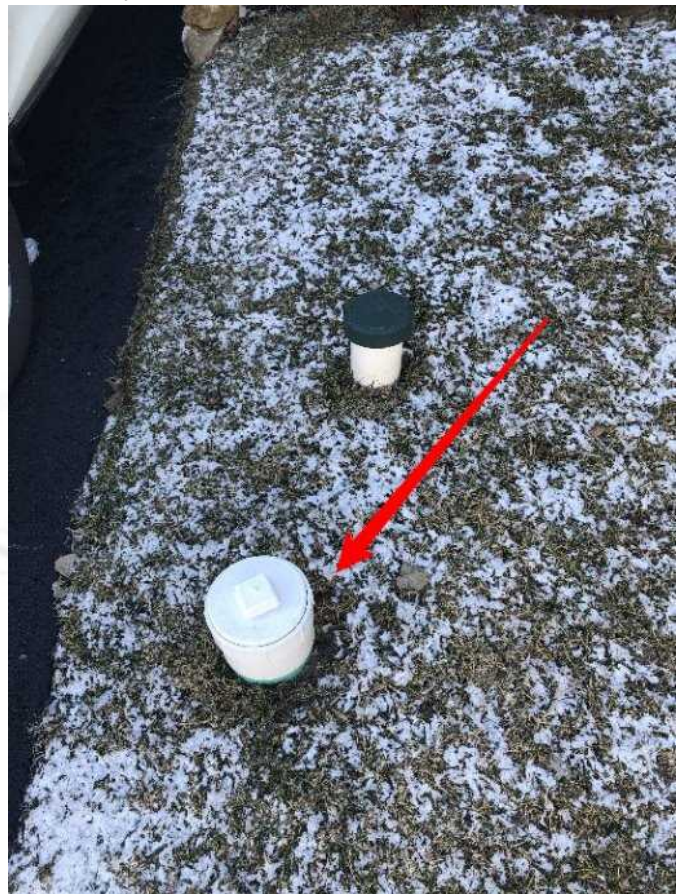
The camera was accessed from the clean-out fitting in the front yard.

Camera accessed through the exterior vent

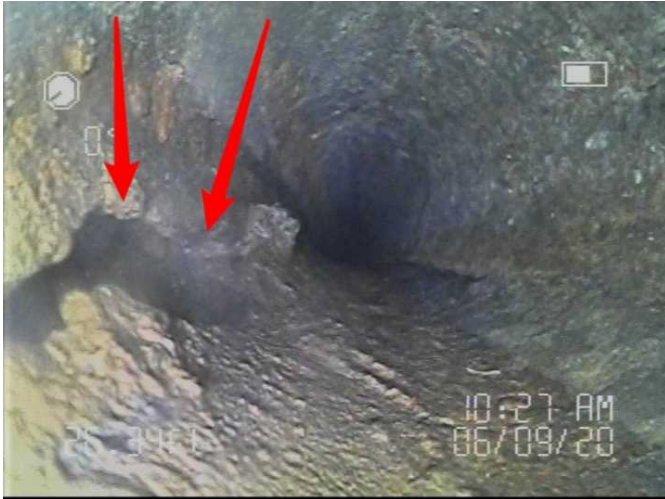
Damaged Line: A section of damaged sewer line was found. There is a crack in the sewer line at approximately 26 ft. from the basement clean-out.

Crack in sewer line 25 ft. from basement clean out.

I recommend further review and repair as needed by a qualified plumber.

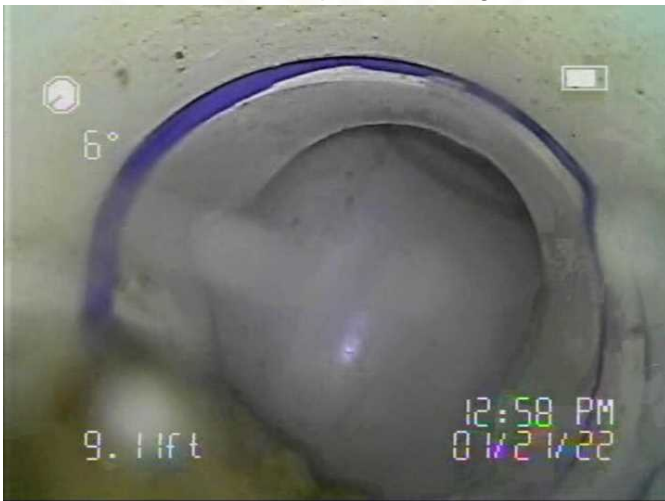
When the camera is pushed through the trap it shows that the top of the downflow side is dry. It should be filled with water. Coming from the house side the camera shows the sewer lateral starting to hole water as 45 1/2 ft.

The outlet side of the trap is set to high.

Downflow side of the trap

A qualified plumber should repair the sewer lateral by setting the trap at the correct pitch.

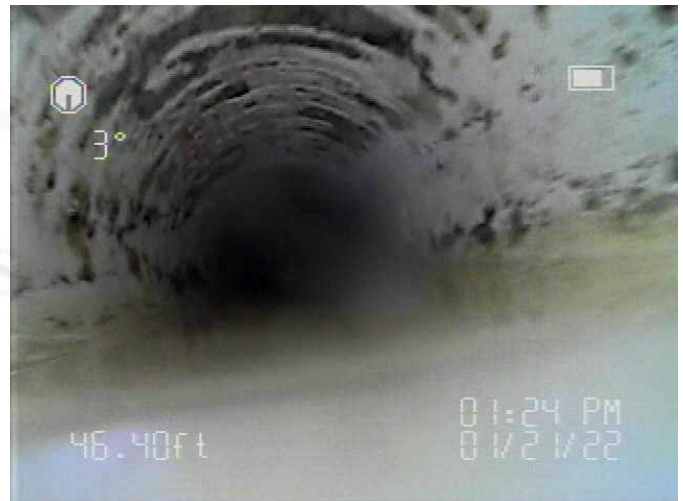
UP flow side of the trap

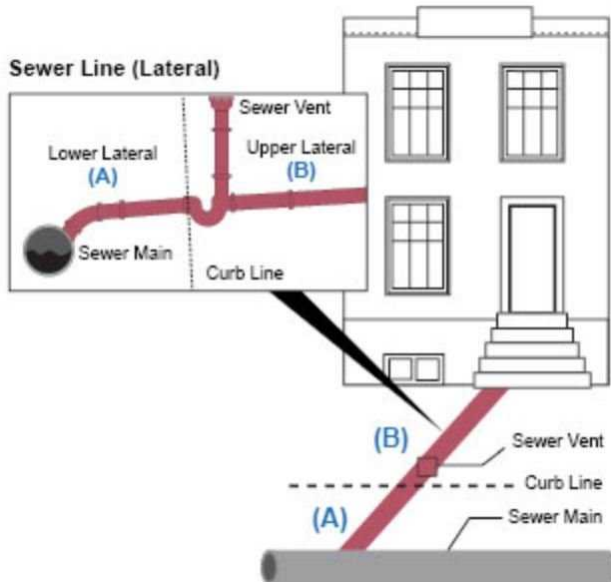
The diagram below shows how the trap should be set. The trap for your home is set so that the inlet side (house side) is lower than the outlet side (to the main sewer connection). Water is backing up on the inlet side. This is due to the outlet side being set too high. This condition increases the possibility of clogging the sewer lateral
