SUNLIGHT INSPECTION SERVICE

125 New Home Rd Lot 34 Phoenixville, PA 19460

REPORT# 23021204D

The following numbered and attached pages are your pre-drywall inspection report. The report includes photographs, comments, and the Standards of Practice. This inspection was performed in accordance with the current Standards of Practice for Residential Pre-drywall Inspections of the American Society of Home Inspectors. The Standards contain certain and very important limitations, exceptions, and exclusions to the inspection. A copy is available prior to, during, and after the inspection, and it is part of the report. All components designated in the ASHI standards of practices, except for limitations that may be noted in the report, will be inspected. The inspection is for the most part a limited visual inspection only. A representative sampling of the building components is viewed in areas that are accessible at the time of the inspection. No destructive testing or dismantling of components is performed. Be sure to keep your signed copy of the home inspection agreement along with the report for future reference.

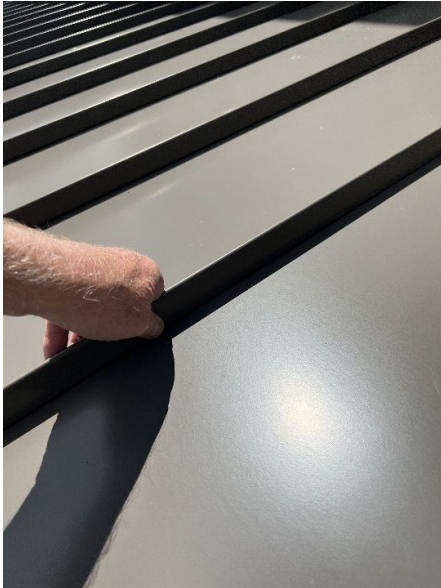
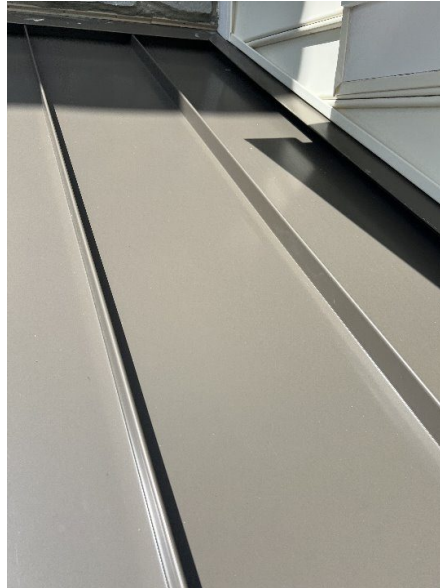
The side wall flashing for the metal roof does not extend far enough up the wall. Sidewall flashing should extend up the exterior wall a minimum of 4 inches.

The sidewall flashing is less than 3 inches high. This will be an issue when installing the Hardi plank siding. Hardi plank siding requires 2 inches of clearance from the bottom of the siding to the roofing material. This will leave less than an inch of coverage over the top edge of the flashing.

R Code Reference**R905.2.8.3 Sidewall flashing.**

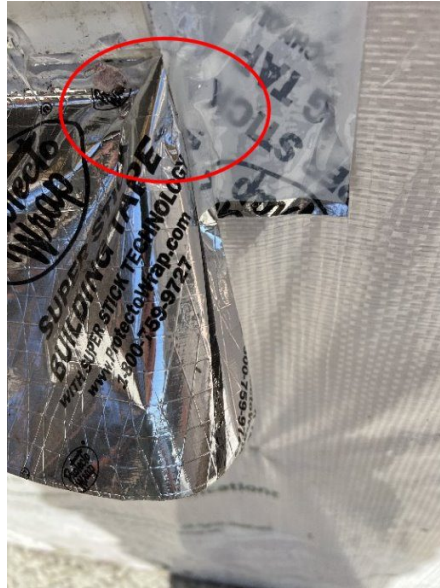
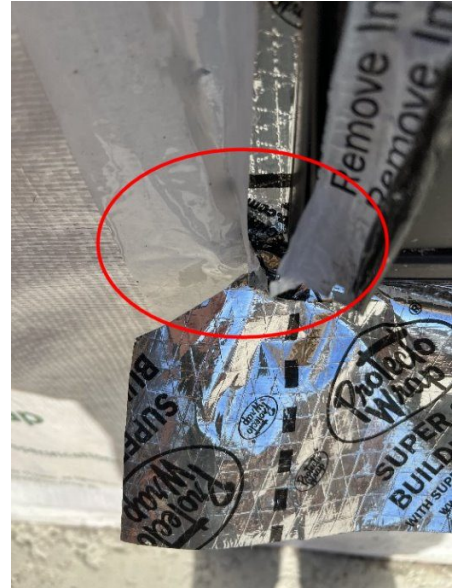
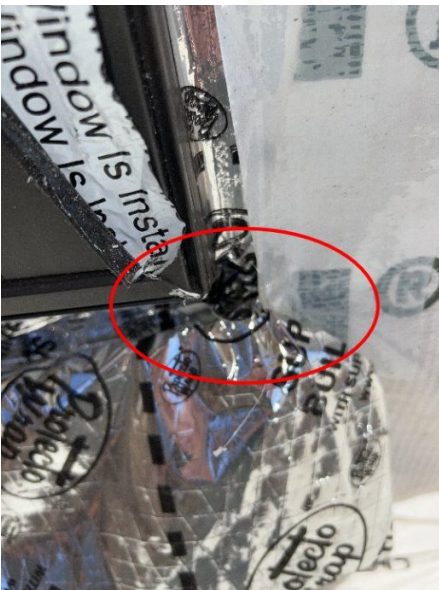
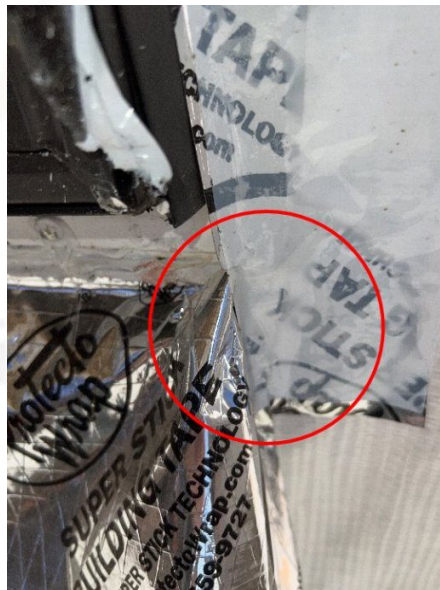
C A poor taping detail was noted on two of the windows at the front of the house. The flashing tape and house wrap should be better integrated to prevent water intrusion.

C 1: A poor taping detail was noted on two of the windows at the front of the house. The flashing tape and house wrap should be better integrated to prevent water intrusion.

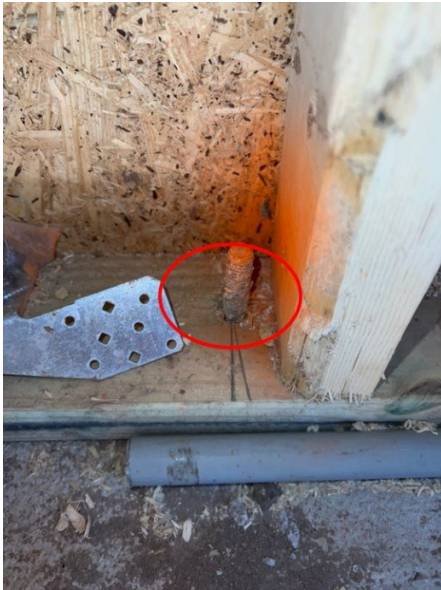
Garage

C Missing foundation bolts were noted. Foundation bolts without nuts and washers on them were noted. Bent and damaged foundation bolts were noted.

Five foundation bolts in the garage were noted without washers and nuts on them. In the basement above the left foundation wall, four foundation bolts are missing and three foundation bolts are damaged.

The bottom sill plate of each exterior wall should be anchored to the top of the foundation wall with 1/2 inch bolts. There should be a bolt within 6 inches of the end of each sill plate and the bolts are 6 ft on center. Each bolt should have a washer and a nut on it.

R403.1.6 Foundation anchorage.

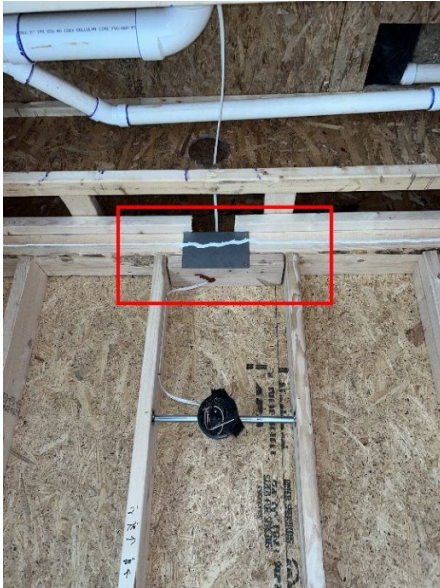
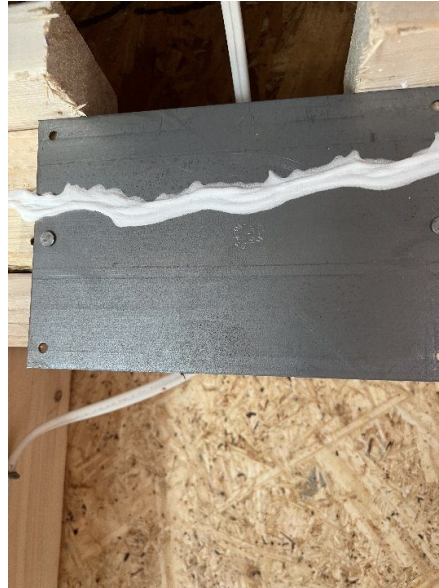
C A top plate that has been cut all the way through was noted in the back left first-floor bathroom wall. When the top plate of a loadbearing wall has been cut more than 50% to allow access for pipes, wires or ducts a metal tie must be installed to add structural support to the wall. The strap must extend 6 inches past the opening on both sides and have eight 10d nails installed on each side.

metal plate in wooden block are not
inadequate repair

C 3: A top plate that has been cut all the way through was noted in the back left first-floor bathroom wall.

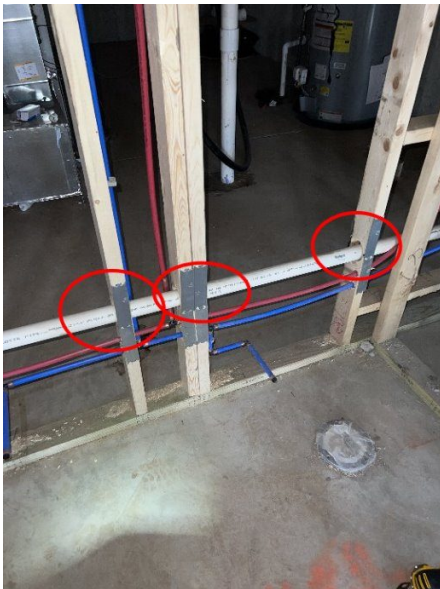
basement bathroom wall

C Improper bored holes were noted in the basement bathroom and second-floor center bathroom. The holes exceed 60% of the stud width that are closer than 5/8 of an inch to the edge of the stud. Bored holes in studs of interior nonbearing walls may not exceed 60% of the stud depth and may not be within 5/8 of the stud edge. The hole may not be located in the same section as a cut or notch.

C 4: Improper bored holes were noted in the basement bathroom and second-floor center bathroom. The holes exceed 60% of the stud width that are closer than 5/8 of an inch to the edge of the stud. Bored holes in studs of interior nonbearing walls may not exceed 60% of the stud depth and may not be within 5/8 of the stud edge. The hole may not be located in the same section as a cut or notch.

2. Drilling. Any stud shall be permitted to be bored or drilled, provided that the diameter of the resulting hole is no more than 60 percent of the stud width, the edge of the hole is no more than 5/8 inch (16 mm) to the edge of the stud, and the hole is not located in the same section as a cut or notch. Studs located in exterior walls or bearing partitions drilled over 40 percent and up to 60 percent shall also be doubled with no more than two successive doubled studs bored. See Figures R602.6(1) and R602.6(2).

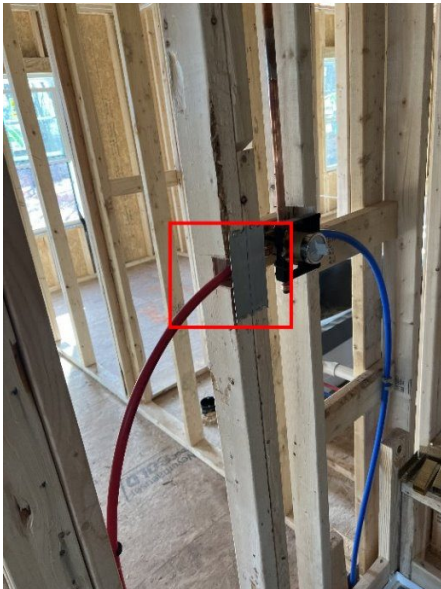
second floor right bathroom

C Over notched stud was noted near the shower in the second-floor right bathroom wall. Studs in nonbearing interior walls may not be cut or notched more than 40% of their width.

C 5: Over notched stud was noted near the shower in the second-floor right bathroom wall. Studs in nonbearing interior walls may not be cut or notched more than 40% of their width.

1. Notching. Any stud in an exterior wall or bearing partition may be cut or notched to a depth not exceeding 25 percent of its width. Studs in nonbearing partitions shall be permitted to be notched to a depth not to exceed 40 percent of a single stud width.

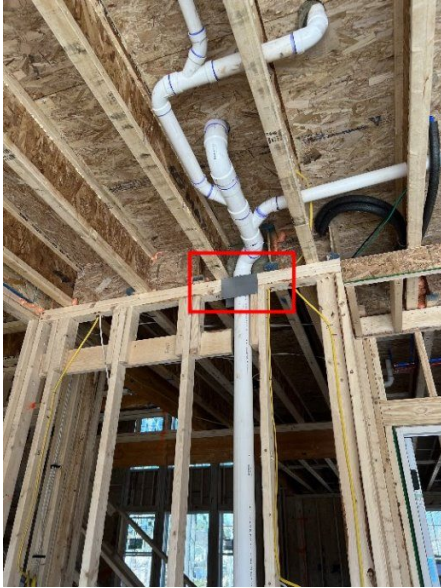
Rear wall of the garage

C missing metal ties were noted in the top plates of the two rear interior walls that separate the garage from the living space. Both these walls are loadbearing walls. When the top plate of a loadbearing wall has been cut more than 50% to allow access for pipes, wires or ducts a metal tie must be installed to add structural support to the wall. The strap must extend 6 inches past the opening on both sides and have eight 10d nails installed on each side. The metal shields that are in place are not adequate.

Steel plate not adequate

C 6: missing metal ties were noted in the top plates of the two rear interior walls that separate the garage from the living space. Both these walls are loadbearing walls. When the top plate of a loadbearing wall has been cut more than 50% to allow access for pipes, wires or ducts a metal tie must be installed to add structural support to the wall. The strap must extend 6 inches past the opening on both sides and have eight 10d nails installed on each side.

When piping or ductwork is placed in or partly in an exterior wall or interior loadbearing wall, necessitating cutting, drilling and notching of the top plate by more than 50% of its width, a galvanized metal tie not less than 0.054 inch thick and 1 1/2 inches wide shall be fastened across and to the plate at each side of the opening with not less than eight 10d nails having a minimum length of 1 1/2 inches at each side or equivalent. The metal tie must extend a minimum of 6 inches past the opening.

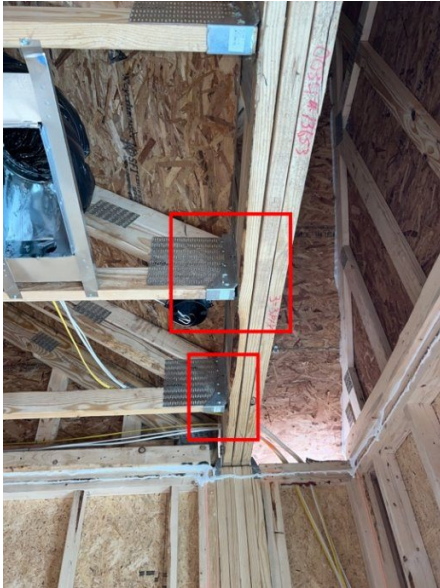
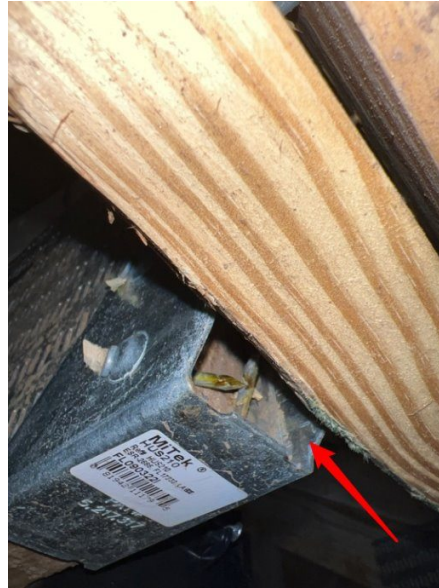
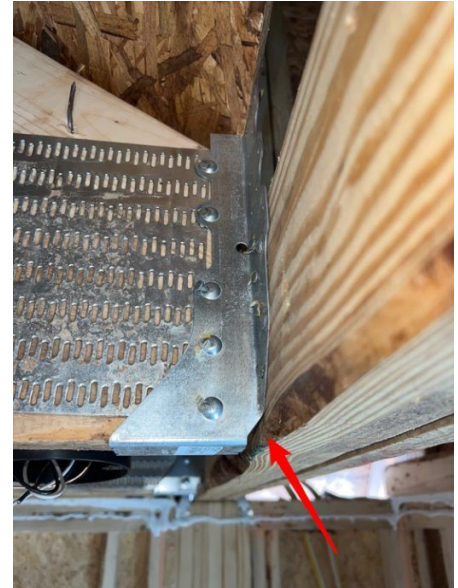
C Gaps were noted between all the ends of the roof trusses and the girder in the front right bedroom. Gaps between the trusses and the girder should not exceed 1/8 of an inch. When gaps exceed 1/8 of an inch the capacity of the connection is reduced.

C 7: Gaps were noted between all the ends of the roof trusses and the girder in the front right bedroom. Gaps between the trusses and the girder should not exceed 1/8 of an inch. When gaps exceed 1/8 of an inch the capacity of the connection is reduced.

The truss manufacturer should be consulted to determine if corrective action is needed.

In all cases involving a gap between the end of the carry trusts in the girder that exceed 1/8 of an inch the truss manufacturer should be notified to ensure that the truss is not adversely affected by the gap. In addition all field remedies and repairs for gaps must be designed and approved by the trusts designer or another design professional.

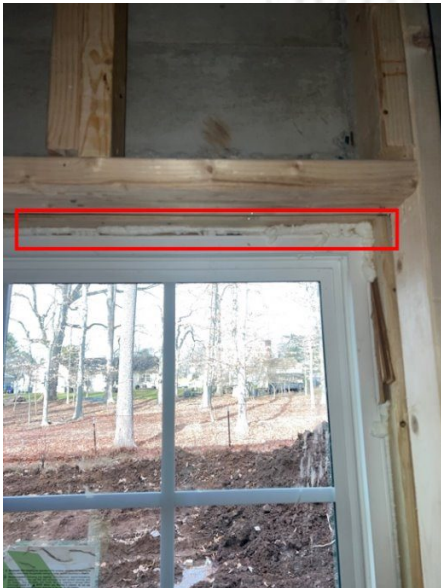
basement window

C Missing and poorly applied foam insulation was noted around many of the windows. Large gaps can be seen between the windows and the framing. These gaps should be filled with foam to prevent air leakage.

C 8: Missing and poorly applied foam insulation was noted around many of the windows. Large gaps can be seen between the windows and the framing. These gaps should be filled with foam to prevent air leakage.

The building thermal envelope shall be durably sealed to limit infiltration. The sealing methods between dissimilar materials shall allow for differential expansion and contraction. The following shall be caulked, gasketed, weatherstripped or otherwise sealed with an air barrier material, suitable film or solid material.

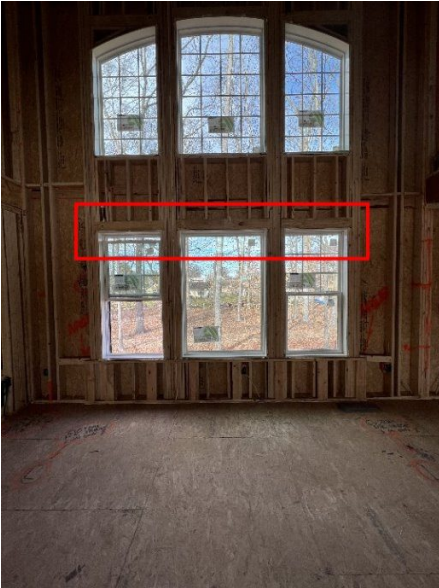
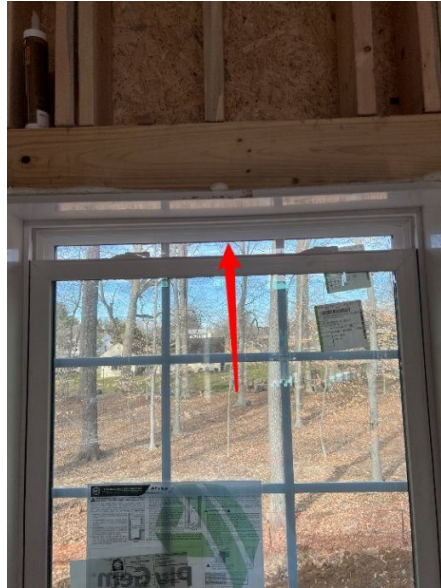
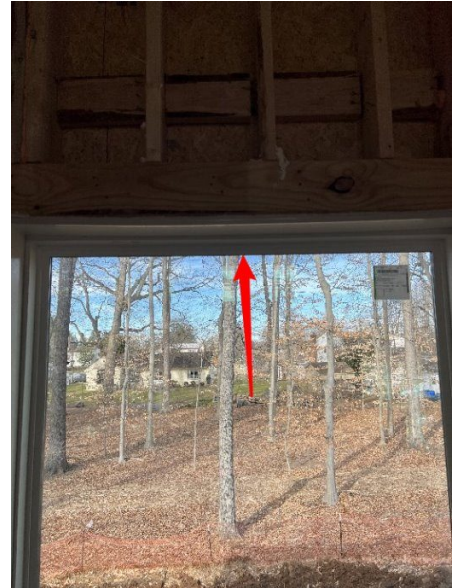
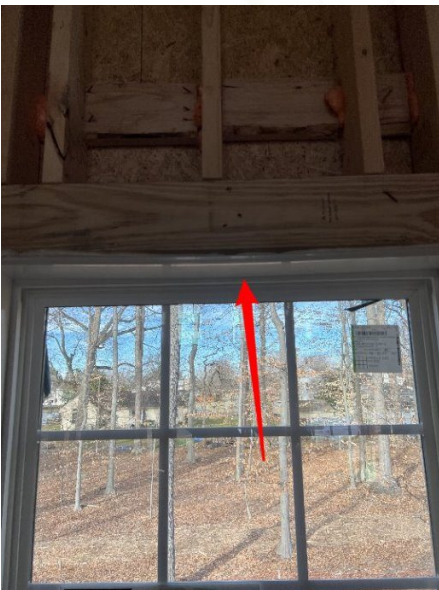
C Bowing trim boards were noted on the three lower family room windows. The top piece of trim is bowed in the center of all three windows.

C 9: Bowing trim boards were noted on the three lower family room windows. The top piece of trim is bowed in the center of all three windows.

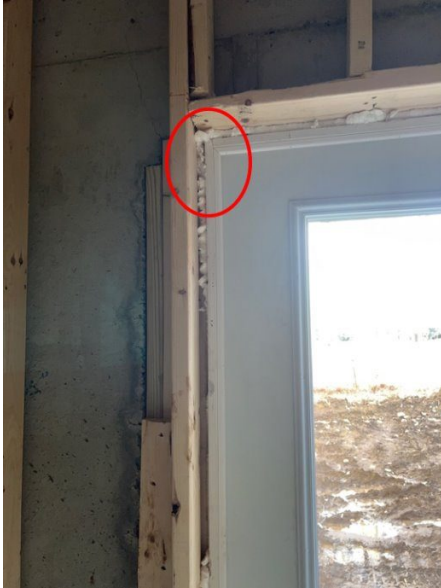
basement door

C Missing and poorly applied foam insulation was noted around the basement door. Large gaps can be seen between the door and the framing. These gaps should be filled with foam to prevent air leakage.

C 10: Missing and poorly applied foam insulation was noted around the basement door. Large gaps can be seen between the door and the framing. These gaps should be filled with foam to prevent air leakage.

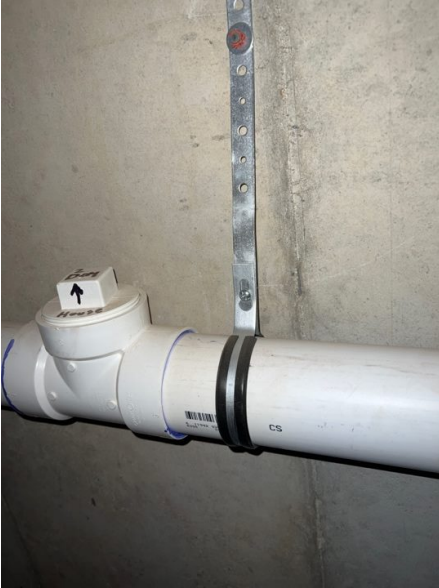
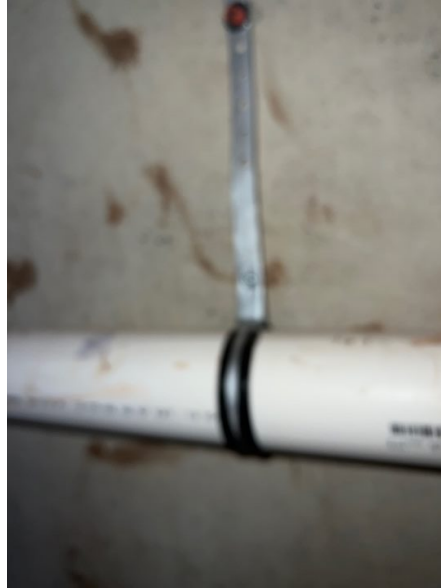
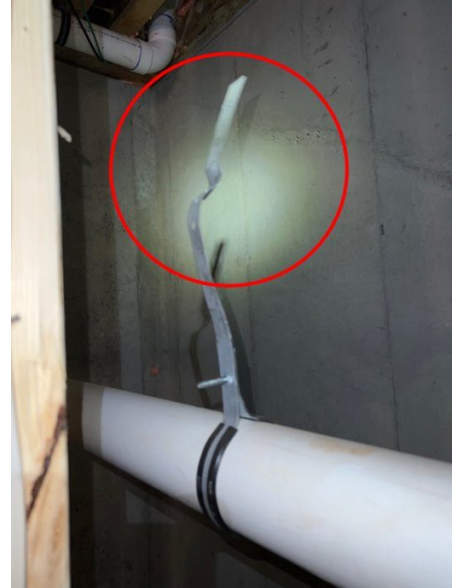
C The waste lines are properly sloped and supported. One hanger at the back left corner has come loose and needs to be reinstalled.

The hanger needs to be reinstalled

C 11: The waste lines are properly sloped and supported. One hanger at the back left corner has come loose and needs to be reinstalled.
