100 Nice Street Phoenixville, PA 19460  
**MOLD & MOISTURE Report**

**Thursday, August 31, 2023**

100 Nice Street  
Phoenixville, PA 19460

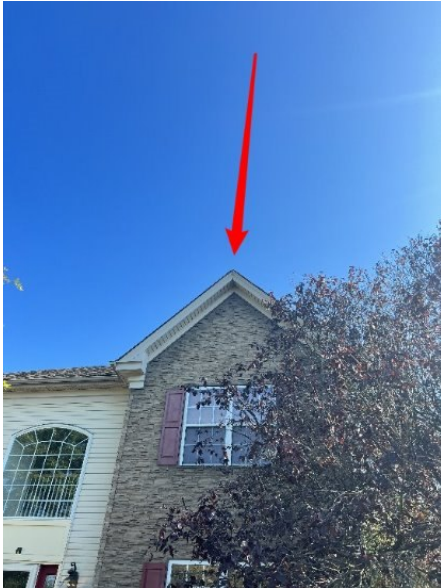
**IMP** A small hole was noted at the ridge cap at the front of the house. A qualified roof should repair the damaged ridge cap to prevent the possibility of water intrusion.

**IMP 3:** A small hole was noted at the ridge cap at the front of the house. A qualified roof should repair the damaged ridge cap to prevent the possibility of water intrusion.

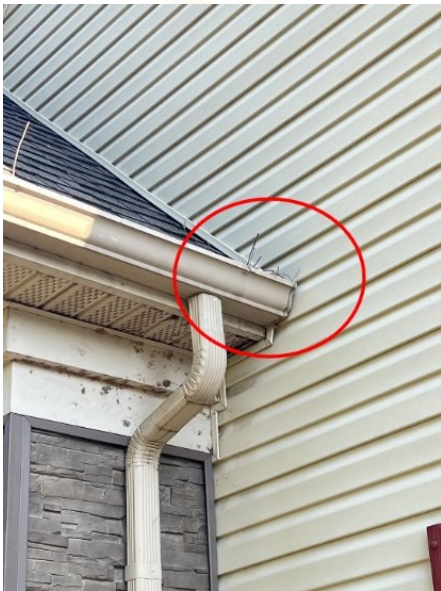
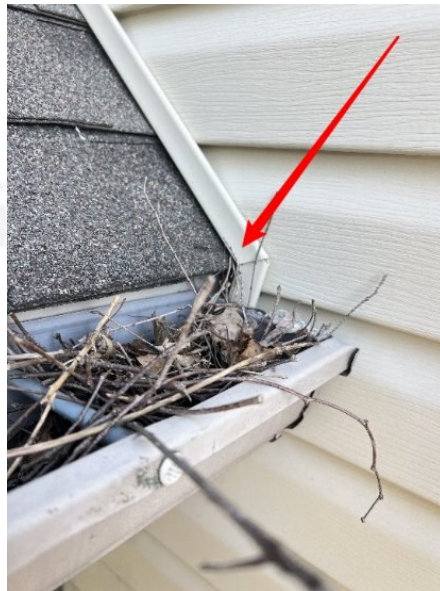
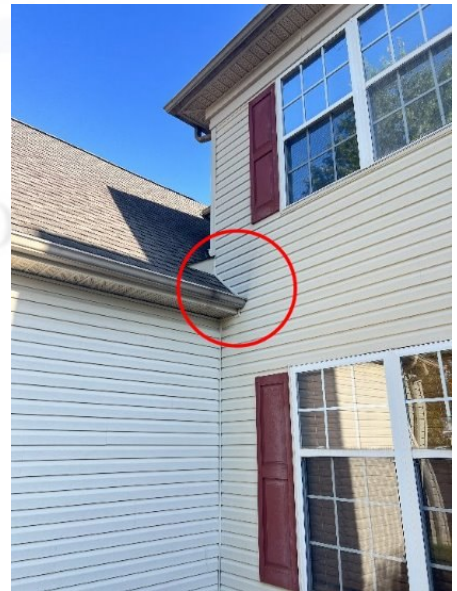
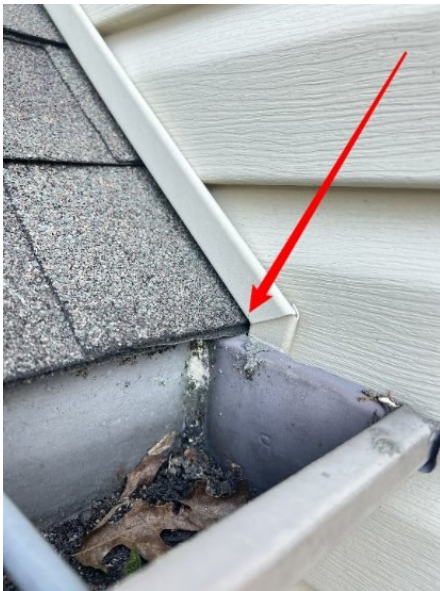
**IMP** Missing kick-out or diverter flashings were noted at the front of the house in two locations. The flashing detail called a kick-out is needed at locations where a roof ends on an exterior wall. The kick-out prevents water from running behind the siding and from streaking down the front of the siding by diverting it from the roof surface into the gutter. Proper flashings reduce the chances of water intrusion. A qualified siding contractor should install the kick-out flashings.

**IMP 4:** Missing kick-out or diverter flashings were noted at the front of the house in two locations. The flashing detail called a kick-out is needed at locations where a roof ends on an exterior wall. The kick-out prevents water from running behind the siding and from streaking down the front of the siding by diverting it from the roof surface into the gutter. Proper flashings reduce the chances of water intrusion. A qualified siding contractor should install the kick-out flashings.

Option 1 & 2 for kick out or diverter flashing

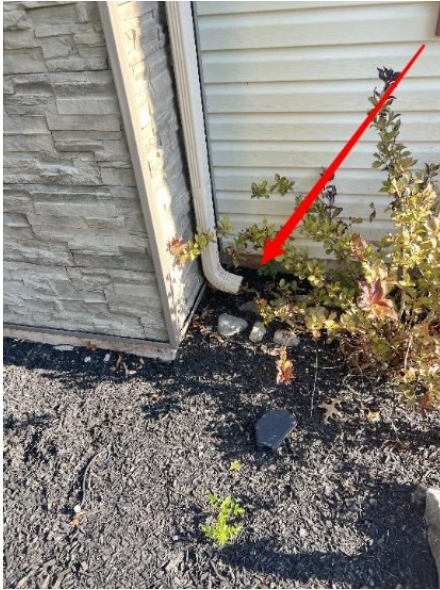
Front of house

**IMP** Downspouts were noted draining too close to the house at the front of the house to the left of the front entrance, at the back left corner, and at the right front corner where there is a broken drain pipe. The downspout should be extended to take water further away from the house. Water should not be allowed to drain right next to the foundations. Ideally, the downspout should extend 4 to 6 feet away from the house. A qualified person should extend the spout.

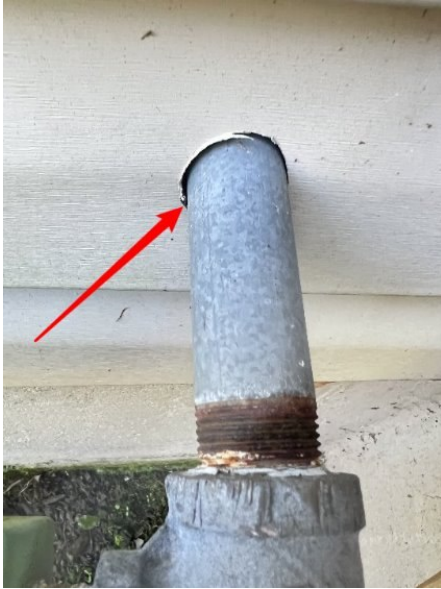
Gas line left side of house

**IMP** Unsealed exterior wall penetrations were noted.

All pipes, vents, cables, and other wall penetrations should be sealed with exterior-grade caulking to prevent water intrusion and energy loss.

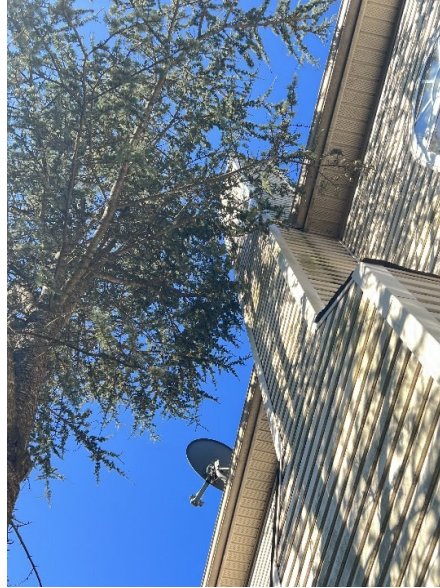
**IMP** Shrubs and trees were noted growing on the side of the house. Shrubs and tree limbs should not be leaning on or touching the house. Plants on the side of a house can hold moisture against the house for extended periods of time. This can contribute to decay and water intrusion. Pruning of the shrubs and trees around the house is recommended.

Pruning of the shrubs and trees around the house is recommended.

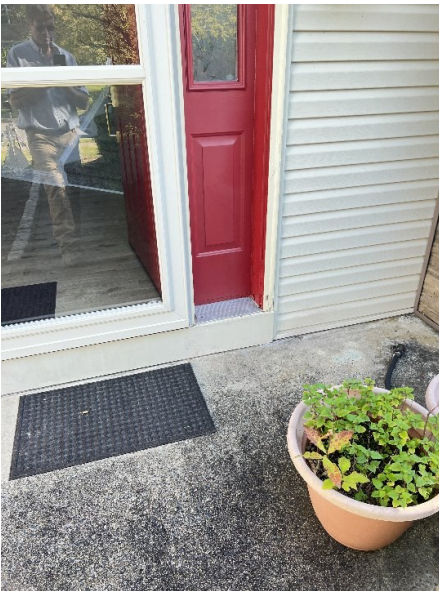
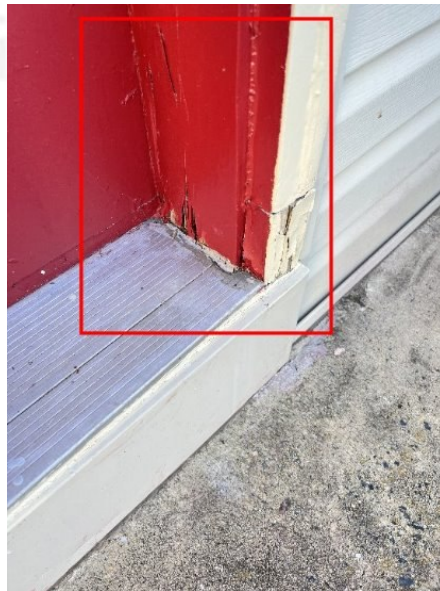
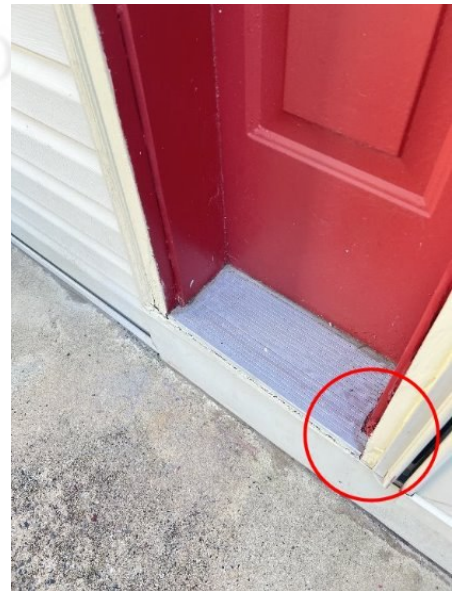
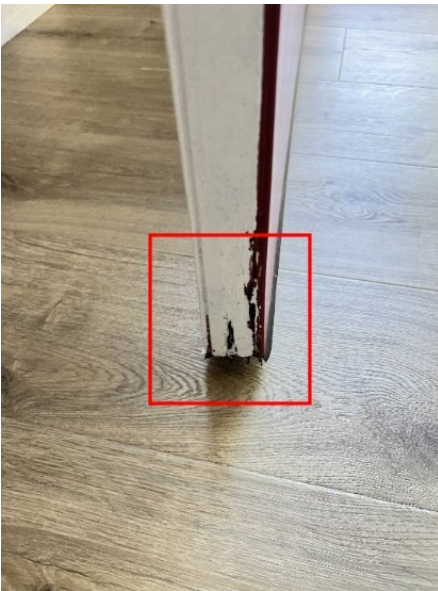
**IMP** Wood decay was noted at the bottom of the main entry door where the side jams meet the threshold. Some deterioration was also noted on the door itself. To prevent the possibility of water intrusion a qualified contractor should repair as needed.

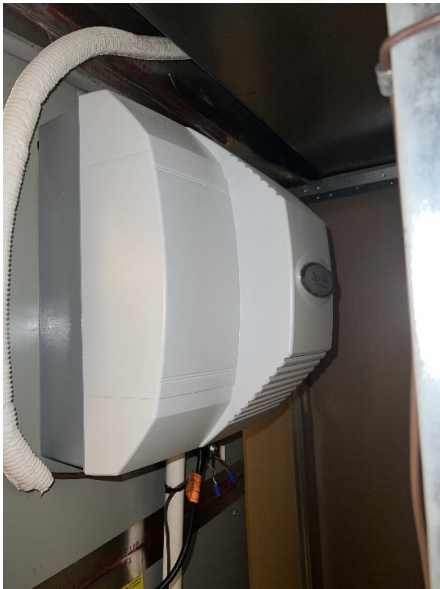
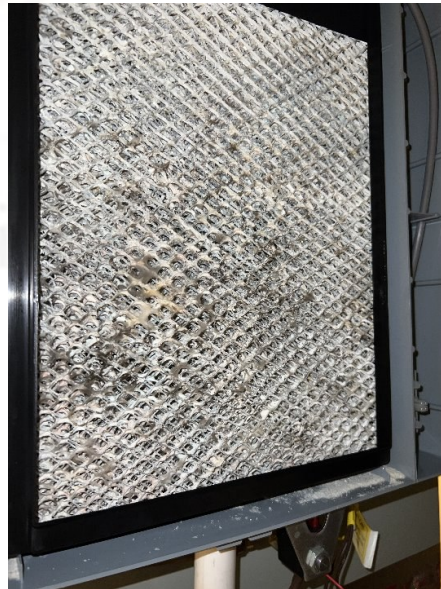
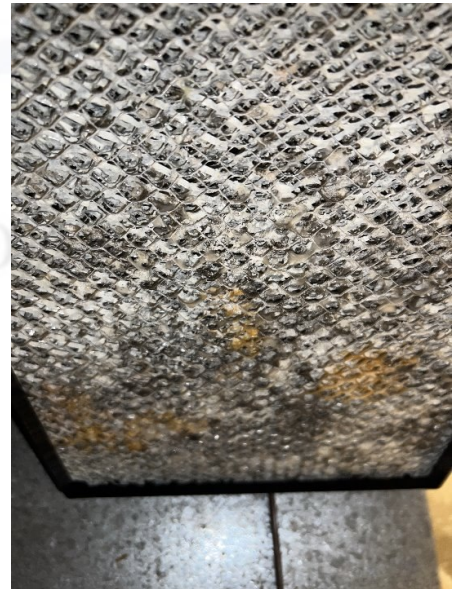
**C** The water panel in the humidifier is dirty. The discoloration on the water panel could be mold growth. I recommend replacing the water panel and cleaning the inside of the humidifier.

**C 2:** The water panel in the humidifier is dirty. The discoloration on the water panel could be mold growth. I recommend replacing the water panel and cleaning the inside of the humidifier.

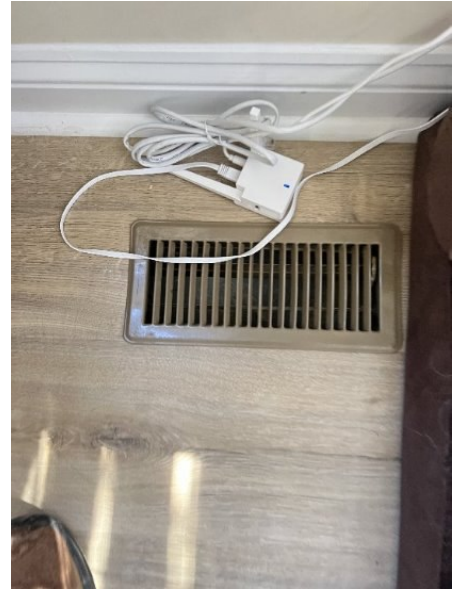
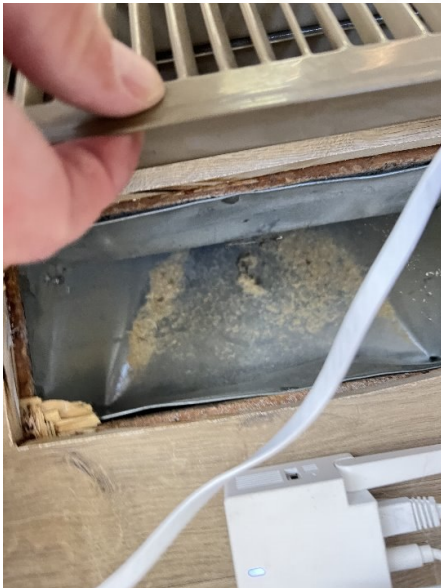
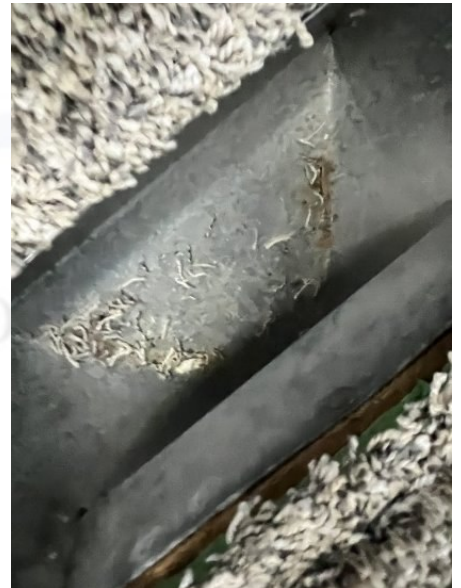
**IMP** A representative number of register covers were removed for inspection. Debris was just inside the ductwork. Dust, dirt, sawdust, and other debris can be a food source for mold. I recommend removing and cleaning under the HVAC registers.

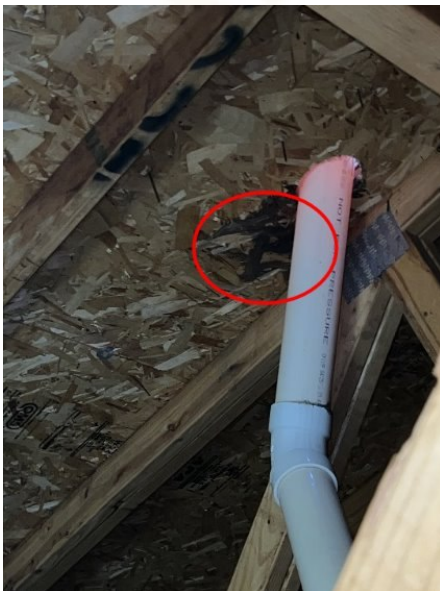
A water stain was noted under the upper rear plumbing vent. The leak appears to be from a pasted leak at the plumbing flashing collar. Currently, the flashing collar is in good condition. There does not appear to be an active roof leak.
