SUNLIGHT INSPECTION SERVICE

123 New Home Rd. Phoenixville, PA  
REPORT# 23032501D

**REVISED** Inspector  
Dan Keogh  
InterNACHI 13121612

The following numbered and attached pages are your pre-drywall inspection report. The report includes photographs, comments, and the Standards of Practice. This inspection was performed in accordance with the current Standards of Practice for Residential Pre-drywall Inspections of the American Society of Home Inspectors. The Standards contain certain and very important limitations, exceptions, and exclusions to the inspection. A copy is available prior to, during, and after the inspection, and it is part of the report. All components designated in the ASHI standards of practices, except for limitations that may be noted in the report, will be inspected. The inspection is for the most part a limited visual inspection only. A representative sampling of the building components is viewed in areas that are accessible at the time of the inspection. No destructive testing or dismantling of components is performed. Be sure to keep your signed copy of the home inspection agreement along with the report for future reference.

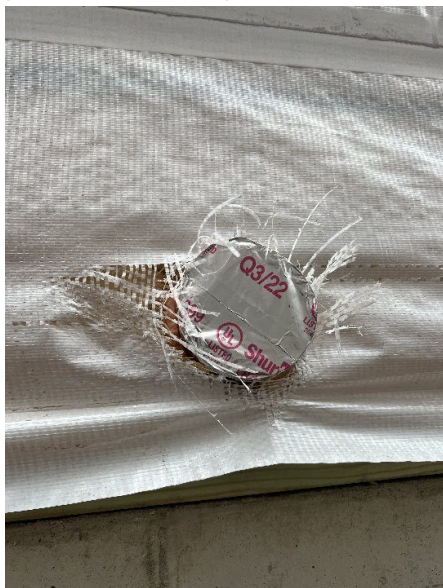
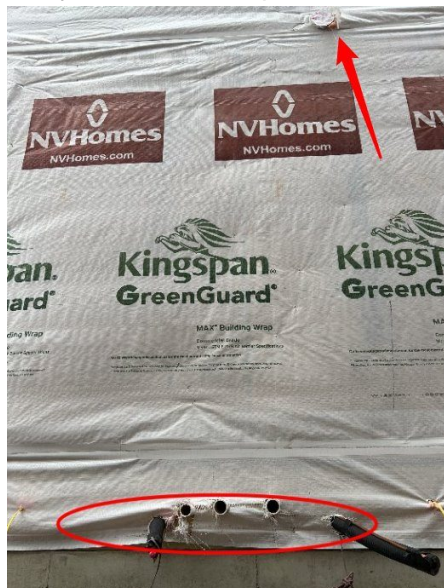
**C** Damaged house wrap was noted around some of the wall penetrations.

**C 2:** Damaged house wrap was noted around some of the wall penetrations. This is not uncommon during the course of construction. Prior to the siding being installed these areas should be repaired with house wrap tape or a house wrap patch and tape.

This is not uncommon during the course of construction. Prior to the siding being installed these areas should be repaired with house wrap tape or a house wrap patch and tape.

The repairs will most likely be done as the siding is installed. To verify that these areas have been repaired prior to the siding being installed I recommend that you ask the builder (siding contractor) to take pictures of the repaired areas before they are covered up.

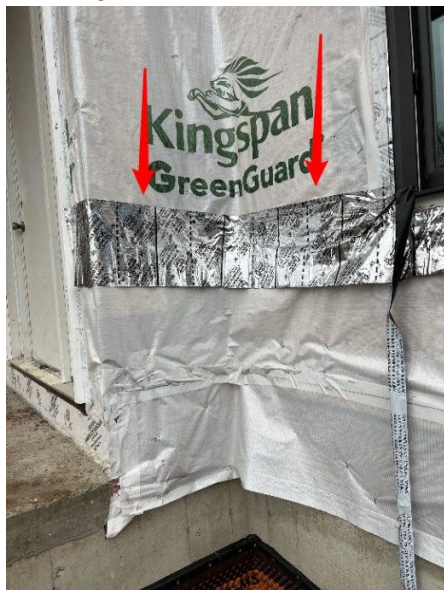
**M** It is unclear what the builder's intention is with the flashing tape installed at the approximate height of where the stone veneer will terminate on the front walls. The flashing tape has been installed in reverse lap flat fashion. Metal coping flashing will be installed over the top edge of the stone veneer. The metal coping flashing should be installed **behind the house wrap that comes down behind the vinyl siding.** I recommend discussing this with the builder to verify what his intentions are in making this transaction watertight.

**M 17:** It is unclear what the builder's intention is with the flashing tape installed at the approximate height of where the stone veneer will terminate on the front walls. The flashing tape has been installed in reverse lap flat fashion. Metal coping flashing will be installed over the top edge of the stone veneer. The metal coping flashing should be installed **behind the house wrap that comes down behind the vinyl siding**. I recommend discussing this with the builder to verify what his intentions are in making this transaction watertight.

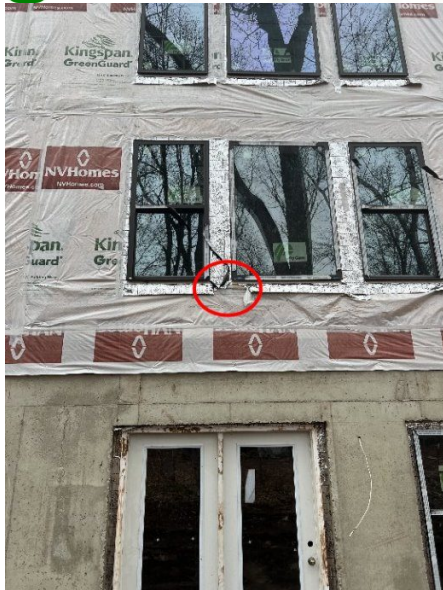
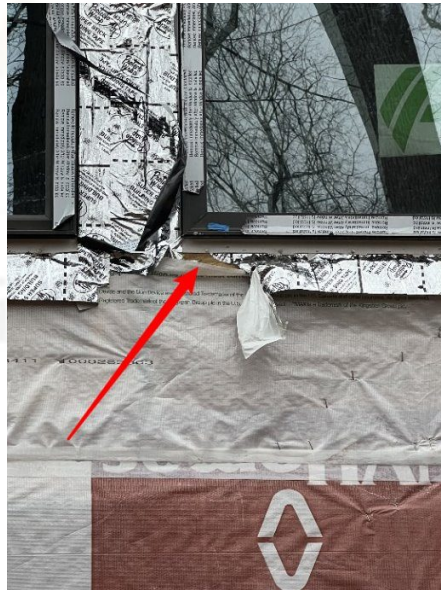
**C** Damaged window flashing was noted under the rear first floor triple windows.

**C 5:** Damaged window flashing was noted under the rear first floor triple windows.

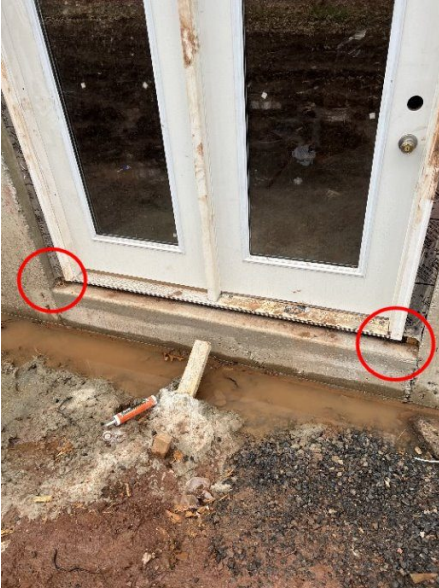
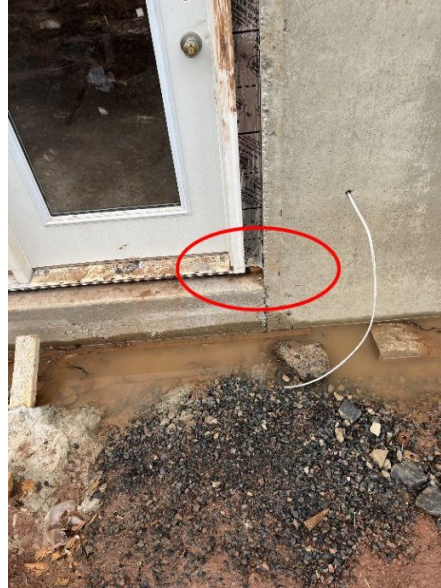
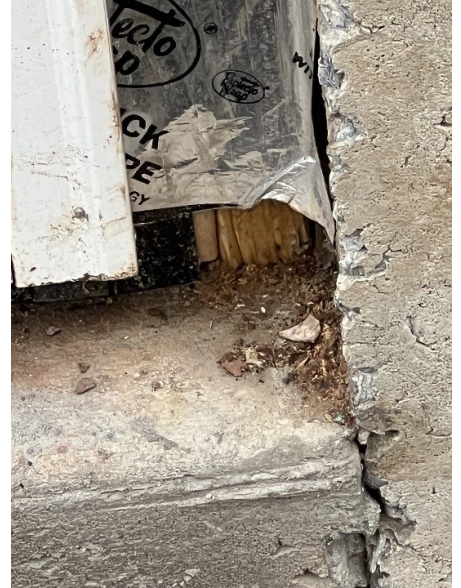
**C** The flashing tape on the sides of the exterior basement door have been installed short. The flashing tape does not extend down to the bottom of the door corners.

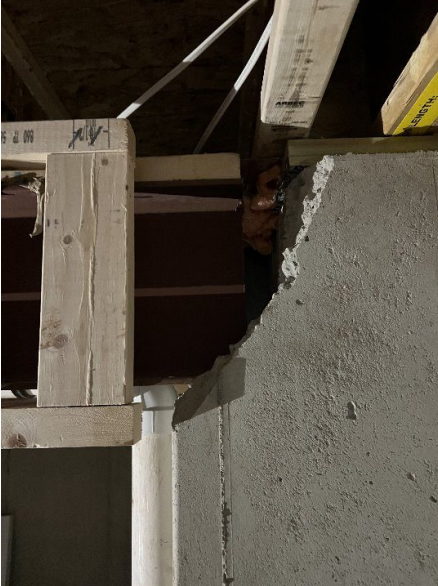
**C** The beam pocketed the front of the house is damaged. I recommend grouting the beam in place to prevent the possibility of structural movement.

**C 7:** The beam pocketed the front of the house is damaged. I recommend grouting the beam in place to prevent the possibility of structural movement.

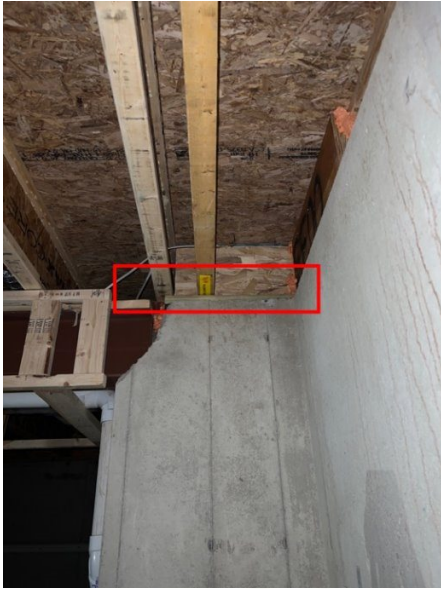
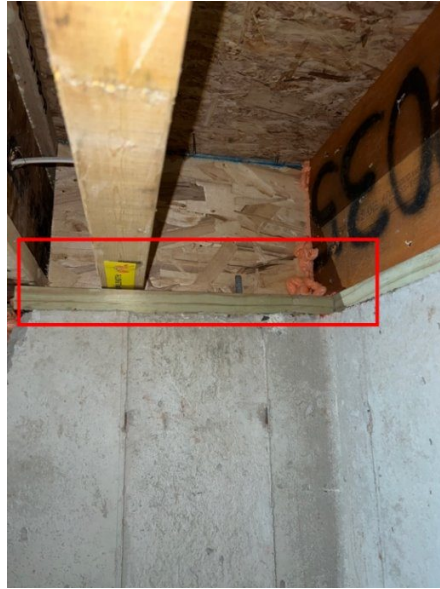
**C** A missing foundation bolt was noted on the short wall section at the front center of the basement and another at the front right corner. A minimum of two bolts is required in each sill plate. A bolt is required within 12 inches of the end of each sill plate.

only one bolt on this section

front right corner no bolt

**C 8:** A missing foundation bolt was noted on the short wall section at the front center of the basement and another at the front right corner. A minimum of two bolts is required in each sill plate. A bolt is required within 12 inches of the end of each sill plate.

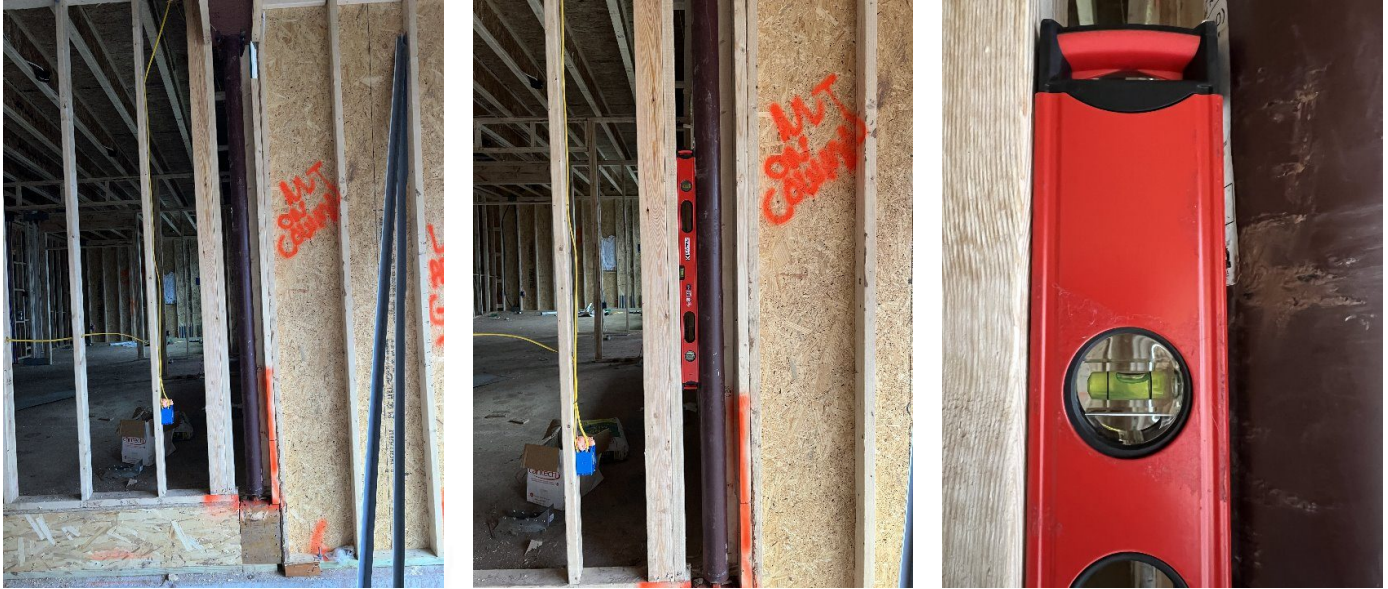
**C** The steel column near the basement HVAC system is out of plumb. The steel columns should not be out of plumb in excess of 3/8 of an inch and 8 feet. The bottom of this column is not been set yet. The builder should plumb the column before the concrete is poured.

**C** The steel column on the right side of the garage is out of plumb. The steel columns should not be out of plumb in excess of 3/8 of an inch and 8 feet. This column should be plumbed before the sheet rock is installed.

**Observation:** A steel column is out of plumb.

**Performance Guideline:** Steel columns shall not be out of plumb in excess of 3/8-inch in 8 feet when measured vertically.

**Corrective Measure:** The contractor shall repair any deficiencies in excess of the performance guideline.

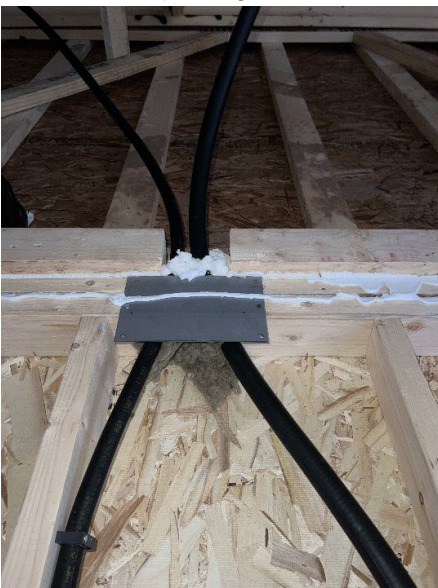
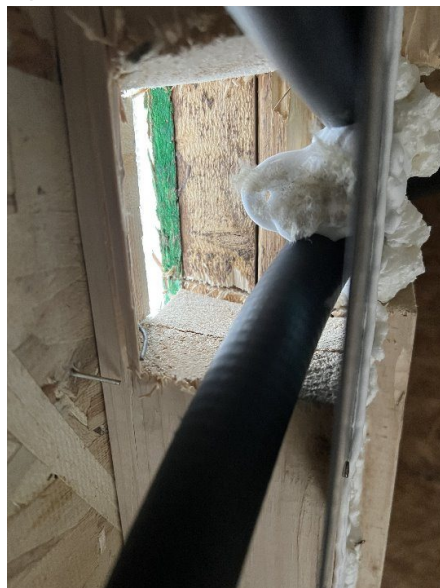
**C** A missing or incorrectly installed metal tie strap was noted at the top of the right exterior wall on the second floor. When a wall top plate is cut or notched more than 50% of its with metal tie strap is needed across the opening. The metal tie strap restores the structure to the wall.

**C 11:** A missing or incorrectly installed metal tie strap was noted at the top of the right exterior wall on the second floor. When a wall top plate is cut or notched more than 50% of its with metal tie strap is needed across the opening. The metal tie strap restores the structure to the wall.

When piping or ductwork is placed in or partly in an exterior wall or interior loadbearing wall, necessitating cutting, drilling and notching of the top plate by more than 50% of its width, a galvanized metal tie not less than 0.054 inch thick and 1 1/2 inches wide shall be fastened across and to the plate at each side of the opening with not less than eight 10d nails having a minimum length of 1 1/2 inches at each side or equivalent. The metal tie must extend a minimum of 6 inches past the opening.

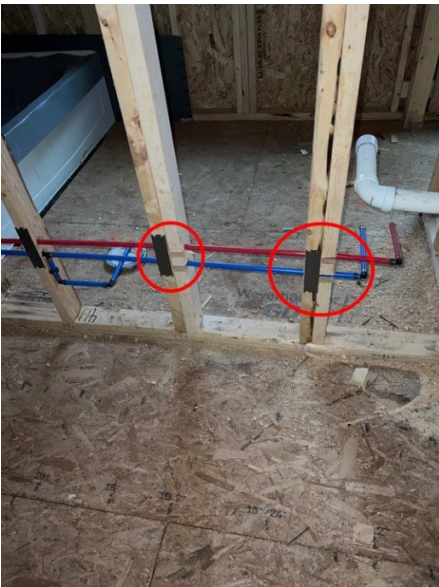
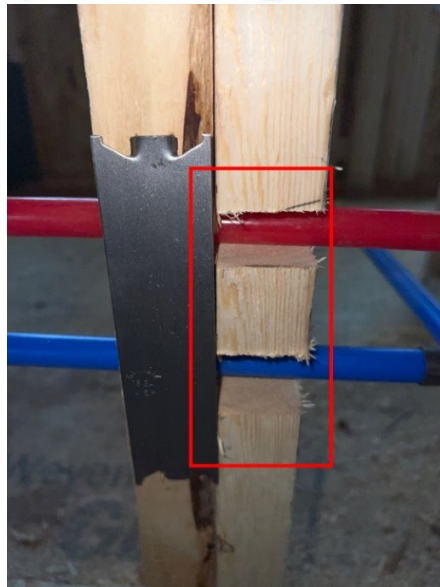
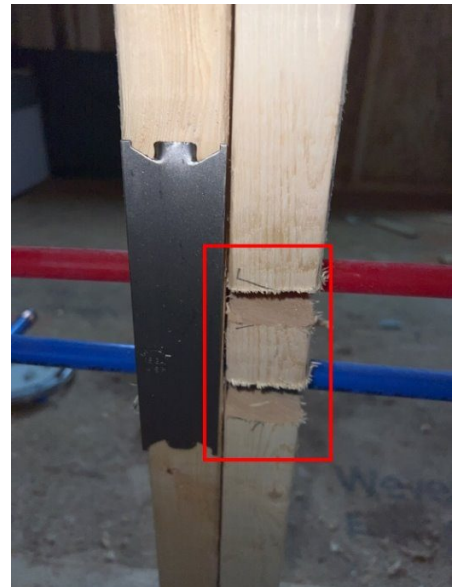
Second floor back right bathroom

**C** Unprotected water lines were noted in the second floor back right bedroom. When water lines are installed through studs, joists, or rafters and are closer than 1 1/4 inch from the edge of the framing member they need to be protected by steel plates to prevent possible damage from fasteners that may be installed in the wall.

**C 12:** Unprotected water lines were noted in the second floor back right bedroom. When water lines are installed through studs, joists, or rafters and are closer than 1 1/4 inch from the edge of the framing member they need to be protected by steel plates to prevent possible damage from fasteners that may be installed in the wall.

**P2603.2.1 Protection against physical damage** In concealed locations, where piping, other than cast-iron or galvanized steel, is installed through holes or notches in studs, joists, rafters or similar members less than 1 1/4 inch from the nearest edge of the member, the pipe shall be protected by steel shields. Such shield plates shall have a thickness of not less than 0.0575 inch. Such plates shall cover the area of the pipe where the member is notched or board, and shall extend not less than 2 inches above sole plate and below top plates

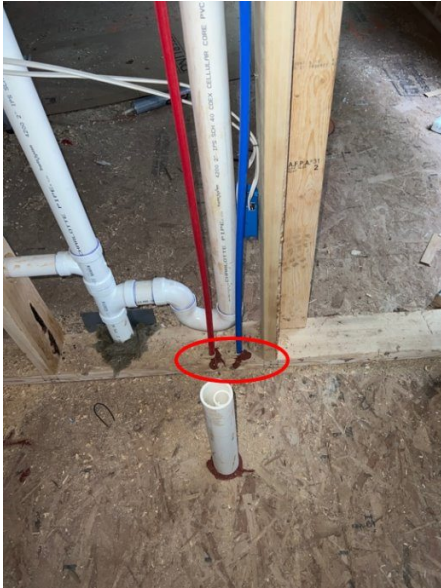
Laundry room

**C** Unprotected water lines were noted in the laundry room. When water lines are installed through studs, joists, or rafters and are closer than 1 1/4 inch from the edge of the framing member they need to be protected by steel plates to prevent possible damage from fasteners that may be installed in the wall.

**C 13:** Unprotected water lines were noted in the laundry room. When water lines are installed through studs, joists, or rafters and are closer than 1 1/4 inch from the edge of the framing member they need to be protected by steel plates to prevent possible damage from fasteners that may be installed in the wall.
