SUNLIGHT INSPECTION SERVICE

15 Nice Lane Sunnyside, Pennsylvania 19000
REPORT# 23020900D

Report Prepared For
John & Joan Buyer

Inspector
Dan Keogh
InterNACHI 13121612

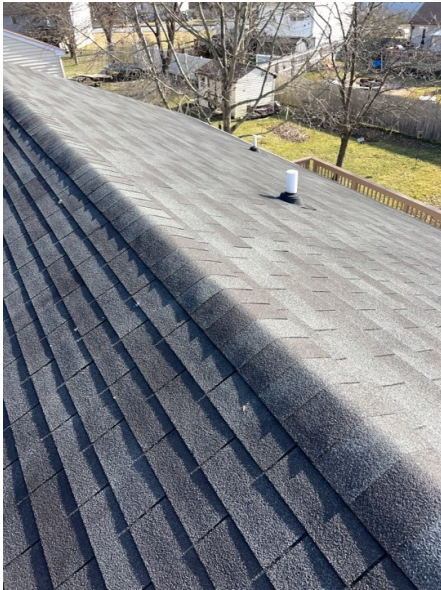
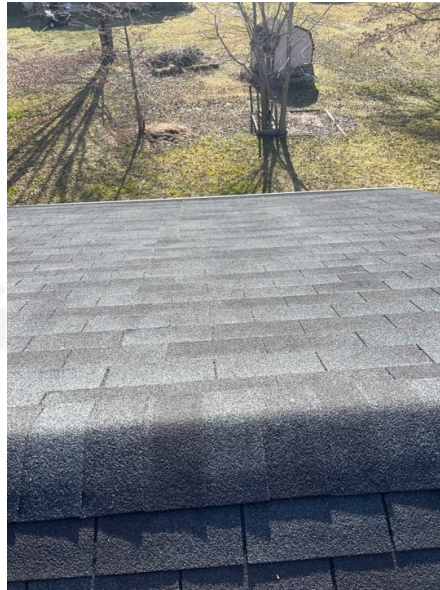
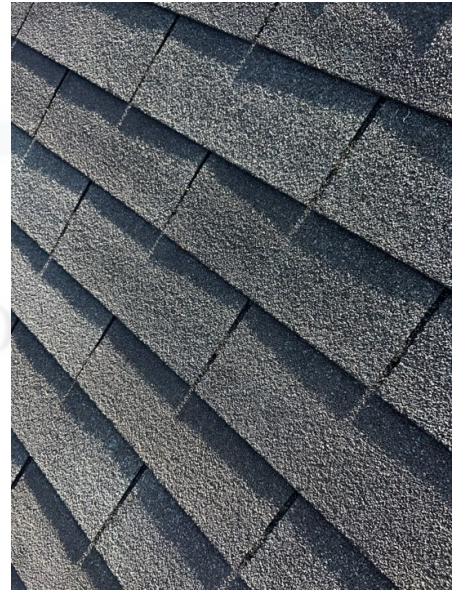
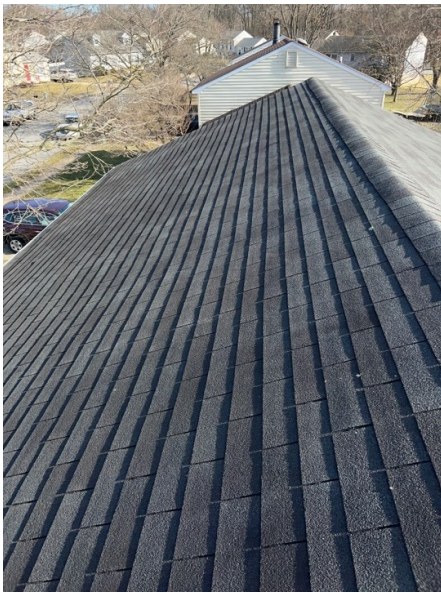
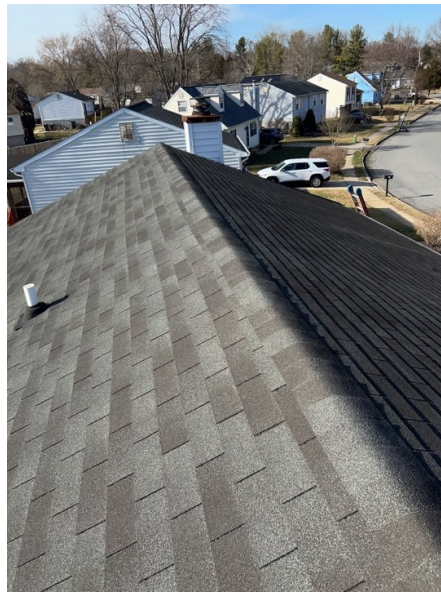
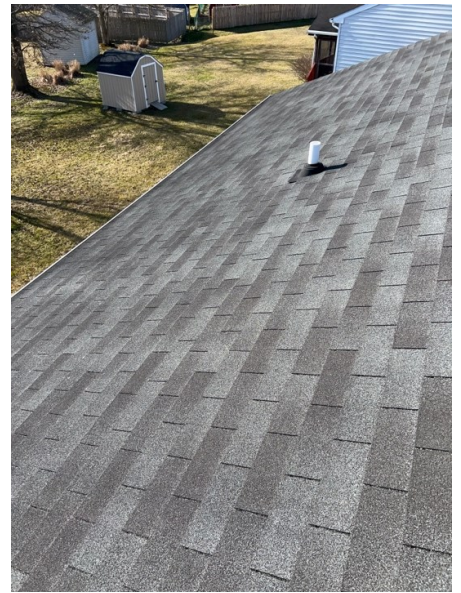
ASPHAT SHINGLES

The asphalt fiberglass shingles on the roof appear to be in functional condition.

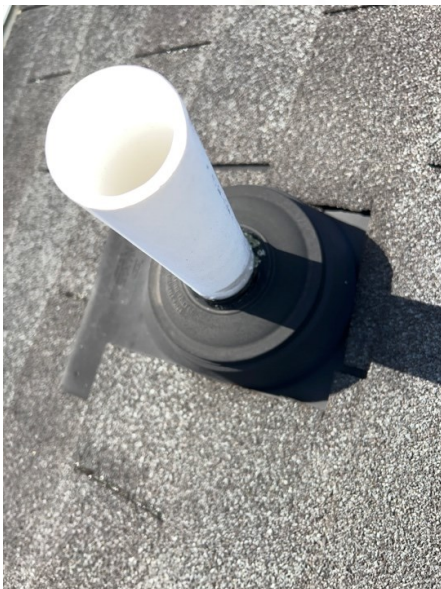
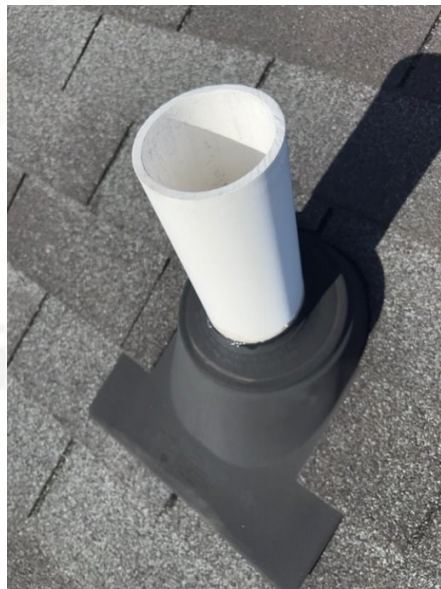
PLUMBING VENTS

There is visible flashing installed around the plumbing stacks. No damage. Good.

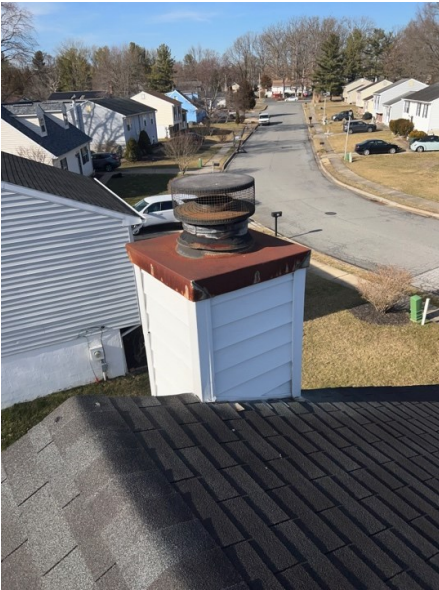
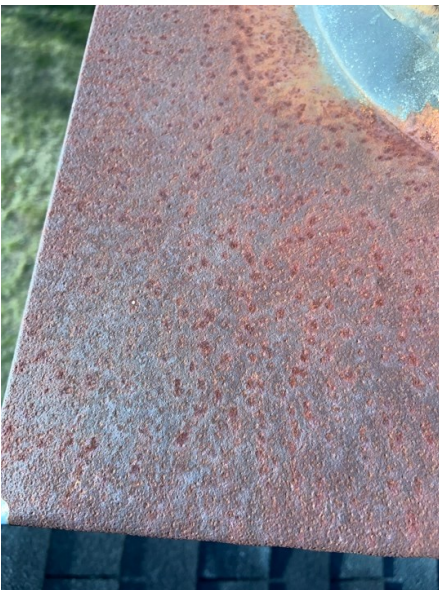
REC Rust and corrosion was noted on the chimney cover. The metal cover at the top of the chimney chase that houses the metal flue for the manufactured fireplace was corroded/rusted.

It is very important that the metal cover remain watertight. If water penetrates the metal cover and runs down the chimney chase it may damage the manufactured fireplace, the chimney chase, or other components of the house.

A qualified chimney sweep should replace the cover before pin holes and leaks develop.

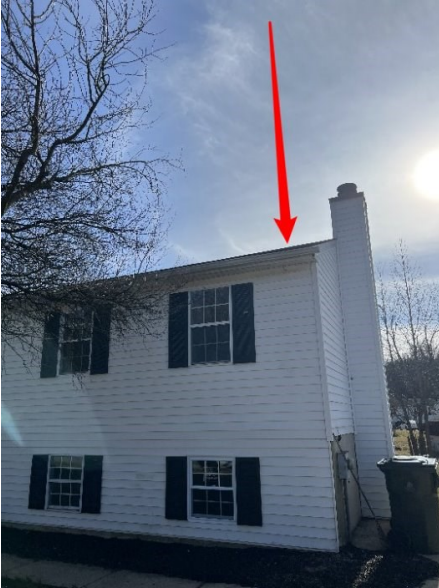
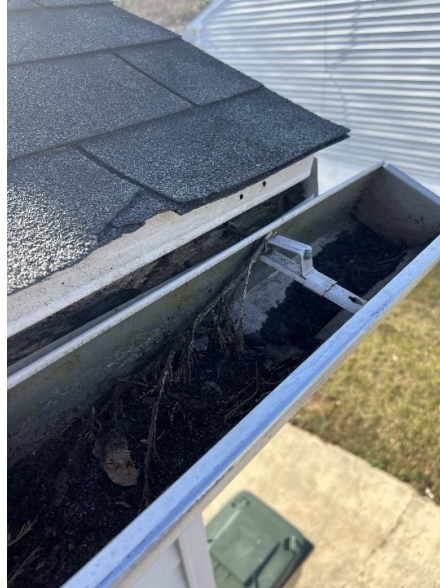
REC A loose and sagging gutter was noted. The front gutter is sagging on the right side. The fascia board behind the gutter has deteriorated and is no longer able to hold the gutter hangers.

After the fascia board has been repaired the gutters should be secure to the house and slope continually toward the downspouts.

A qualified roofing contractor should repair the gutters as needed.

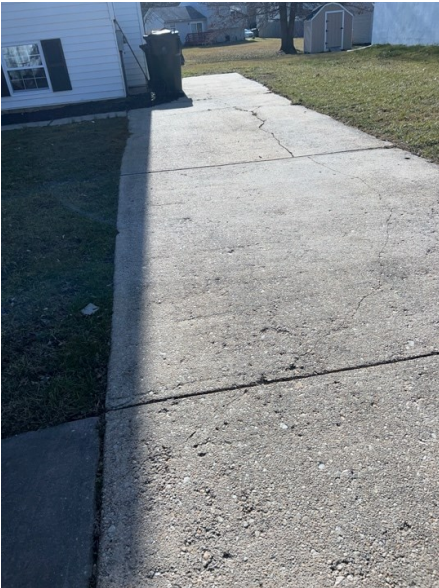
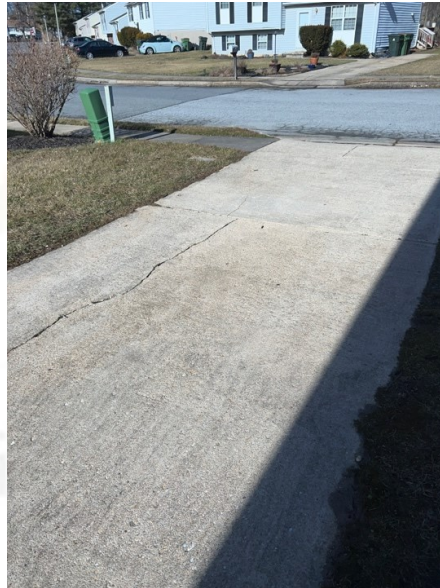
The driveway and parking area appeared functional.

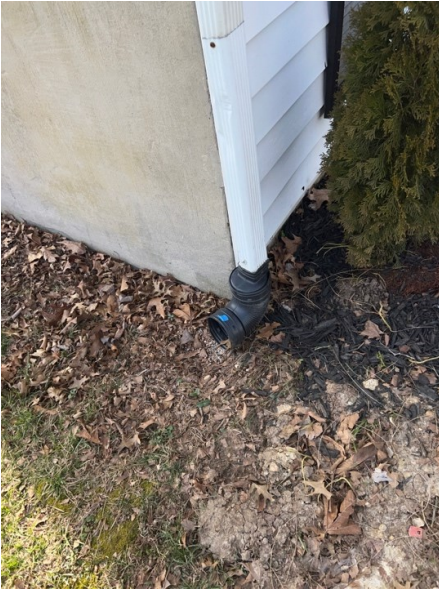
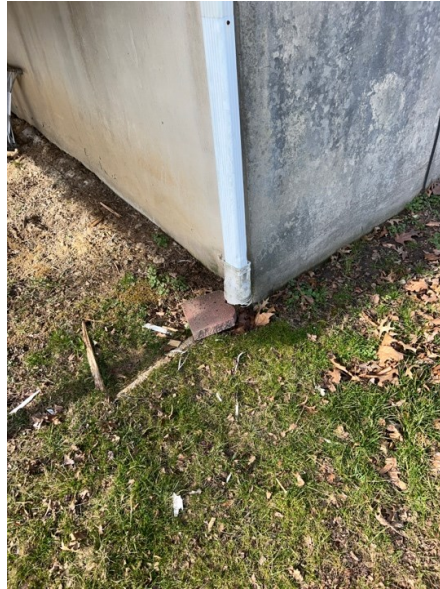
REC The downspout at the front left corner and back left corner needs to be extended to take water further away from the house. Water should not be allowed to drain right next to the foundations. A qualified person should extend the spout.

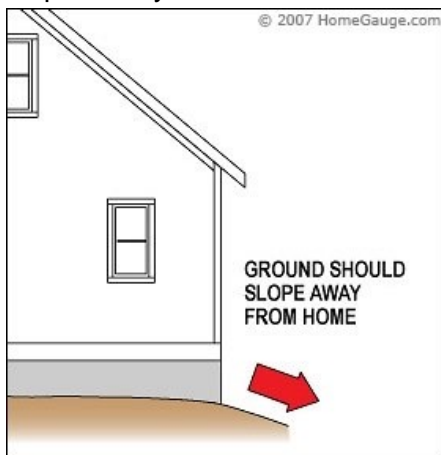
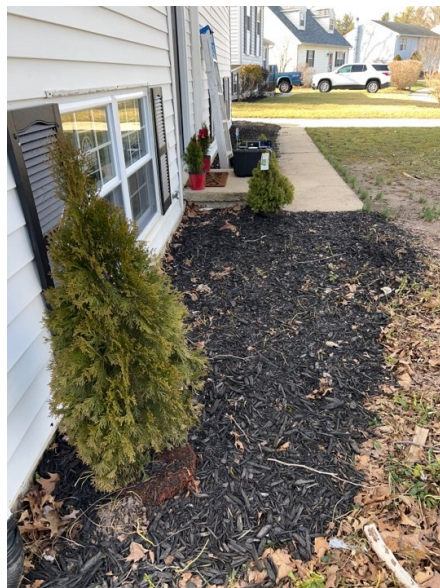
REC Poor drainage (grading) was noted near the foundation. The ground around the home is level and not sloped away from the house.

In order for drainage to be effective, the landscaping must be configured so that the yard is sloped away from the foundation at a pitch of no less than 6 inches in the first ten feet. Failure to maintain sufficient drainage will cause rain and surface runoff to drain toward the foundation where it can seep into basements and crawlspaces.

The soil around the home should be graded to take water away from the foundation.

A qualified landscaping professional should add and regrade soil around the home so that the ground slopes away from the house.

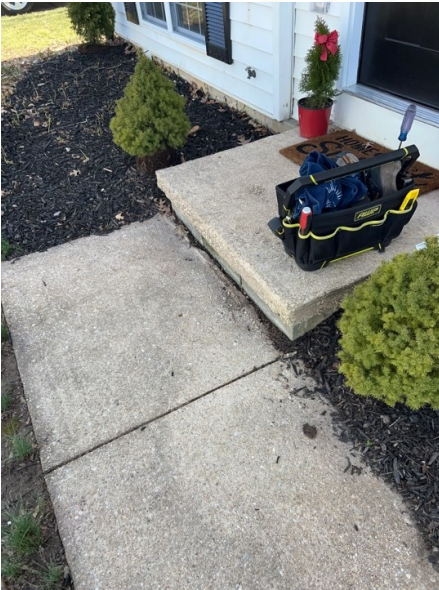
The steps and walkways leading to the dwelling entrances appeared functional.
No major trip hazards are apparent.

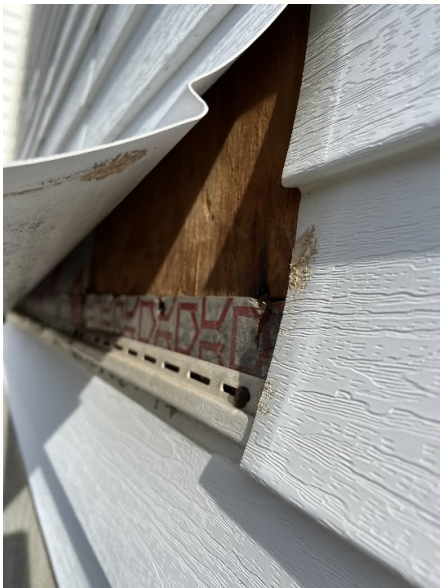
INSP The vinyl siding was installed without building paper or house wrap behind it (drainage plane). Vinyl siding is a watershed and not waterproof. Water will get behind the siding at the window, door, siding, and J channel locations. A drainage plain, house wrap, or building paper, is needed behind the siding to shed water down the wall and to the exterior.

A drainage plane can only be installed by removing the siding. This should be considered when factoring in repair options for the nailing issue noted below.

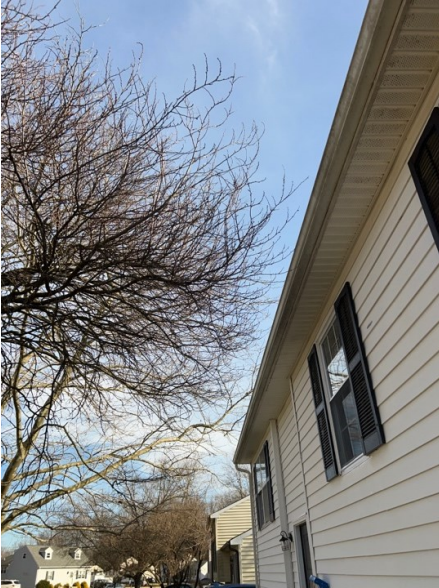
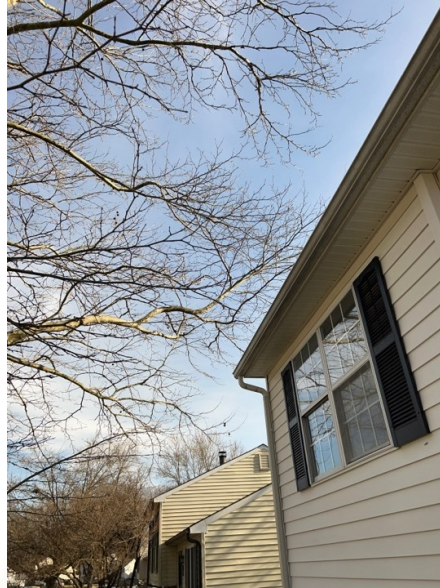
IMPR Shrubs and trees were noted growing on the side of the house. Shrubs and tree limbs should not be leaning on or touching the house.

Plants on the side of a house can hold moisture against the house for extended periods of time, rub against the siding, and can create a path for insects to enter the house.

Pruning of the shrubs and trees around the house is recommended.

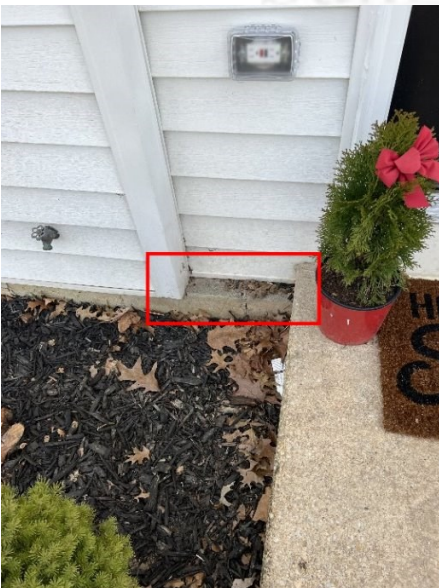
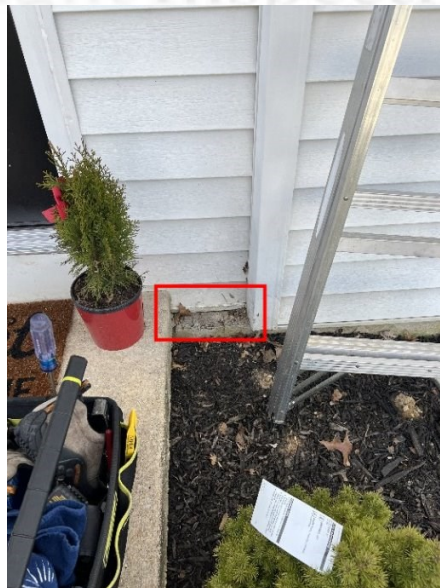
REC Metal flashing is missing at the bottom of the exterior wall sections to the right and the left of the front door. Metal flashing should be installed up behind the siding and run out over the top of the foundation. Flashing is needed to prevent water from running under the wall framing where it could damage the wall. A qualified siding contractor should stall the flashing.

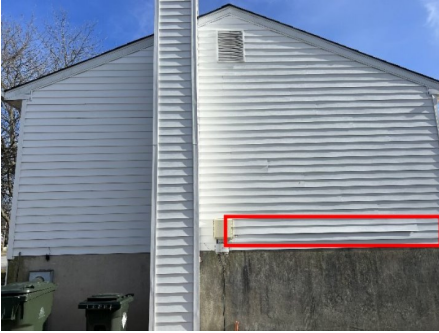
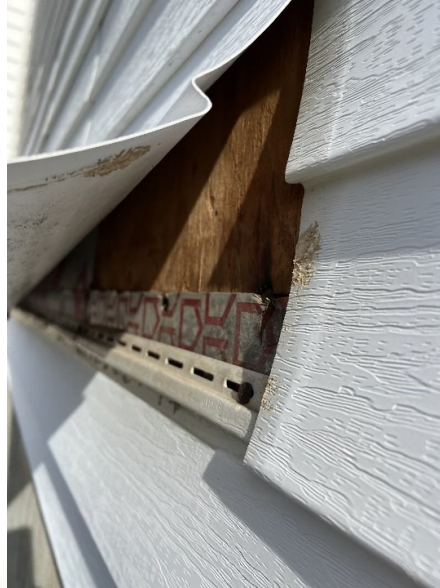
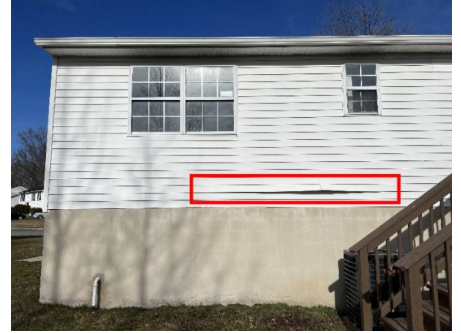
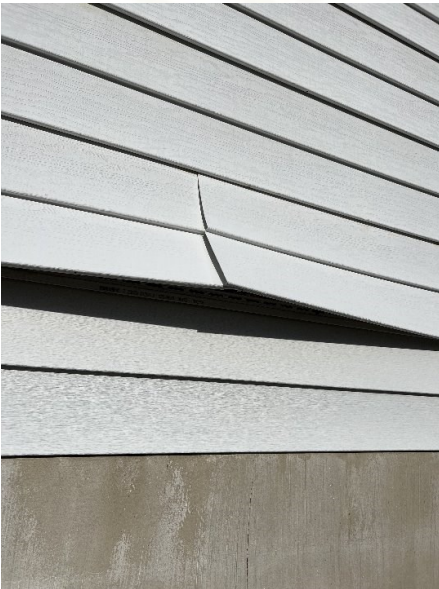
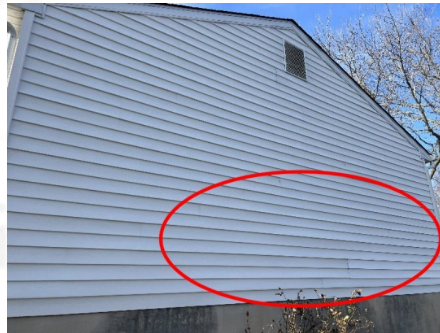
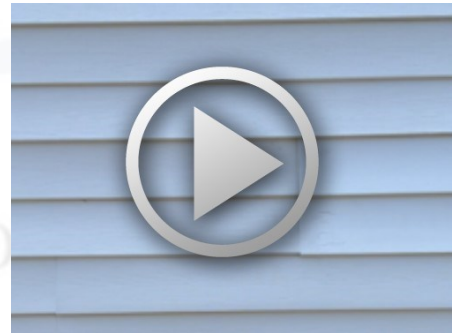
Loose and damaged siding was noted in several locations. The siding has been under-nailed or improperly nailed. This has caused several of the siding panel to come loose from the wall. Loose siding can allow water intrusion and damage to the exterior wall.

To prevent water intrusion and further siding panels from separating a qualified siding contractor should evaluate further and repair as needed.

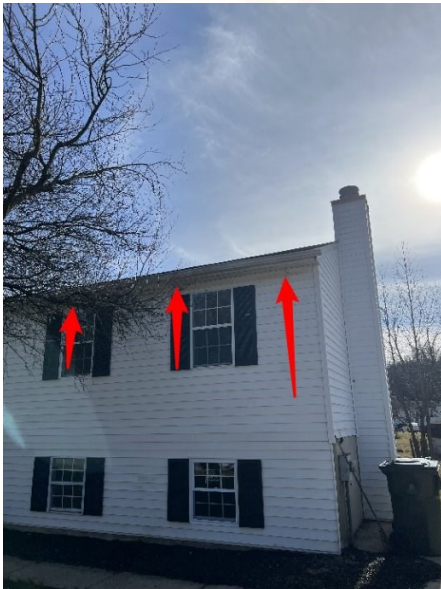
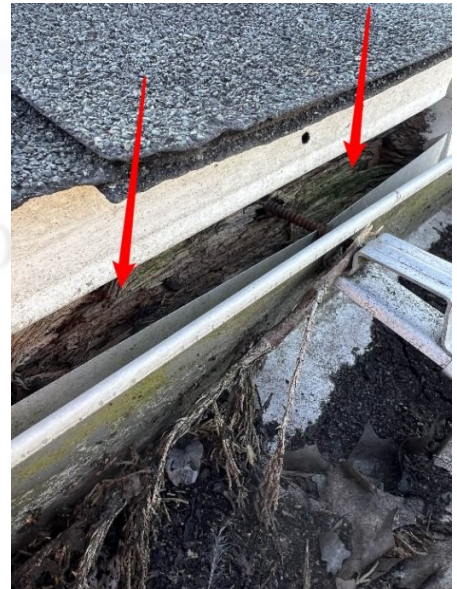
REC Wood deterioration was noted on the fascia board behind the front gutter. The front gutter will need to be removed to determine how much of the fascia board will need to be replaced.

A qualified siding contractor should repair and replace the fascia as needed.

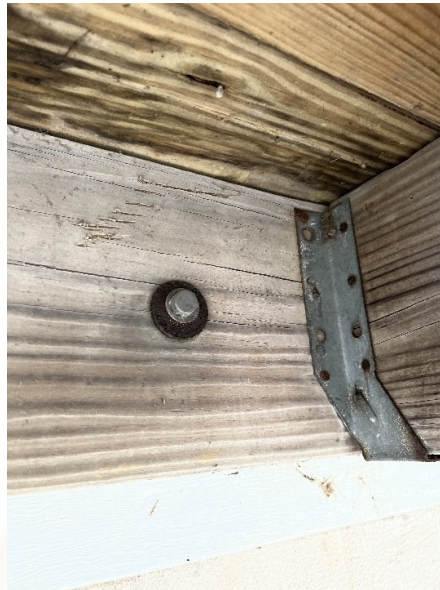
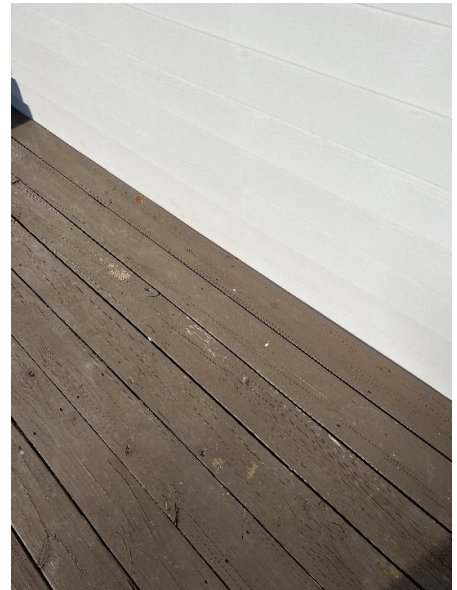
REC There was missing flashing along the ledger board of the deck.

Water can run behind the ledger board and rot the deck and the framing of the house. Water can also weaken the bolt-to-band joist connections that hold the deck to the house.

Flashing needed to prevent water from running behind the ledger board

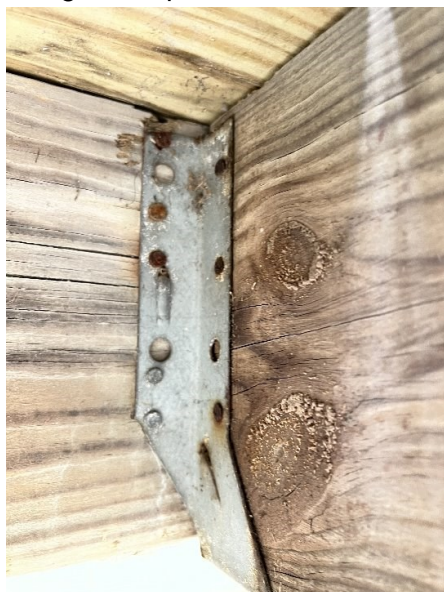
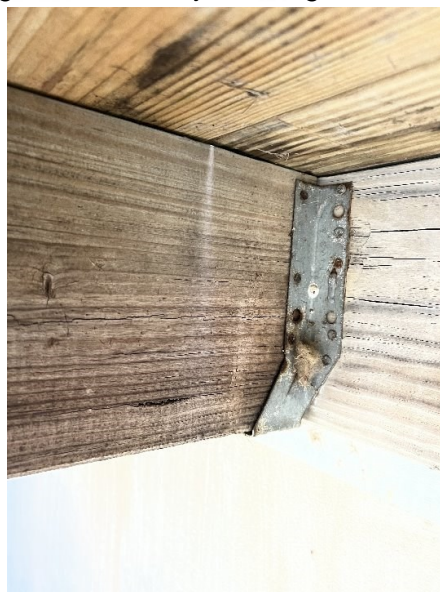
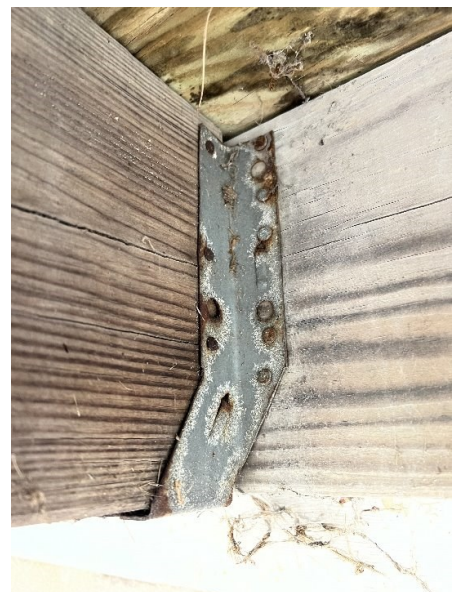
REC The joist hangers are fastened with "common" nails. Using the wrong nails to fasten joist hangers is unsafe. Common nails do not have enough shear strength to be used as joist hanger nails. The proper nails should be installed in the joist hangers for safety.

Special N10 nails (1 1/2' long x 9 gauge hot-dip galvanized) are recommended. N10 nails are specially designed to provide the shear strength needed for joist hangers.

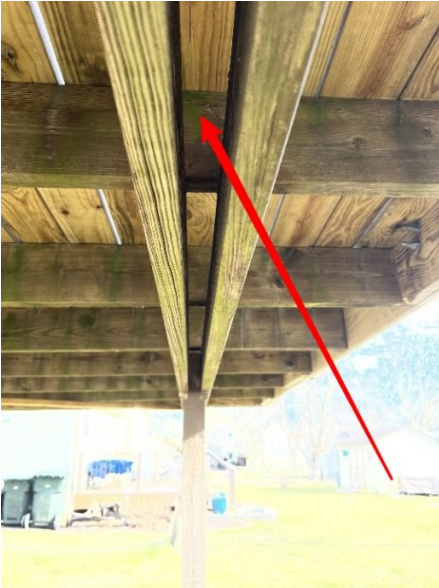
A split beam and incorrect post-to-beam connection were noted at the deck. Current accepted standards recommend that the beam that carries the load of the deck be bolted together. Split beams are not considered strong enough to carry the load of the deck. Current accepted standards recommend that the beam be supported by a post, not the bolts that connect the beam to the post. For increased safety, I recommend having a qualified carpenter improve the deck structure to that it meets today's standards.

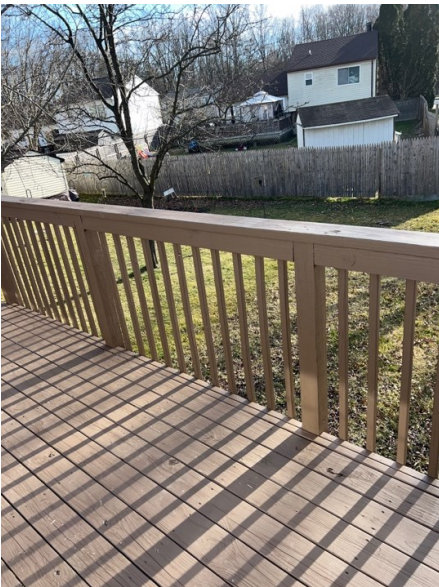
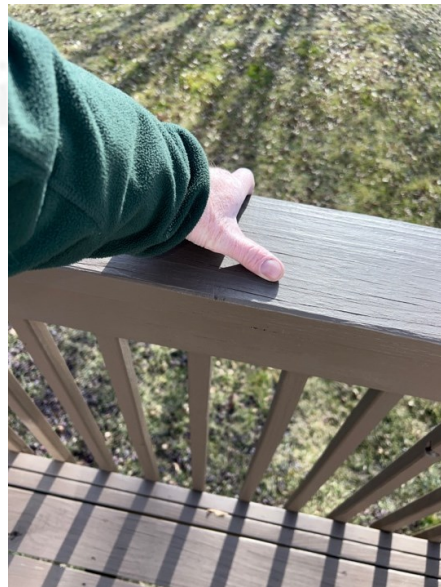
The deck railing felt sturdy. The deck railing should be checked regularly and tightened or improved as necessary.

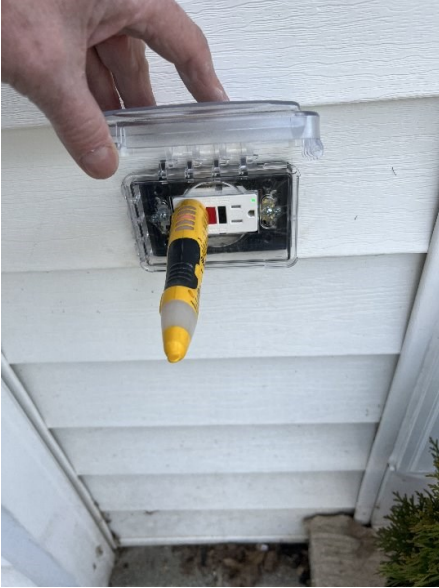
The outside electric receptacle was live and protected by a functional GFCI (or Ground Fault). However, this receptacle has an open ground and should be repaired. See *electrical* section.

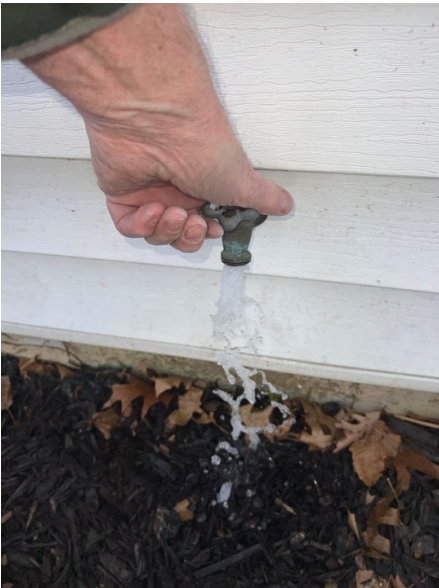
There is running water at the exterior faucet.

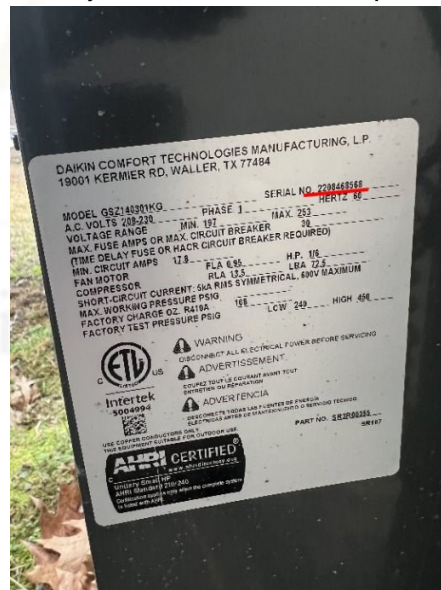
Manufactured August 2022

The condenser for the heat pump is located on the back side of the home. The condenser unit appears level and was securely mounted on a base. The insulation around the condenser's suction line was in good condition. There is an electrical service disconnect for the condenser unit. The fins on the condenser appeared clean. No rust or corrosion was noted.

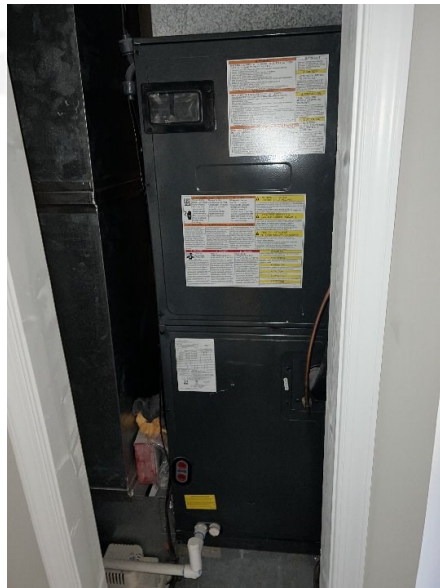
The suction lines that carry the refrigerant to the indoor coil appear to be in good condition and felt warm. No active condensation water leaks seen.

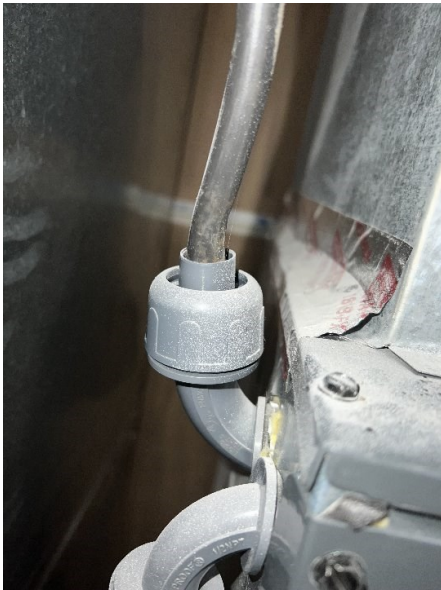
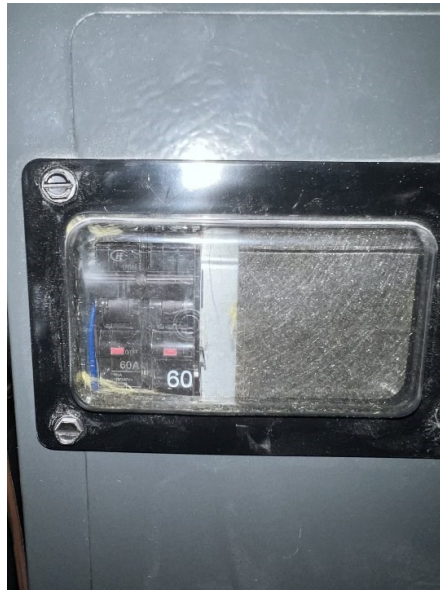
There is an electrical heating element in the air handler for back-up heat. I ran the unit on back-up heat for approximately 15 minutes, the back-up heat produced heat.

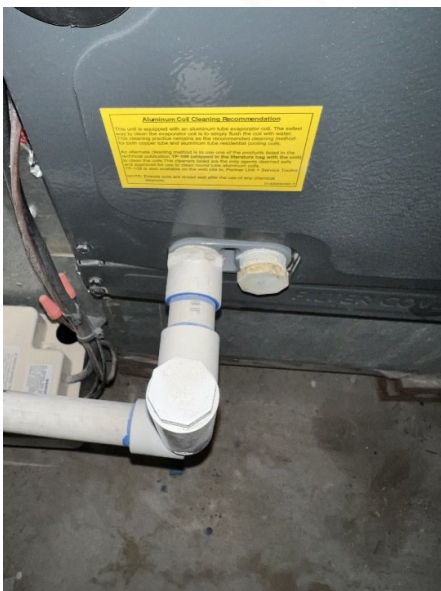
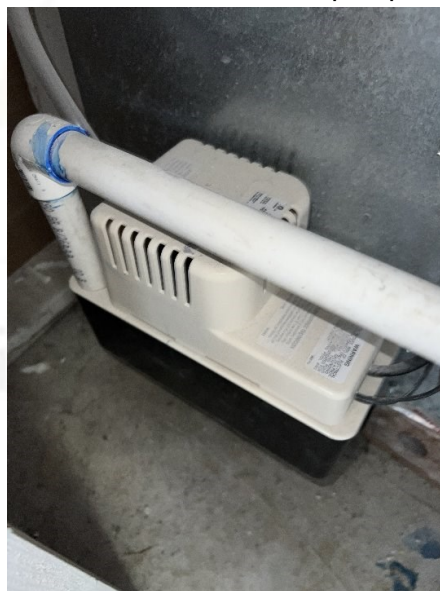
The condensation line drains from the unit to a condensation pump and is pumped outside.

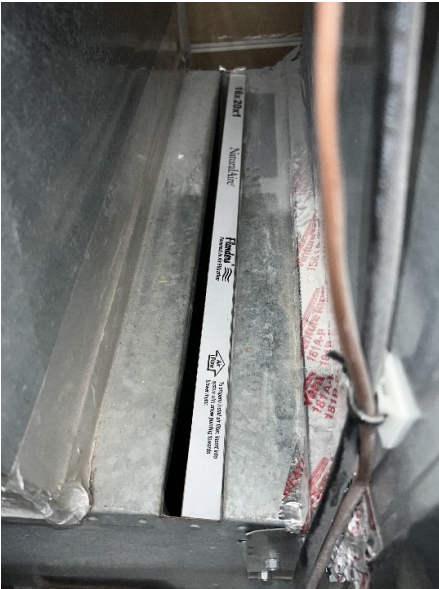
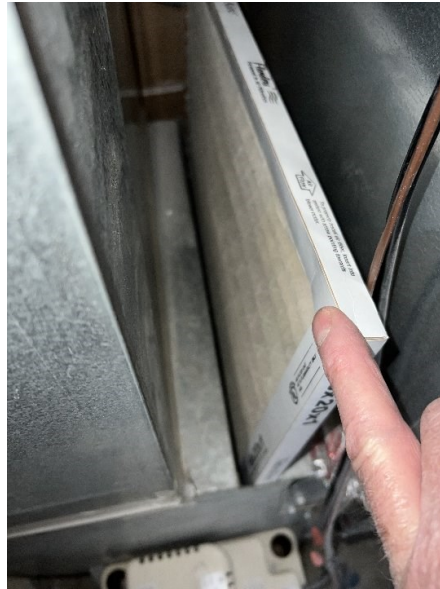
AIR FILTER

At the time of this inspection the air filter for the forced air heating/air conditioner was clean. I recommend that the air filter be checked every month the system is in use and changed as needed. This will prevent dirt from building up on the internal components and and reduce the amount of dirt particles that are distributed through the ductwork a.

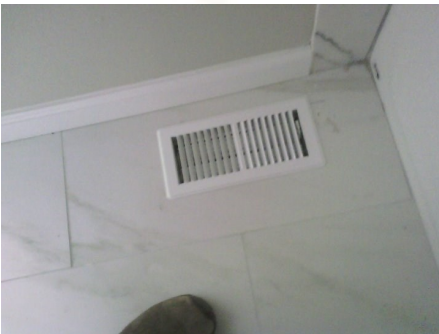
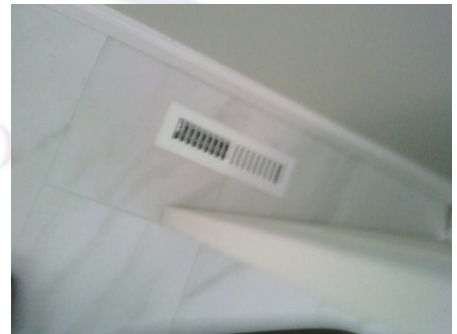
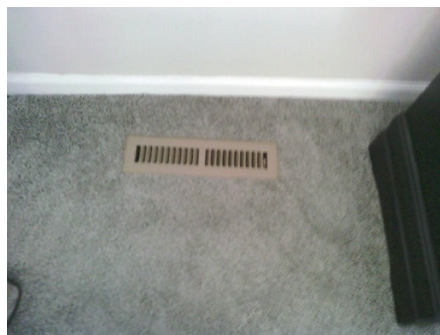
DUCT WORK

A thermal imaging camera was used to check the registers. All the HVAC registers were getting conditioned air at the time of the inspection.

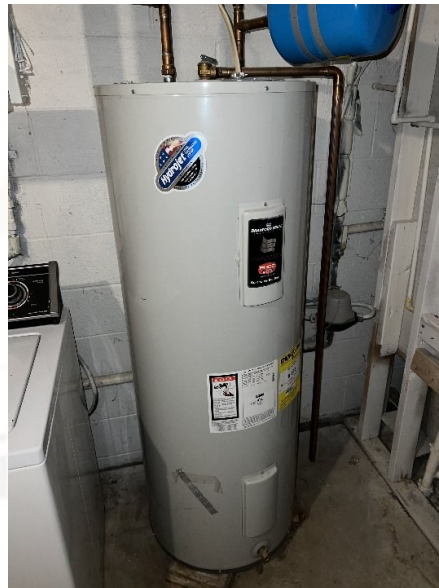
The tank has the properly sized electrical cable connected to it.

The electrical grounding is visible.

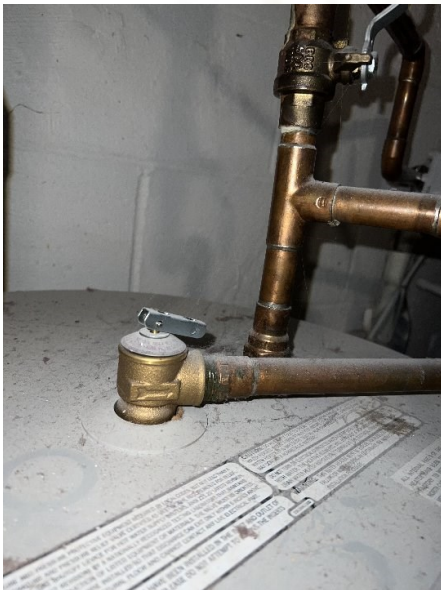
TEMPERATURE & PRESURE RELIEF VALVE

The T&P valve (Temperature and Pressure Relief) for the water heater is present and its discharge pipe is extended to the floor.

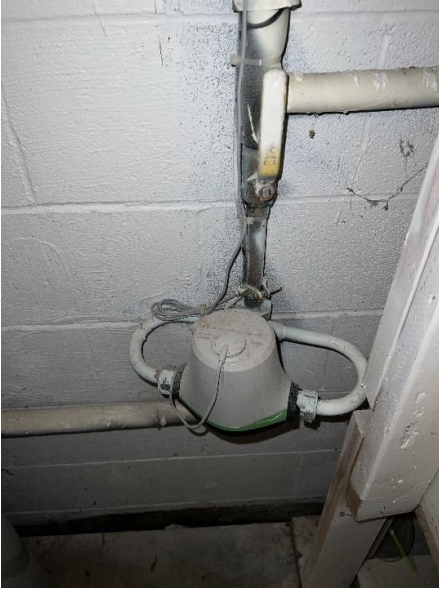
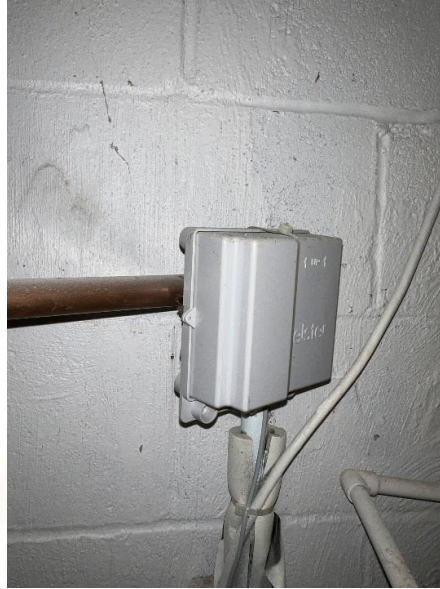
No leaks were observed near the water meter or at any of the visible fittings in the basement.

The water pressure appeared adequate at the time of inspection.

The meter has an electronic reader on it so the water company will not have to come into the house to read the meter.

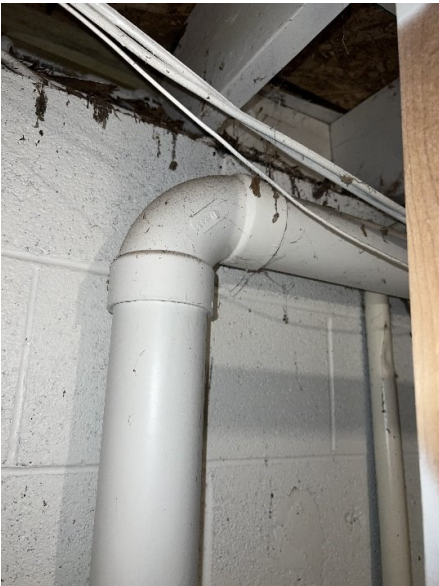
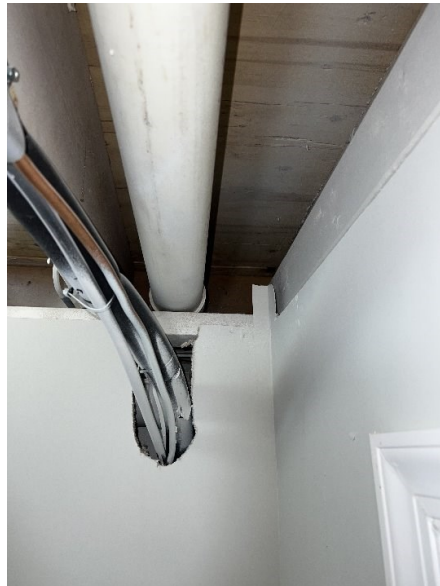
DRAIN & WASTE SYSTEM

The waste line pipes were well supported. No visible cracks in any of the lines.

Water was run at all the plumbing fixtures in the house.

The cleanout fitting was visible.

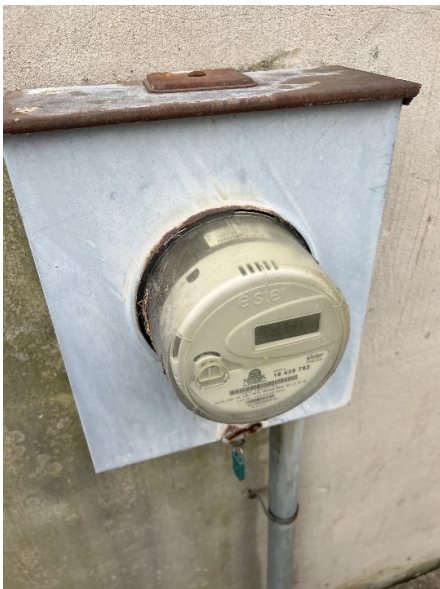
ELECTRICAL METER

With normal hand pressure, the electric meter felt securely attached to the house.
There is no major rust or corrosion visible on the meter box.

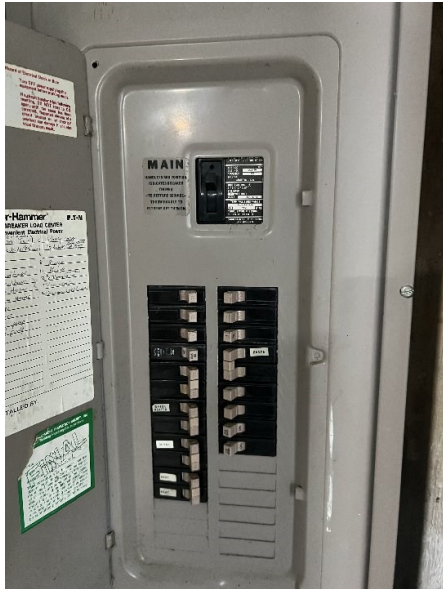
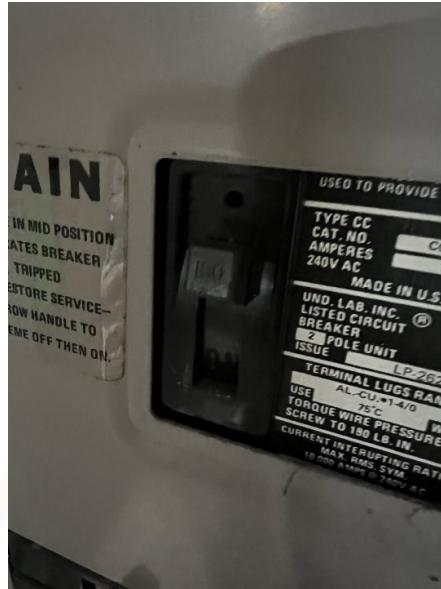
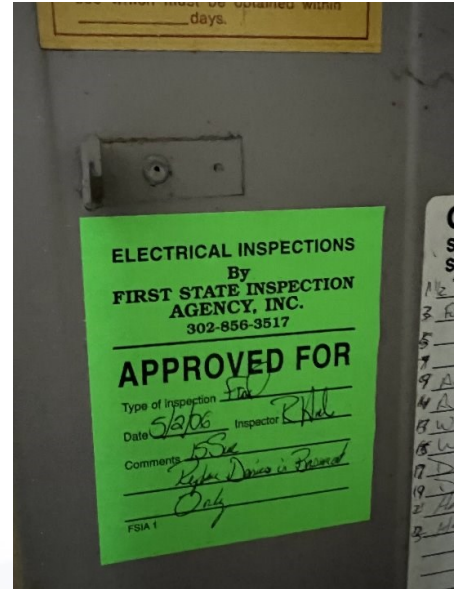
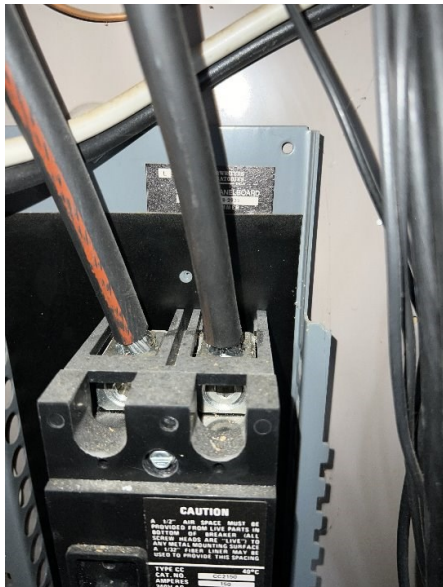
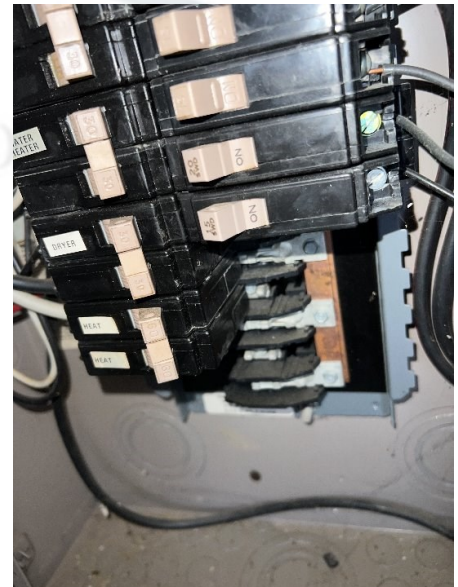
There is room for expansion in the panel.

For safety remember to keep proper clearances around the panel.

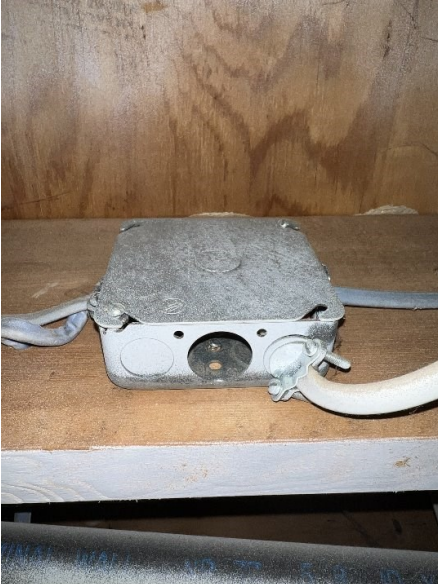
REC A junction with an open knockout (a hole) was noted above the laundry area. There should be no open holes in junction boxes, switch boxes, or outlet boxes. Open holes in junction boxes are an electrical hazard. The hole should be covered with a replacement knockout plate or electrical tape. Electrical repairs should be performed by a qualified electrician.

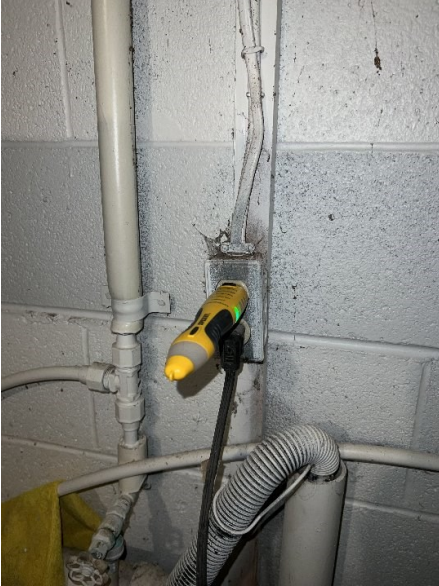
SAFE The receptacle to the right of the utility tub is not GFCI protected.
Current accepted standards recommend that all receptacles that are within six feet of a water source or in a laundry area be GFCI protected.
For increased safety, a qualified electrician should install GFCI protection for the laundry area receptacles.

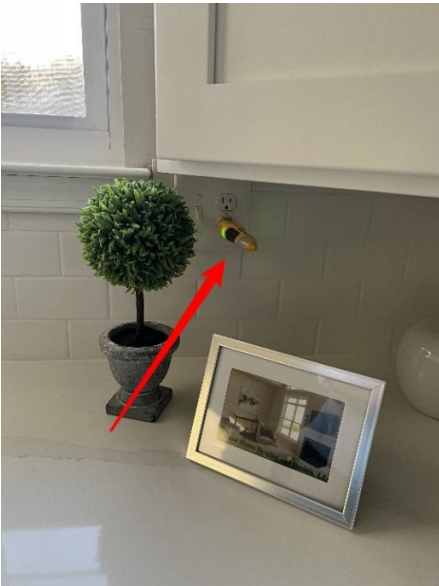
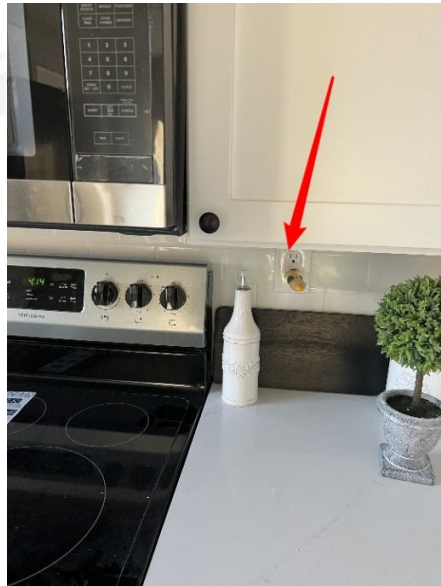
SAFE None of the receptacles that serve the kitchen countertops were GFCI protected.
Current accepted standards recommend that all the receptacles that serve a kitchen countertop be GFCI protected.
For increased safety, I recommend having a qualified electrician install GFCI protection for the kitchen receptacles.

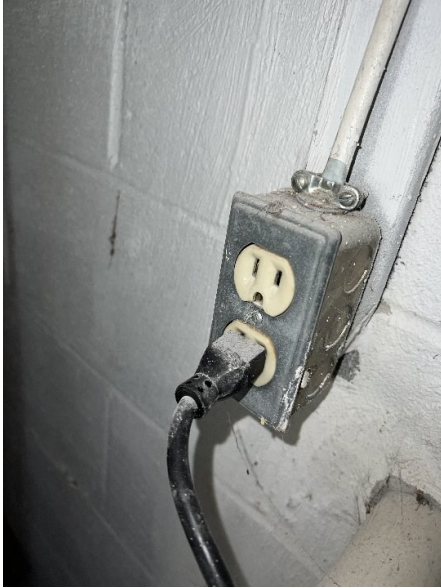
SAFE The receptacle above the sump pump is not GFCI-protected. Current accepted standards recommend that all receptacles in unfinished areas of the basement be GFCI-protected. For increased safety, I recommend having a qualified electrician install GFCI protection for the basement receptacles.

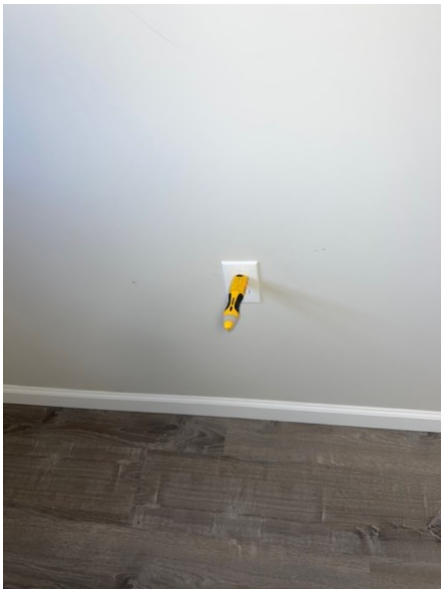
Left wall of left front room in the basement.

REC A receptacle with an open ground was noted on the exterior of the house and in the front left basement room. A qualified electrician should inspect the receptacle circuits and repair as needed.

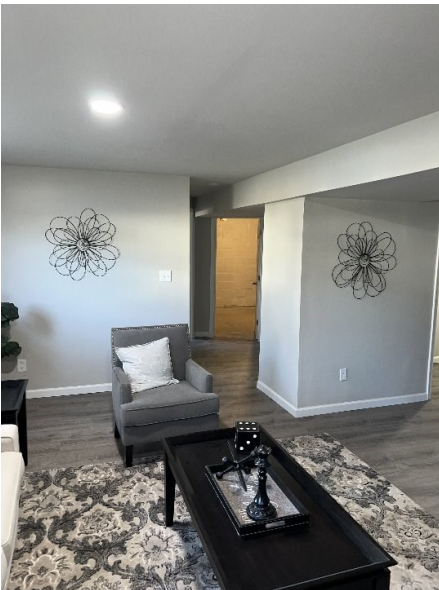
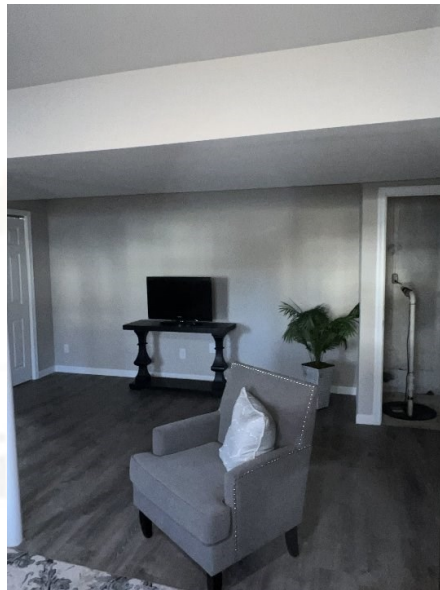
LIMITATIONS

The inspection of the basement is restricted by the finished walls and ceiling. Limited visual access. Much of the electrical wires, water and sewer pipes, heating ducts/pipes, floor structure and foundation can not be seen. There may be components above the ceiling and behind the walls that need improving or correction that the inspector can not see.

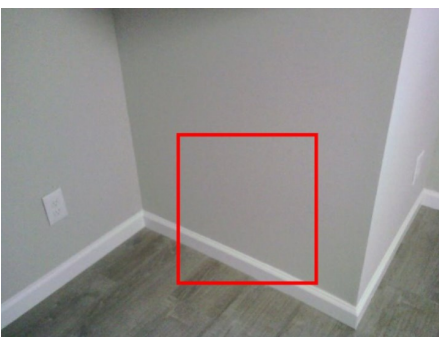
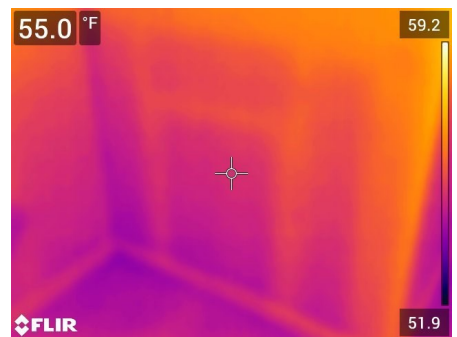
INSP The access to the crawlspace underneath the front stair landing has been closed off. I am unable to inspect the floor structure and foundation underneath the front stair landing. I recommend having access provided to this area so that it can be inspected prior to taking custody of the home.

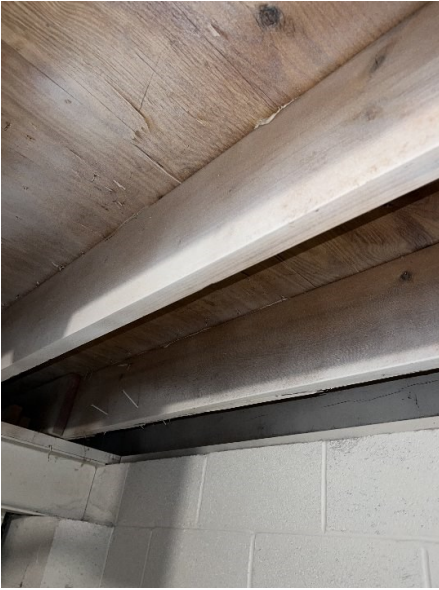
FLOOR STRUCTURE

The floor joists are constructed of dimensional joists. Readily accessible areas were inspected.

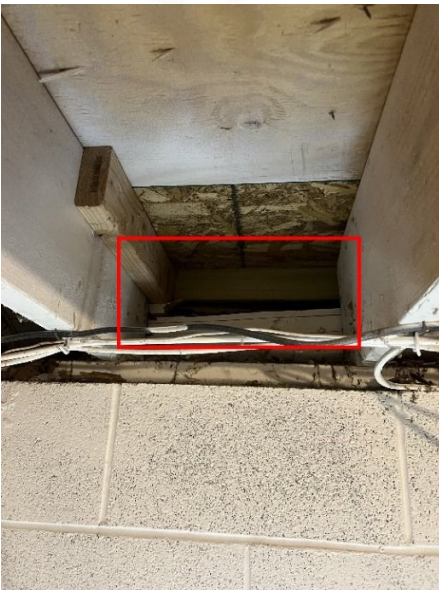
REC Damage to the rear band joists was noted underneath the rear sliding door. Water damage was noted to the band joist underneath the rear sliding door.

Additional repairs are needed in this location. The band joist serves two functions. One is to transfer the load of the rear exterior wall down to the foundation. The other is to prevent the floor joists from rotating. The repair that has been done to install the new sliding door does not address these two factors. A qualified carpenter should evaluate further and repair as needed.

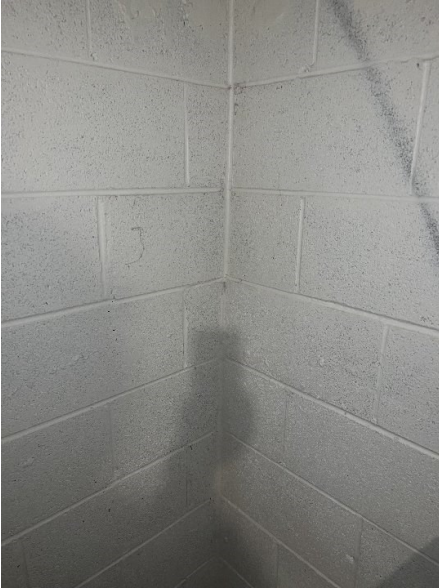
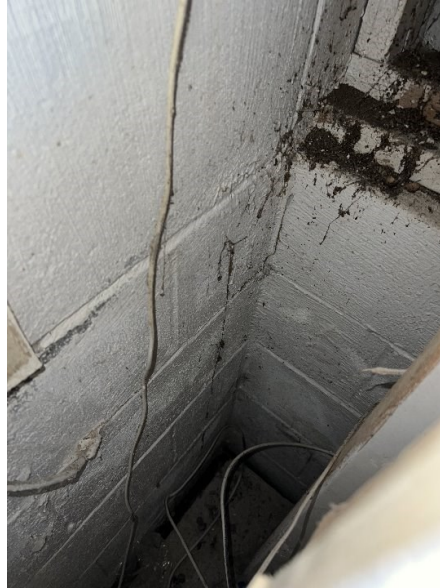
FOUNDATION

The foundation is constructed of masonry block.

Readily accessible areas were inspected. There are no indications of significant structural deficiencies apparent.
