SUNLIGHT INSPECTION SERVICE

15 Nice Lane Sunnyside, Pennsylvania 19000
REPORT# 23020900D

Report Prepared For
John & Joan Buyer

Inspector
Dan Keogh
InterNACHI 13121612

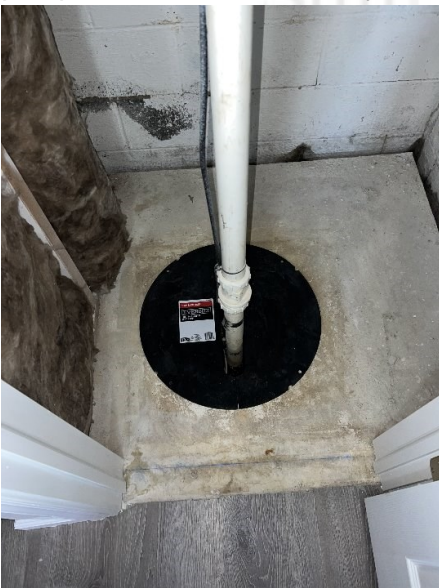
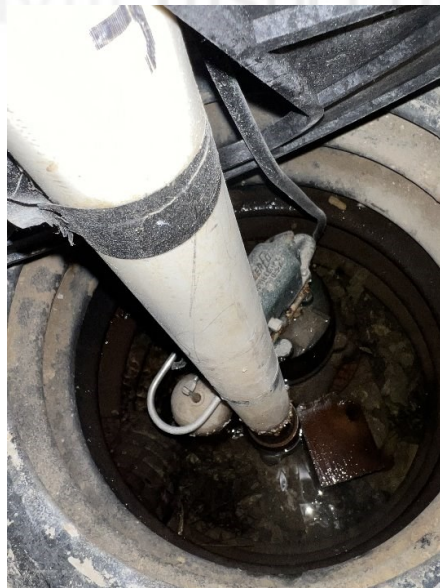
SUMP PUMP

There is a sump pump in the basement.

There is a check valve installed on the discharge pipe, and it appears to be functioning - Good.

Remember to keep the sump pump free of debris and dirt, keep the pump hole covered, and check the pump motor at least once a year.

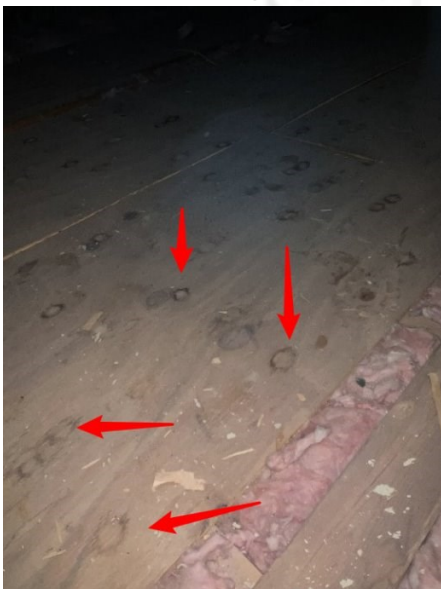
REC There were signs of condensation and moisture on the underside of the roof sheathing. Excessive moisture in attics is caused by warm air infiltrating the attic and condensing on the underside of the cold roof sheathing. If an attic is properly ventilated and insulated this should not happen. Continued moisture buildup in the attic can lead to reduced R value of the insulation, mold growth, and deterioration of the roof sheathing.

water stains from condensation dripping off of the nail ends

I recommend a two-prong approach to correct the problem. Reduce airflow into the attic and increase attic ventilation. A qualified contractor should perform the work.

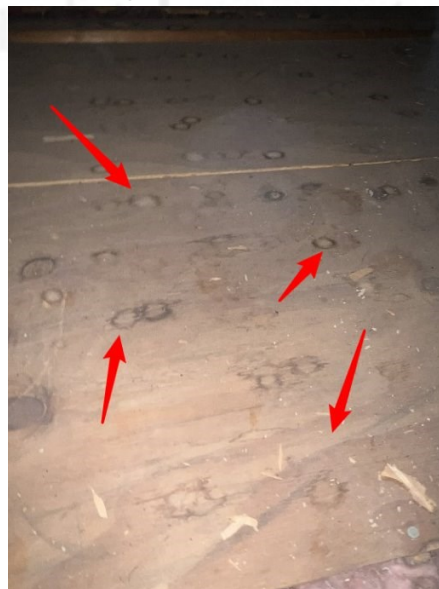
water stains from condensation dripping off of the nail ends

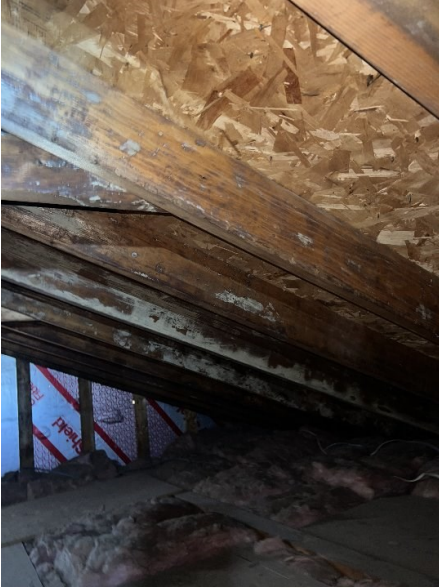
ATTIC ROOF STRUCTURE

Visual inspection only of the attic spaces. Limited access. No major structural defects are readily visible from the access. There were no cut, damage, missing, or loose components of the rafter boards readily visible.

There were no signs of active roof leaks observed from the access. Recommend asking the seller to disclose of any prior roof leaks.

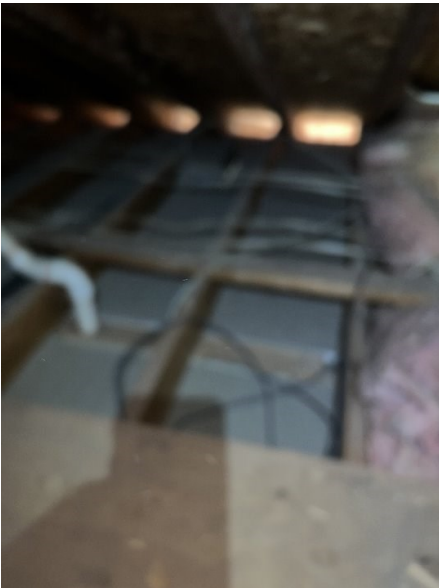
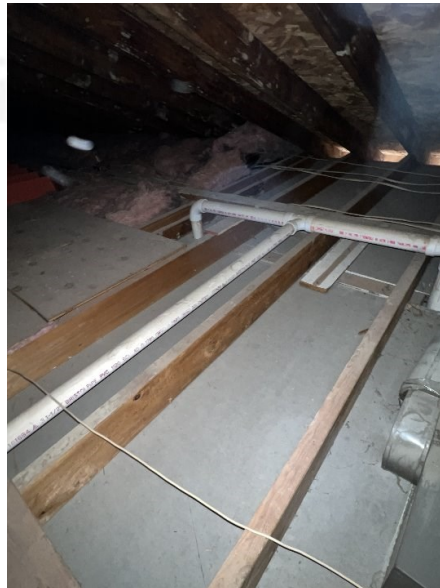
REC Insulation voids were noted on the attic floor. There are some areas in the attic where the insulation is missing. To reduce energy loss I recommend adding/re-disrupting the insulation.

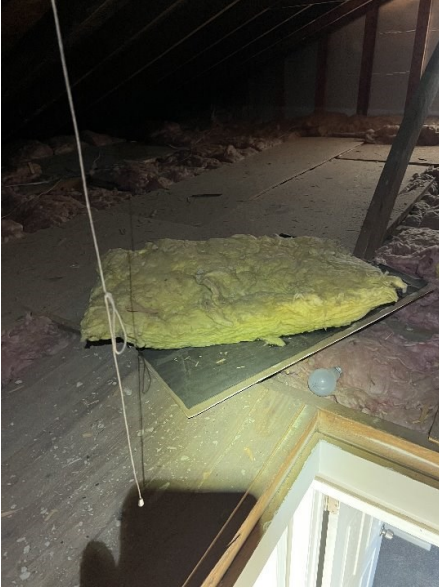
IMPR To reduce energy loss and slow the flow of warm air into the attic I recommend that are insulating the attic access hatch and installing weatherstripping around the opening.

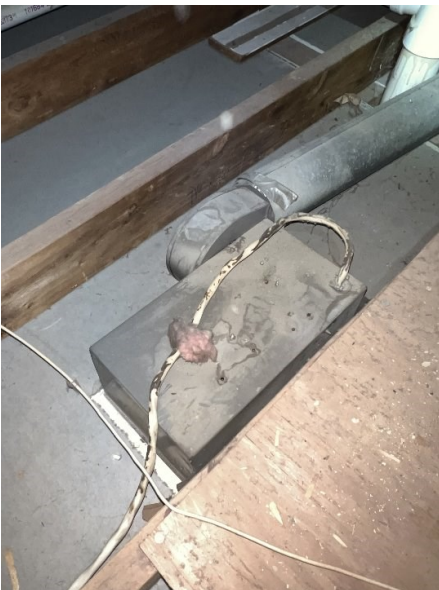
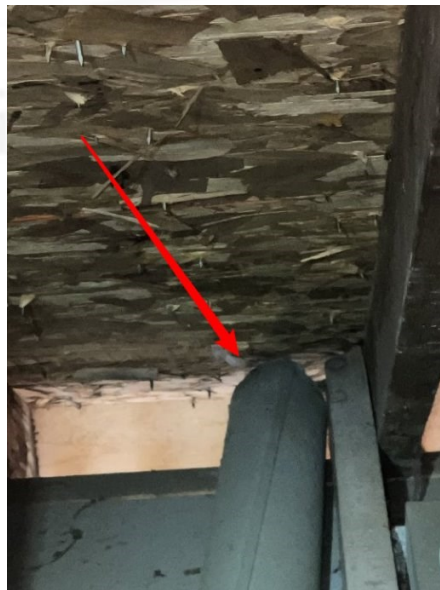
REC The bathroom fans were observed venting into the attic. The fans should be vented to the exterior. Bathroom fans vent moisture into the attic space. This moisture can reduce the R-value of the insulation. The moisture can also contribute to mold and mildew growth on the underside of the roof sheathing. A qualified contractor should vent the fans to the exterior.

venting into the soffit does not work

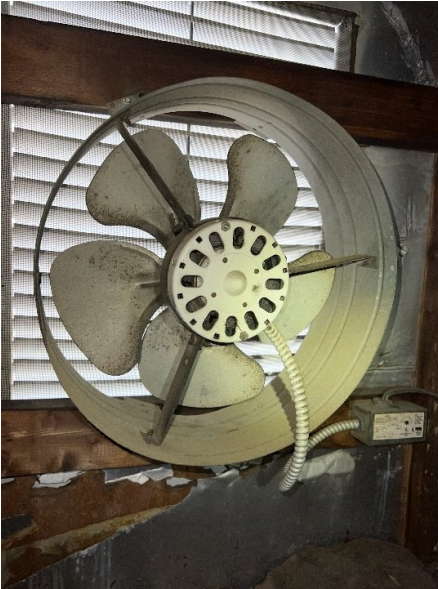
REC The gable fan was getting power but did not function at the time of this inspection. I turned the thermostat down to 60 but the fan did not come on.

A qualified electrician should remove or replace the fan as desired.

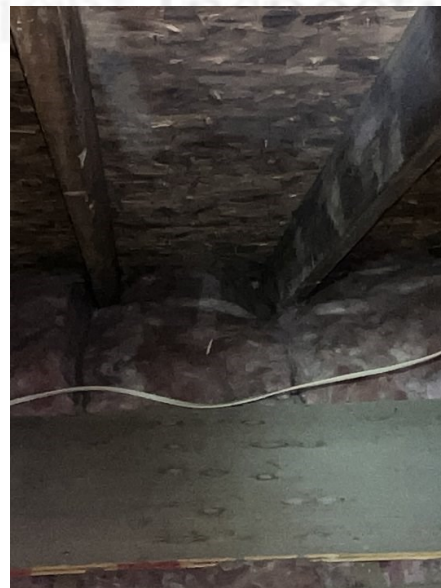
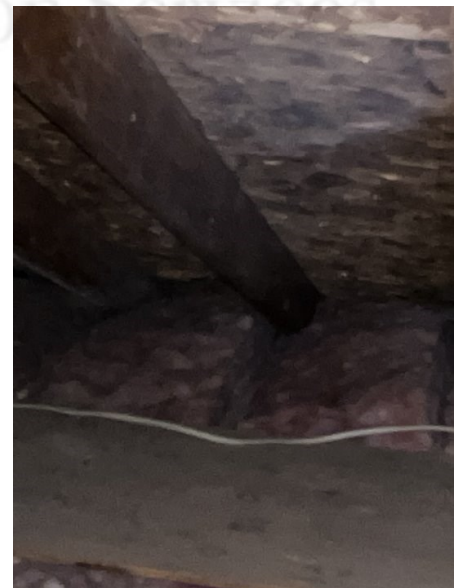
REC Some or all of the intake vents (soffit vents) were blocked with insulation, preventing adequate ventilation to the attic space. It is necessary to keep all vents clear so any infiltration into the attic spaces by moisture-laden air from the home can dissipate.

I recommend having all of the intake vents cleared of obstructions.

A qualified person should perform the work.

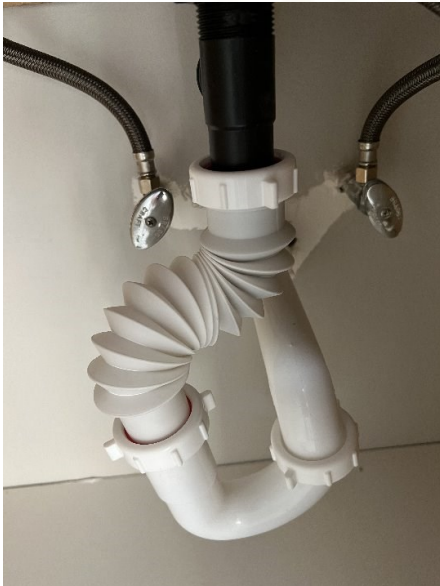
REC I observed a corrugated drainpipe on the second-floor hall bathroom sink drain. Corrugated drainpipes should only be used in vertical connections above the trap. This drainpipe is set horizontally. I recommend a qualified person replace the drain pipe with an approved drain pipe.

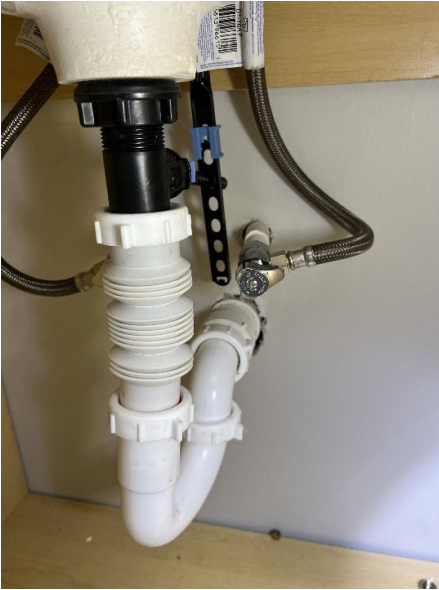
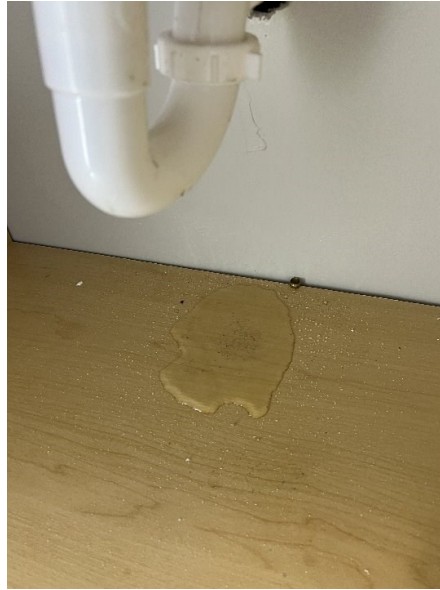
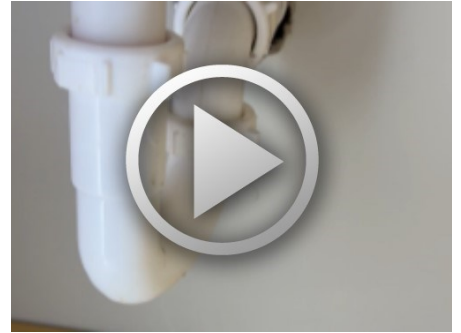
REC I observed a leak at the basement bathroom sink drain pipe. A plumber or qualified person should repair or replace the drain pipe as needed.

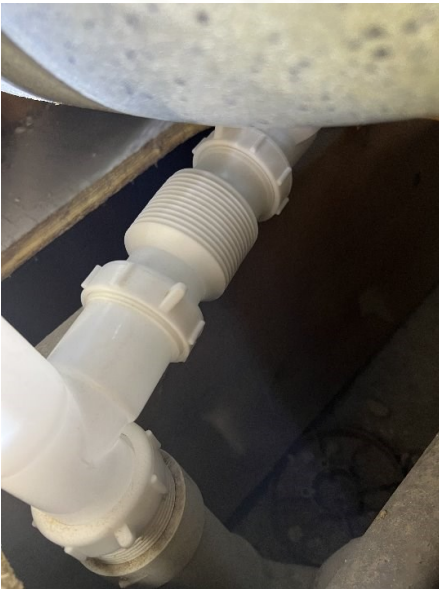
REC A corrugated drainpipe was noted on the second-floor hall bathroom tub/shower drain. The corrugated drainpipe is on a horizontal section of the drain. Current accepted standards allow corrugated drain pipes to be used on vertical connections only and only above the drain trap. A horizontal corrugated drainpipe can catch debris increasing the chances of a leak or blockage. The drainpipe should be replaced with one that meets today's standards. Plumbing repairs should be performed by a qualified plumber.

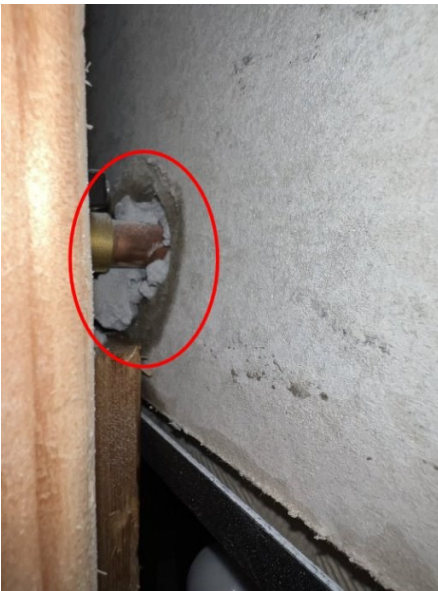
REC The leak was noted at the second-floor hall tub shower. The plumbing Access panel opening does not line up well with the plumbing drain lines. I am unable to determine if the leak is coming from the faucet handle or the showerhead above the faucet handle. A qualified Plumber should evaluate further and repair as needed.

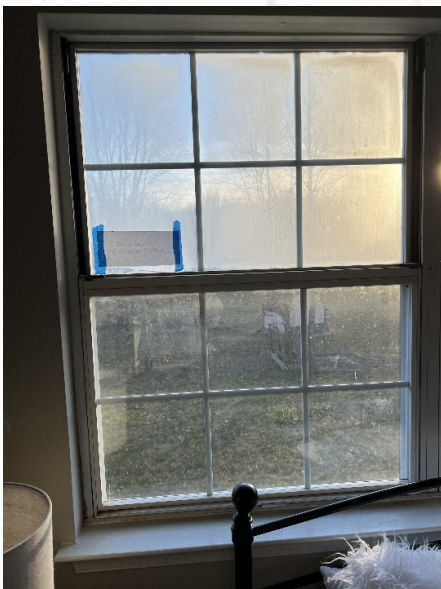
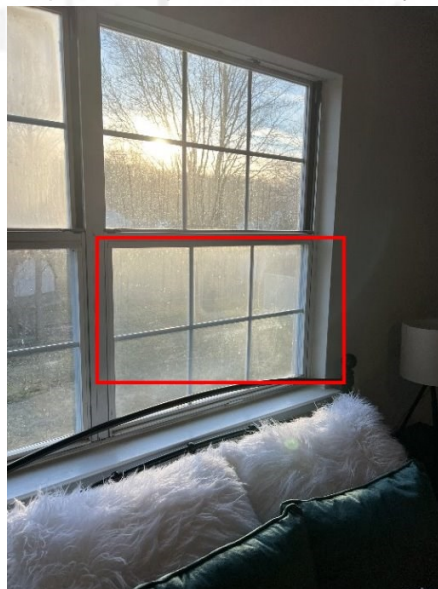
REC Two fogged windowpanes were noted in the master bedroom.

In order to correct the fogged appearance of the glass, the glass windowpane or the window sash will need to be replaced.

A qualified window contractor should repair or replace as necessary.

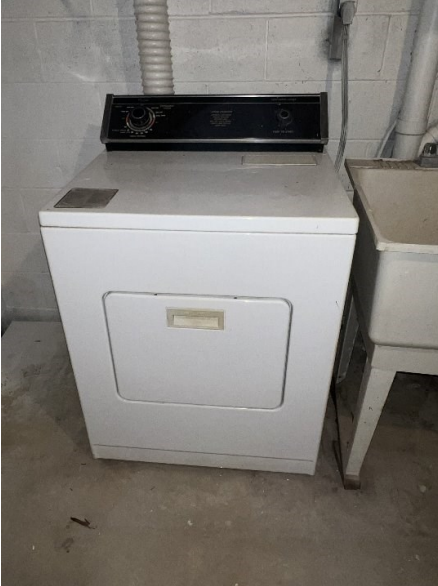
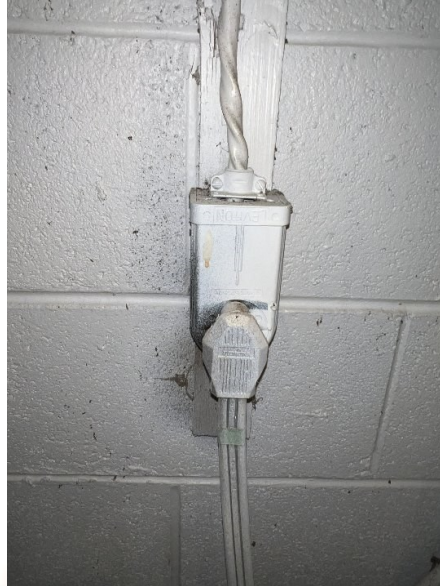
The dryer is hook up is electric. The dryer duct should be cleaned and inspected once or twice a year.

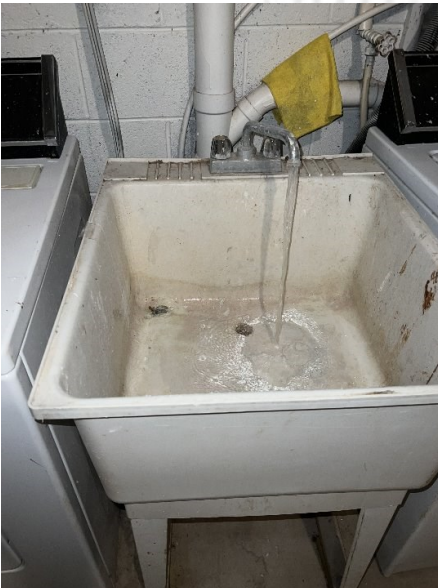
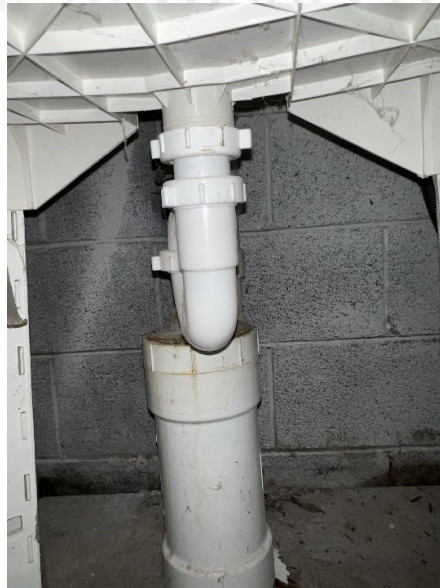
IMPR There was no overflow pan for the washing machine. There is no requirement for an overflow pan under the washing machine however since a leak from the washing machine could cause damage to the home I recommend that an overflow pan with a drain line to the exterior, or other location that would not ruin interior finishes, be installed under the washing machine.

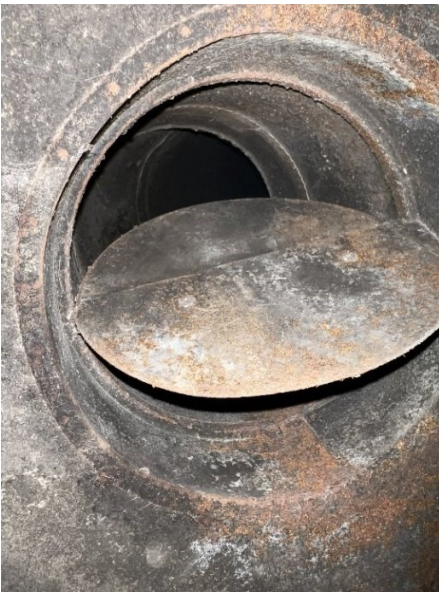
log holder should fit in brackets

IMPR The log holder for the fireplace is missing. A new log holder is needed.

Factory-built fireplaces are tested by Underwriter Laboratories and are listed as a complete unit. All the parts on the fireplace need to be made for, and tested with the particular unit they are designed for. Replacing worn parts or adding accessories that are not designed for this model fireplace can damage the fireplace and could cause a fire hazard.

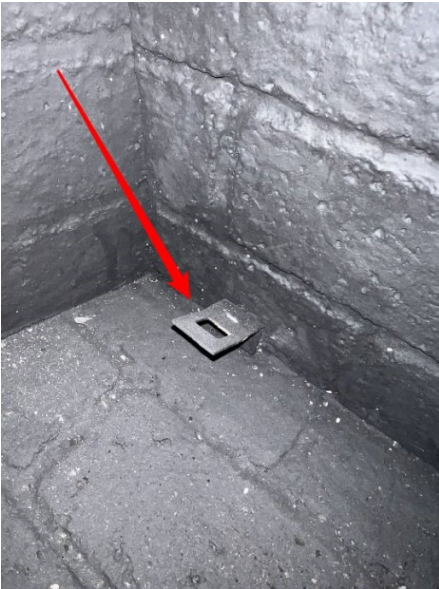
log holder should fit in brackets

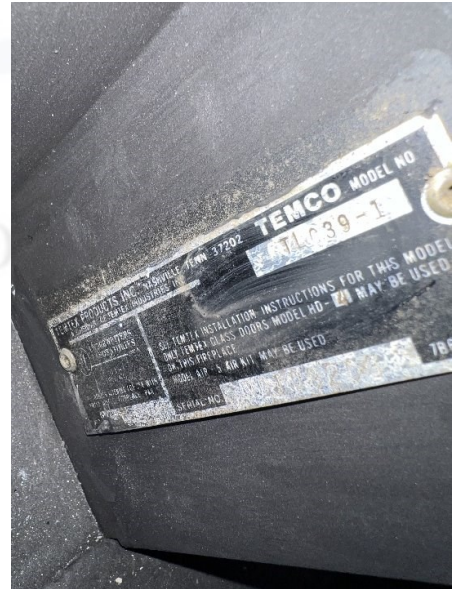
REC Cracks were noted in the rear and bottom refractory panels. The refractory panels are no longer reliable and may fail to perform their intended function. For safety, the damaged panels should be replaced.

Refractory panels are designed to protect the steel firebox from the heat of the fire and to deflect heat into the room. The broken panel should be replaced with the appropriate panel for this make and model fireplace.

Refractory panels are designed to protect the steel firebox from the heat of the fire and to deflect heat into the room. The broken panel should be replaced with the appropriate panel for this make and model fireplace.

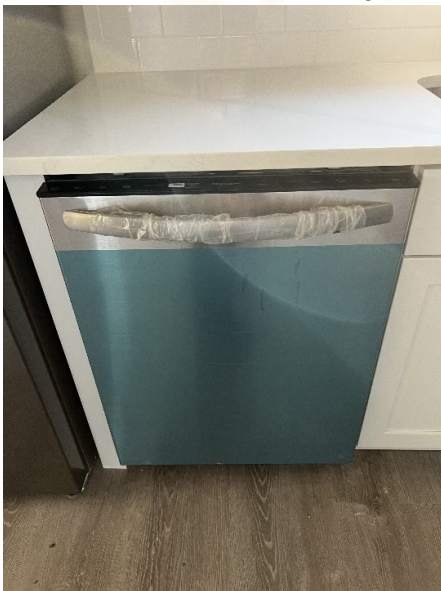
DISHWASHER

The dishwasher appeared to be in serviceable condition at the time of the inspection. The dishwasher was securely mounted. The dishwasher ran through a short cycle. The dishwasher filled and drained. There were no visible leaks coming from the dishwasher.

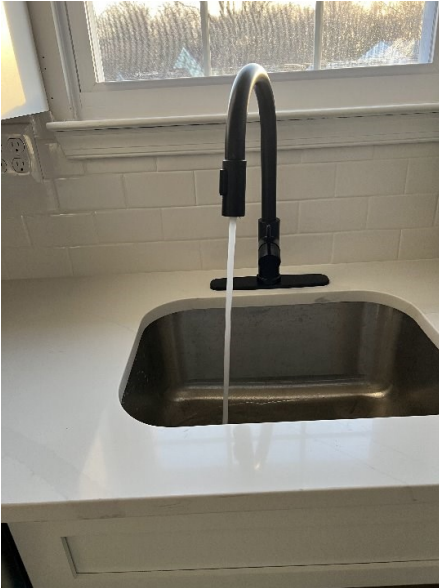
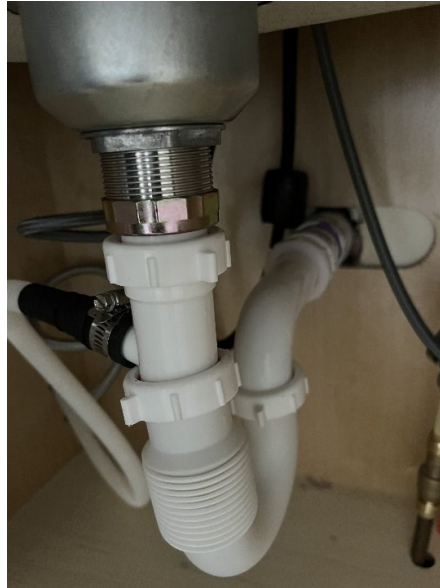
KITCHEN SINK

Hot and cold water ran at the kitchen sink.

There were no leaks under the sink at the water supply lines or the drain pipe.
