SUNLIGHT INSPECTION SERVICE

5 Sunny Dr Great Twon, PA 19000
REPORT# 22100000D

Saturday, October 22, 2022

Introduction

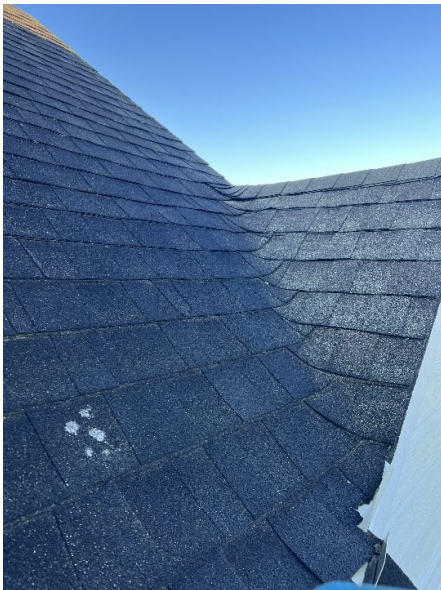
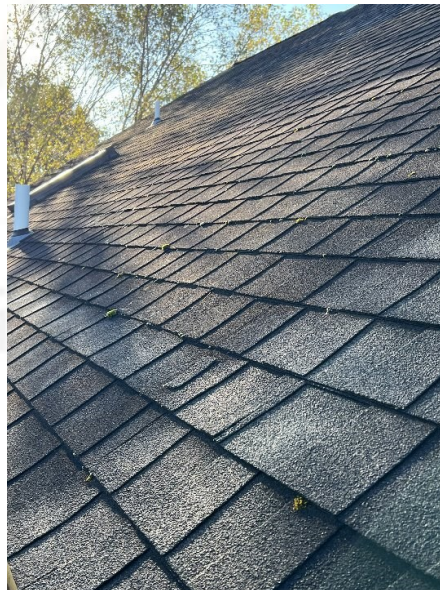
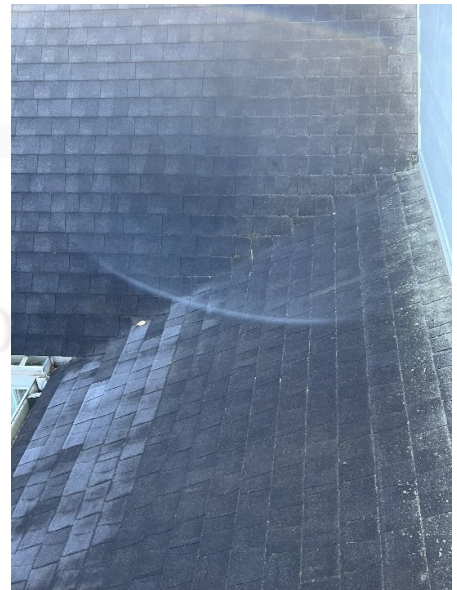
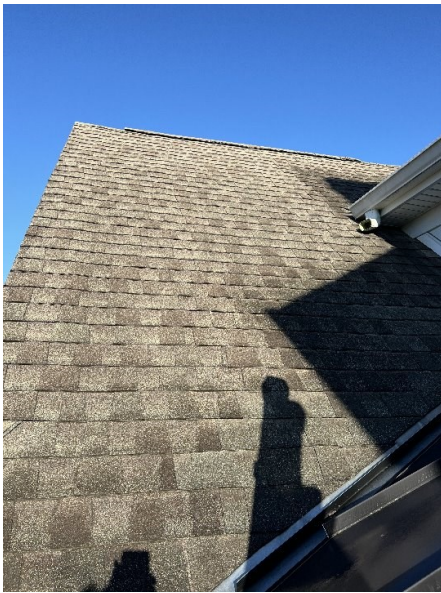
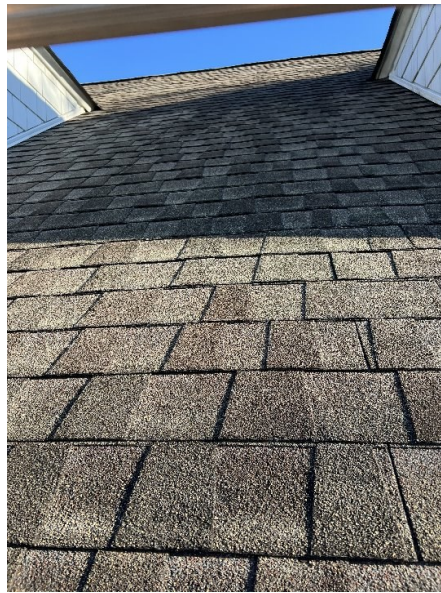
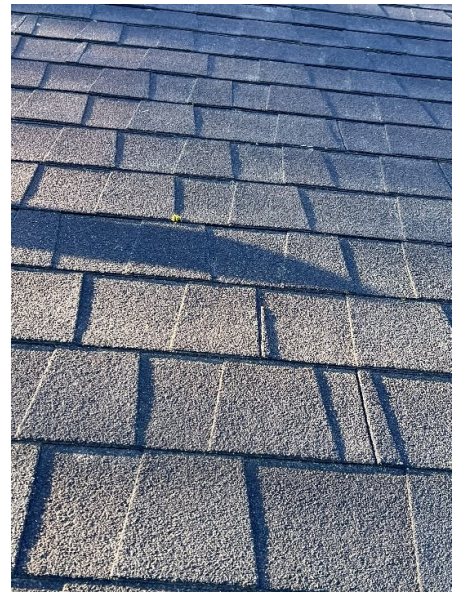
ASPCHAT SHINGLES

The asphalt fiberglass shingles on the roof appear to be in functional condition.

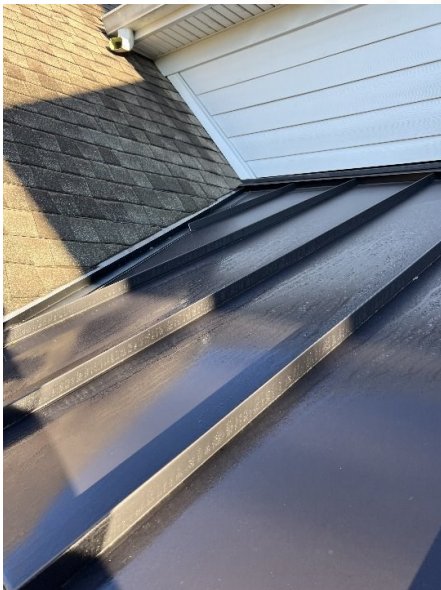
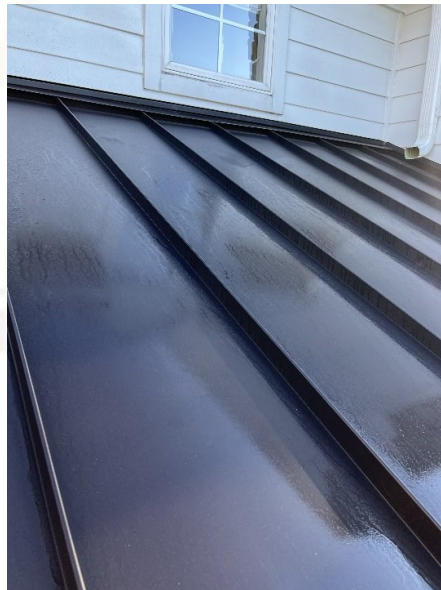
METAL ROOF

I inspected the metal roof. The standing seam metal roof appeared to be in good condition. The surface of the metal was in good condition. The seams are all tight.

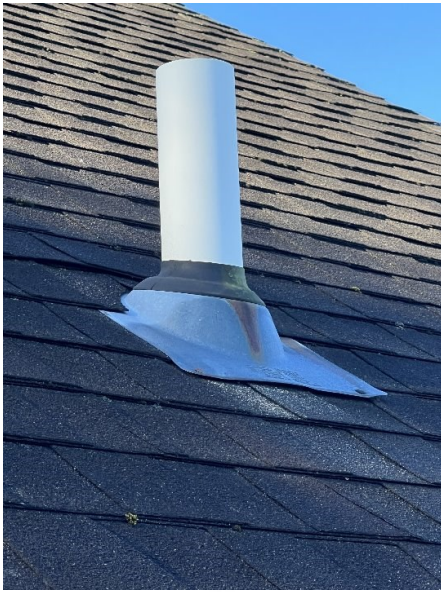
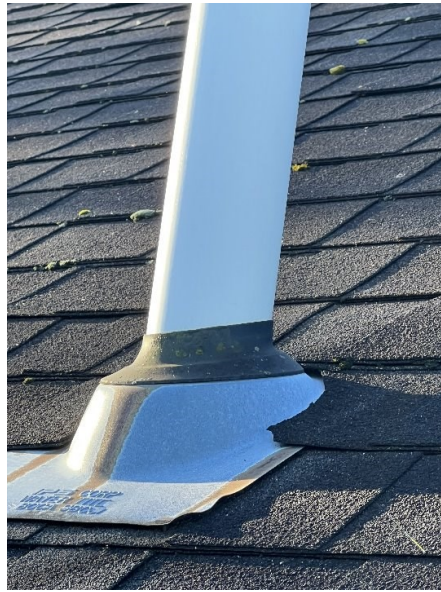
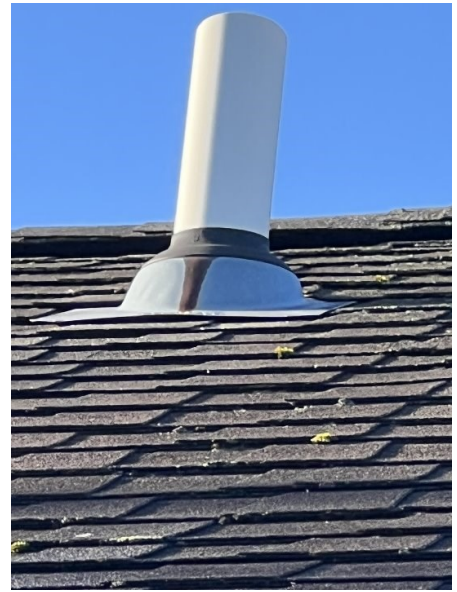
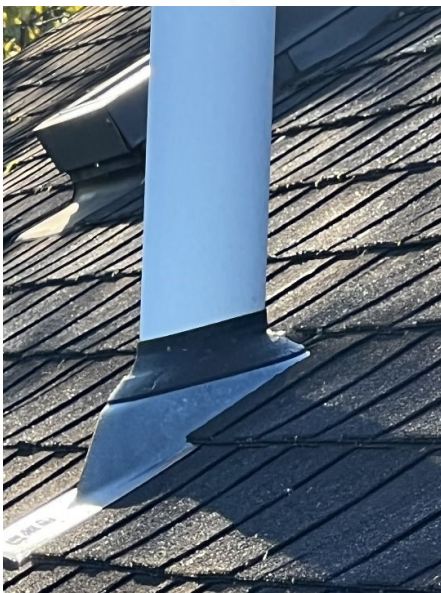
PLUMBING VENTS

There is visible flashing installed around the plumbing stacks. No damage. Good.

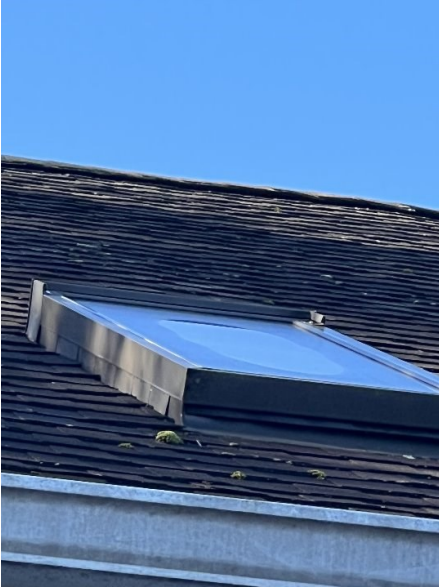
SKYLIGHTS

There was visible metal flashing installed around the perimeter of the skylights. Good. I recommend monitoring the skylights during a heavy rainstorm is recommended.

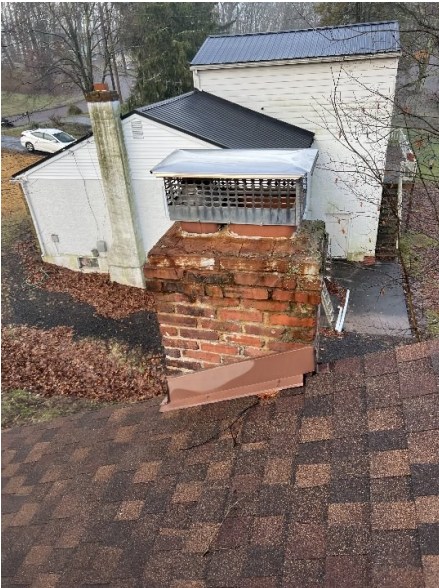
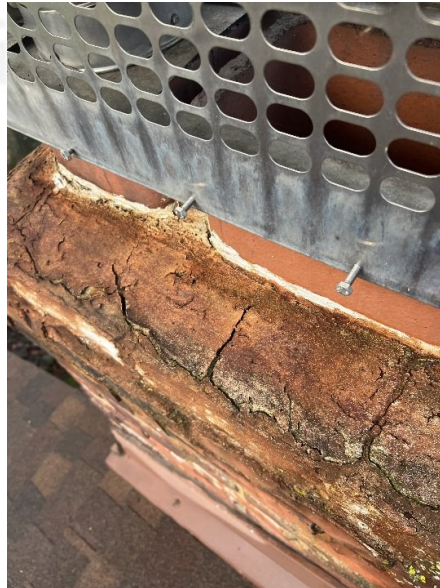
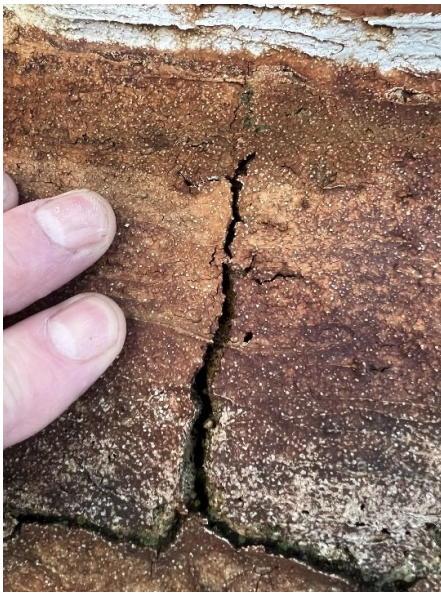
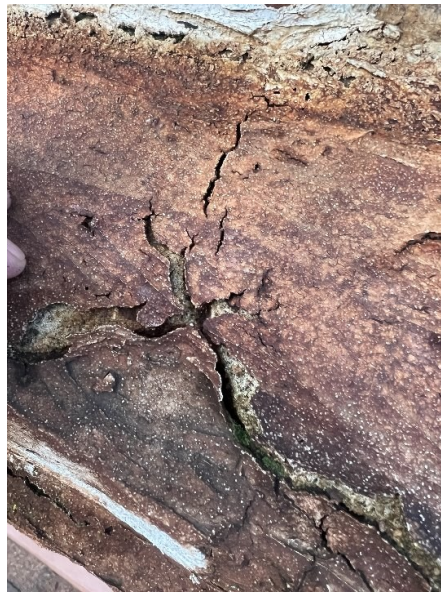
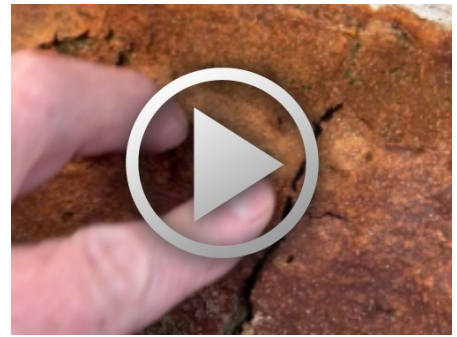
CHIMNEY STRUCTURE

REC Damage/deterioration was noted on the chimney crown.

The chimney crown directs water off the top of the chimney and prevents water intrusion inside the chimney structure. Water intrusion in the chimney structure can cause deterioration and lead to leaks. The crown should be repaired or replaced by a qualified roofer or mason.

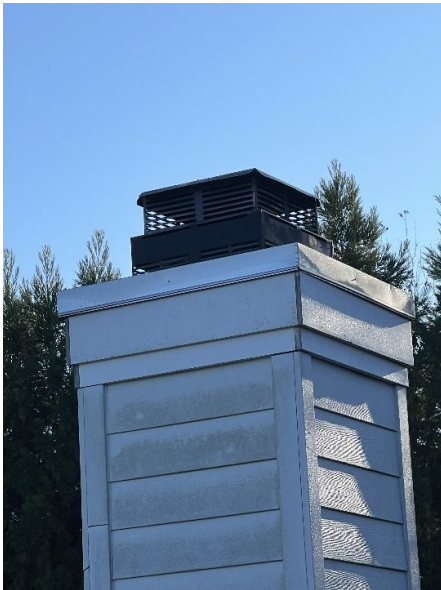
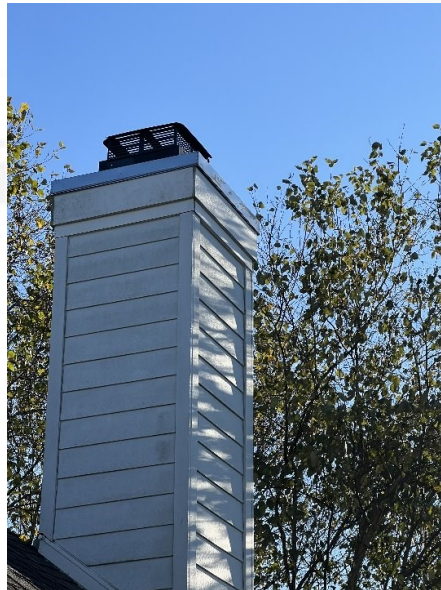
MANUFACTURED CHIMNEY

The chimney chase appears vertical and straight. The galvanized steel cap and termination cap appear to be in good shape. The storm collar and flue pipe appear to be well sealed. This joint should be checked annually and maintained to prevent water from entering the chimney chase and running down the flue pipe.

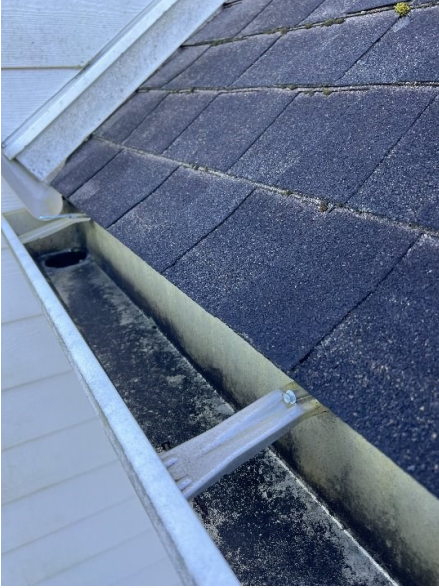
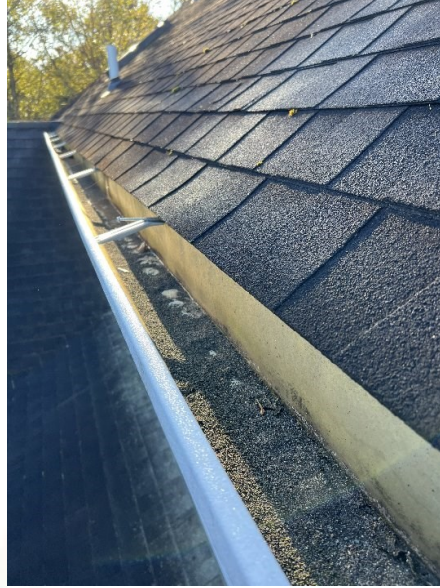
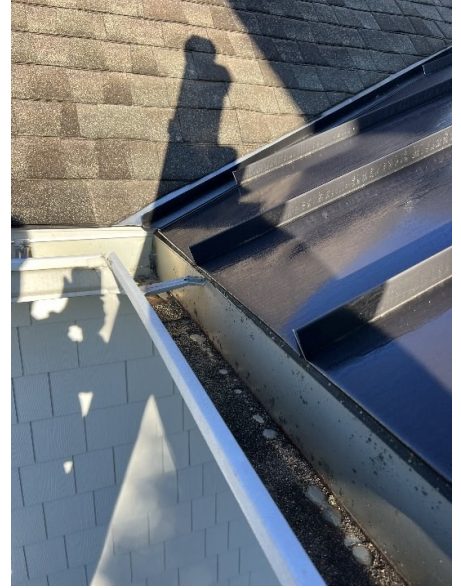
GUTTERS

The gutters appear to be functional.

The gutters appear sloped towards the downspouts.

Gutters require regular maintenance to function properly. The gutters should be kept clean and the gutter seam and joints re-sealed as needed.

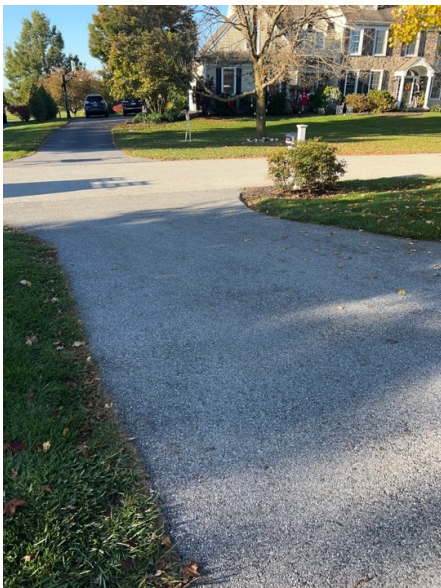
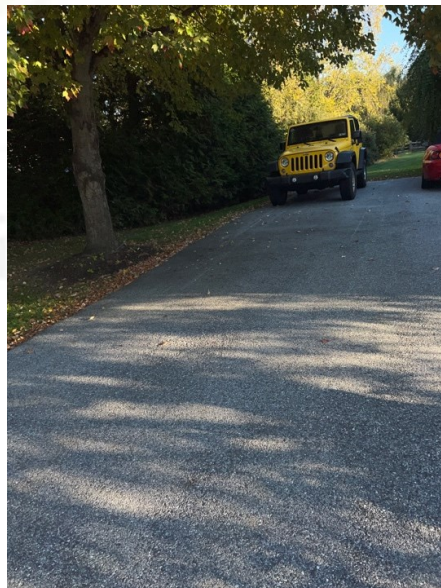
DRIVEWAY & PARKING AREA

The driveway and parking area appeared functional.

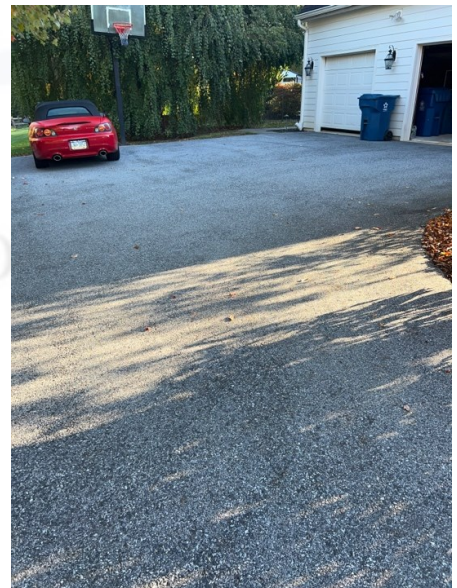
IMPR Poor drainage (grading) was noted near the foundation.
The ground was level and not sloped away from the house.

The soil around the home should be graded to take water away from the foundation. In order for drainage to be effective, the landscaping must be configured so that the yard is sloped away from the foundation at a pitch of no less than 6 inches in the first ten feet. Failure to maintain sufficient drainage will cause rain and surface runoff to drain toward the foundation where it can seep into basements and crawlspaces. I recommend consulting a landscaping professional to re-grade the yard around the home or devise means of diverting rainwater and runoff away from the foundation as appropriate.

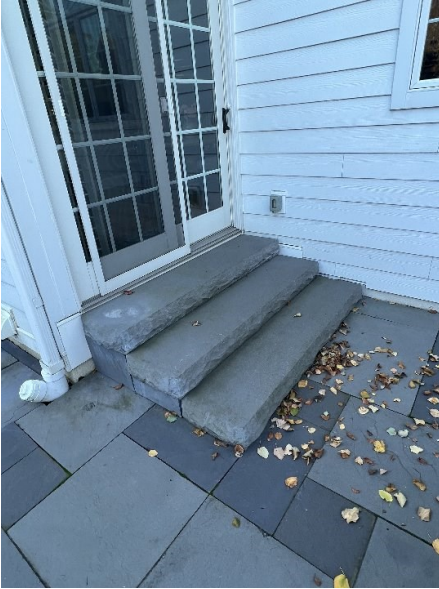
SAFE The rear exterior stairs were noted without a hand railing. Current accepted standards recommend that any set of stairs with 4 or more steps should have a continuous hand railing for safety. For increased safety, I recommend installing a hand railing on the rear exterior stairs.

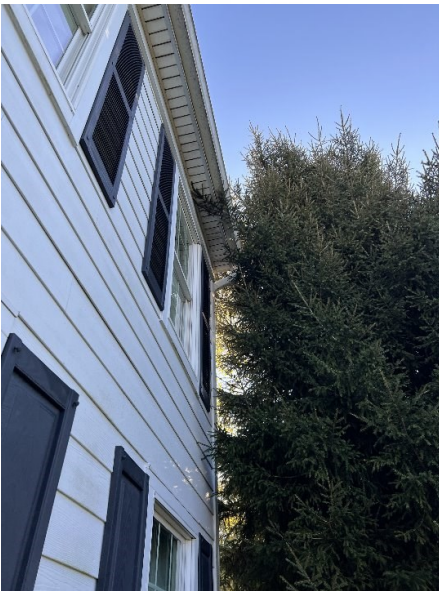
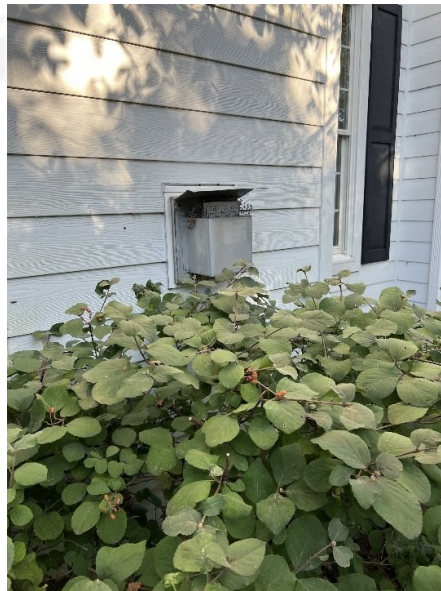
EXTERIOR FINISH MATERIALS

IMPR Shrubs and trees were noted growing on the side of the house. Shrubs and tree limbs should not be leaning on or touching the house. Plants on the side of a house can hold moisture against the house for extended periods of time, rub against the siding, and can create a path for insects to enter the house. Pruning of the shrubs and trees around the house is recommended.

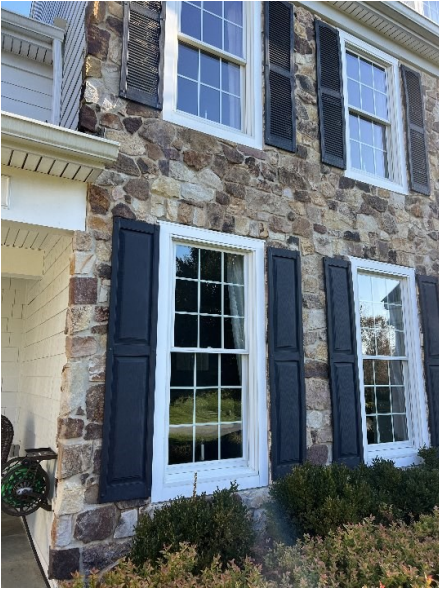
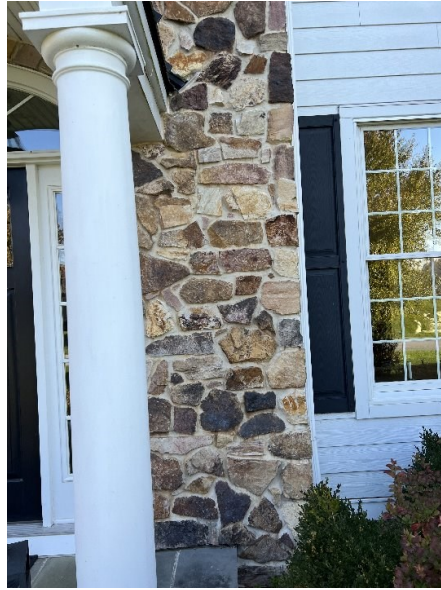
STONE VENEER

The Stone veneer appeared to be in functional condition.

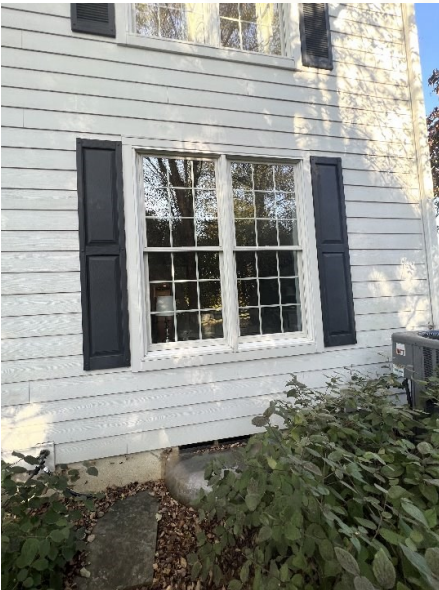
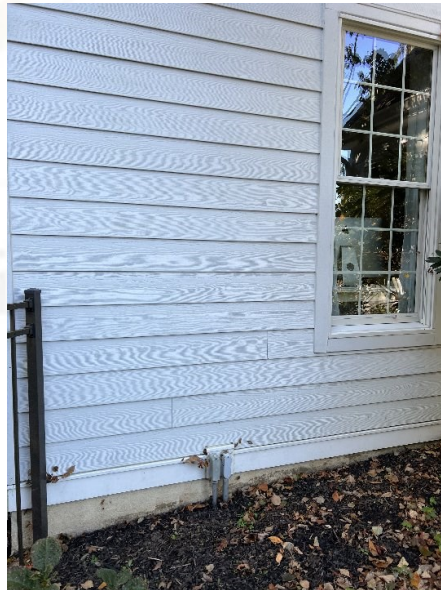
FIBER CEMENT SIDING

The fiber cement siding appears to be in functional condition.

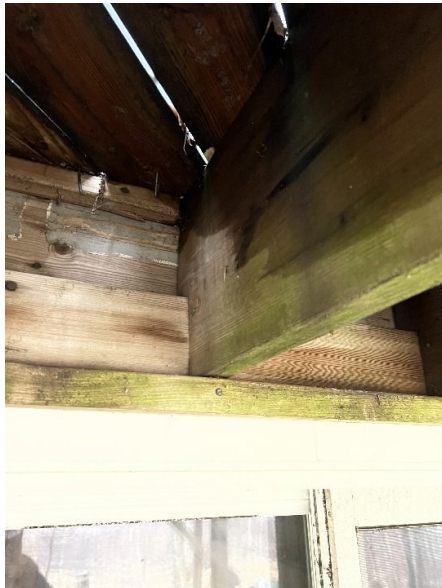
SAFE The deck joist to deck ledger board connection was done using nails that have been toe nailed into the ends of the joist. This connection is not considered strong enough. Toe nailing the joist ends to the ledger board does not provide enough lateral strength. Joist hangers should be used to make this connection.

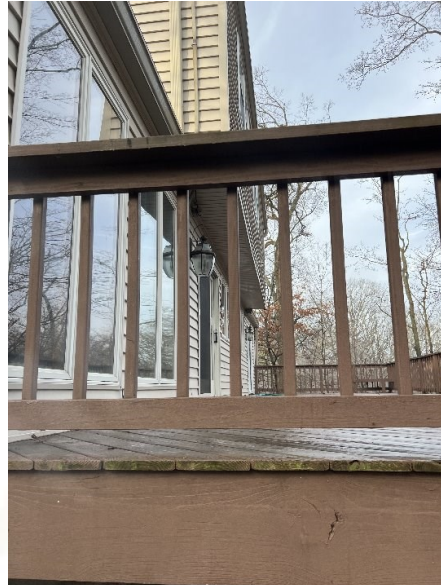
SAFE The spindles (or balusters) on the railing are spaced more than 4 inches apart. Current accepted standards recommend that spindles be spaced so that a four-inch sphere cannot pass through the railing.

Railings that have spindles spaced more than 4 inches apart are considered a safety hazard for small children.

I recommend action by a qualified carpenter according to the standards contained in the American Wood Council document DCA6-15.

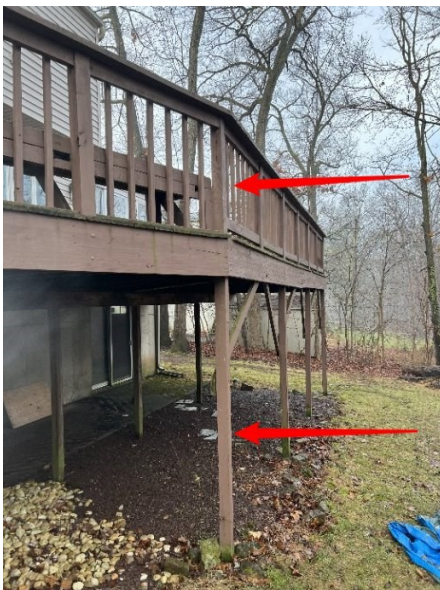
SAFE Inadequate railing support was noted. The posts that are used to support the deck are also used as supports for the railing. This is not considered structurally sound by current accepted standards. If a railing post fails, it usually fails at the deck to post connection. Since this connection also supports the deck platform a railing failure here could cause the deck to collapse.

I recommend repair by a qualified contractor according to the standards contained in the American Wood Council document DCA6-15.

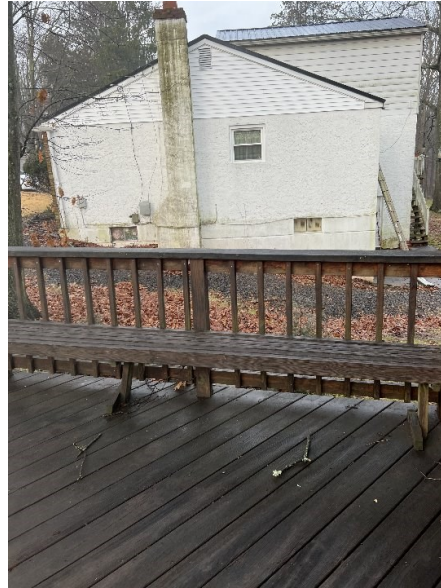
SAFE A permanent bench was noted built on the deck near the railing. Current accepted standards recommend there be a railing 36 inches high above the surface of the bench. A child or person could stand on the bench and fall over. For increased safety, I recommend raising the railing or removing the bench.

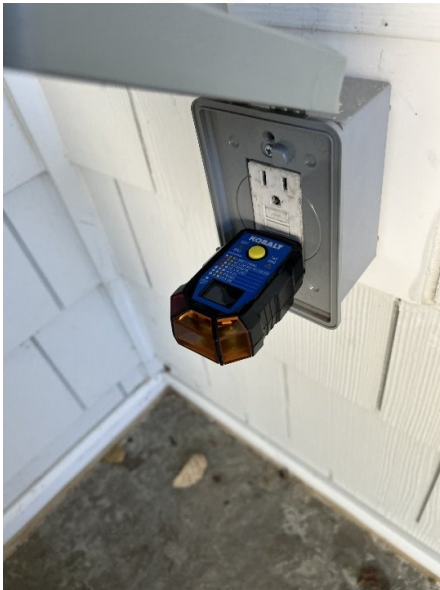
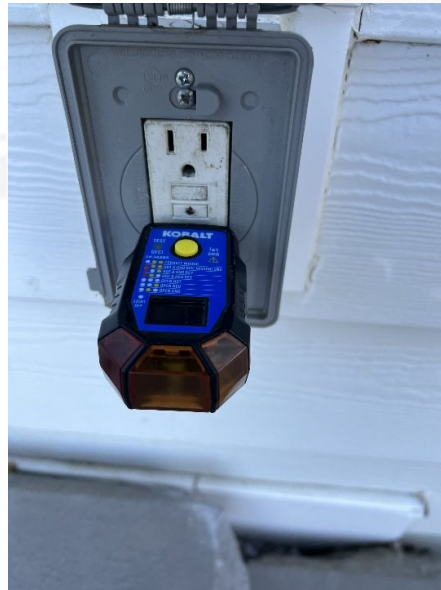
OUTLETS

The outside electric receptacles were live and protected by a functional GFCI (or Ground Fault). Good.

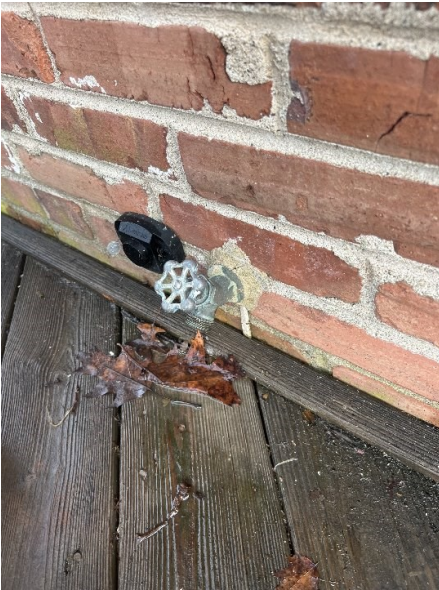
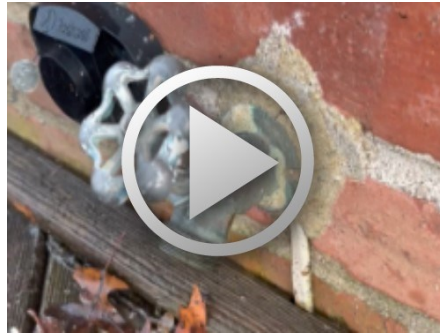
WATER SPIGOTS

REC A dripping exterior faucet was noted.

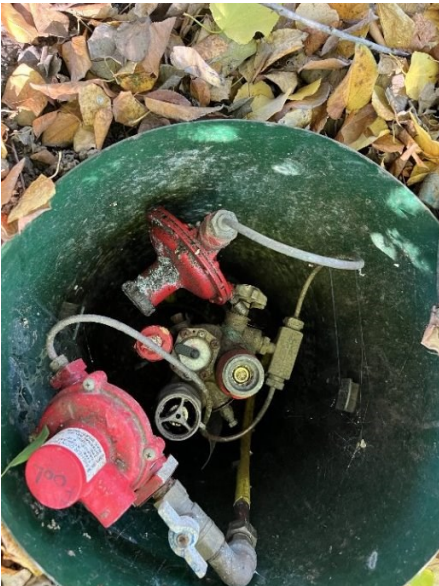
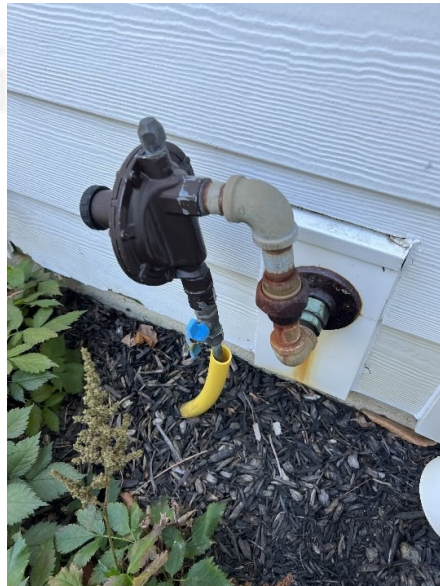
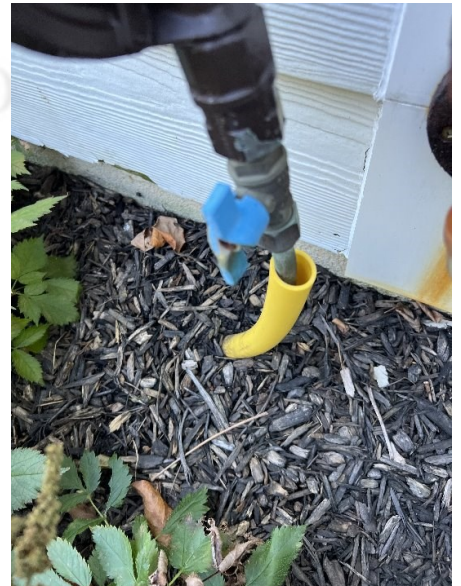
GAS SUPPLY

INSP The propane storage tank is located back side. The fuel line enters the house at the back side. There is a fuel shut off valve at the tank and on the flue line just under the pressure regulator as the line enters the house. This inspection does not include the condition or adequacy of the flue storage tank. Recommend asking the seller if they own the tank, or if they rent it, and if there a service agreement with a fuel supplier for maintaining and filling the tank.

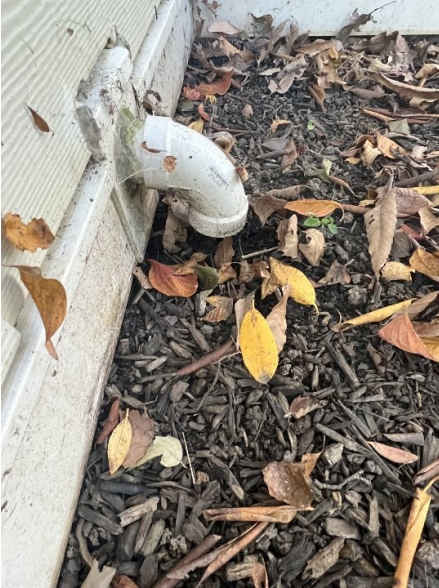
OTHER EXTERIOR COMPONENTS

INSP A low PVC pipe was noted at the rear of the house. The function of this pipe is undetermined. I recommend asking the sellers if they know what this pipe is for or used to be used for.

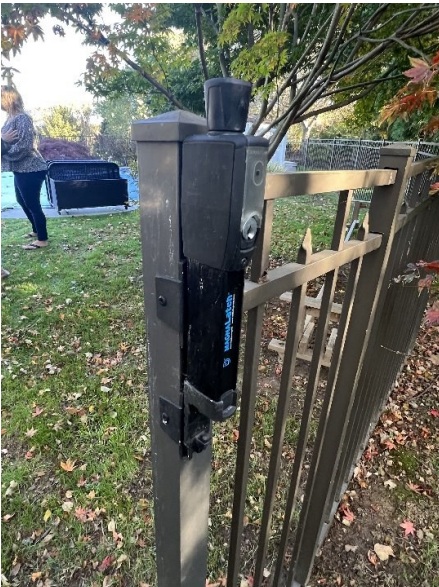
SWIMMING POOL

SAFE The gate on the right side of the house does not latch. The gate's function is important to form an effective barrier around the pool. A qualified contractor should repair the latch.

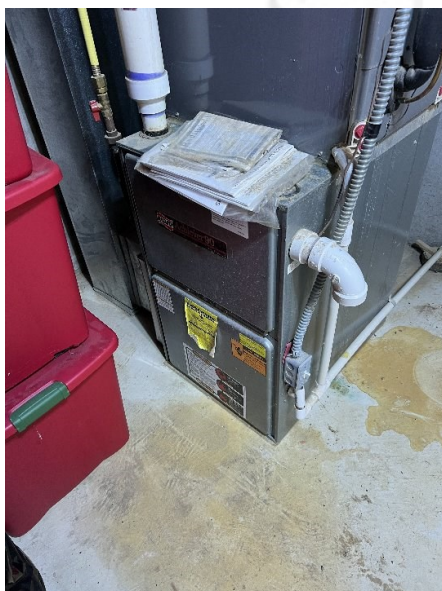
INSP The first floor of the home is heated with a gas furnace. Using the thermostat I turn the heating system on. The heating system functioned normally at the time of the inspection.

Heating and air conditioning systems require regular maintenance. There is no visible service tag on the HVAC system. The heating system appeared dirty and is in need of annual service. I recommend asking the seller for recent service records. Prior to taking custody of the home, I recommend having the heating system cleaned and serviced by a qualified HVAC professional. Need service call

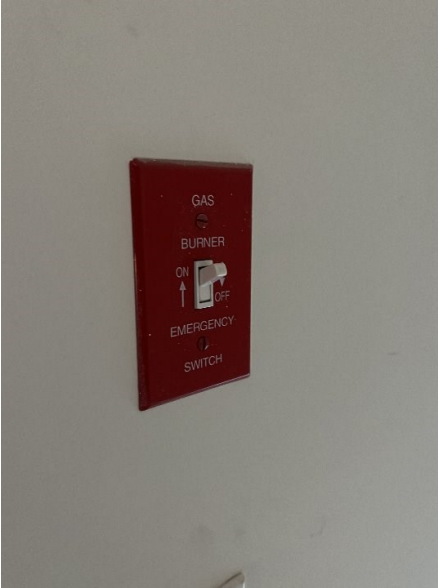
SWITCHES & VALVES

The shut off switches for the heating system functioned when test. Testing fuel shut off valves is outside the scope of the home inspection. The gas shut off valve for the furnace was accessible and appeared to be in functional condition.

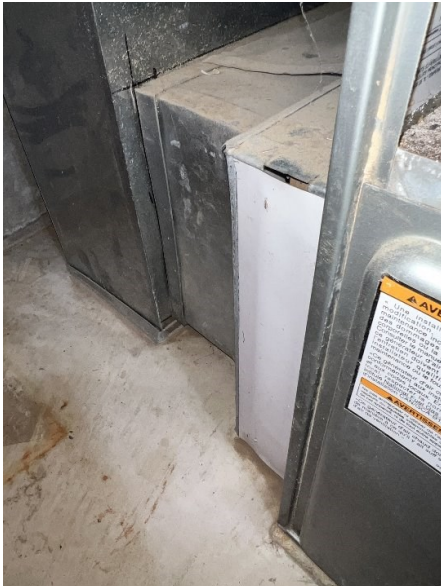
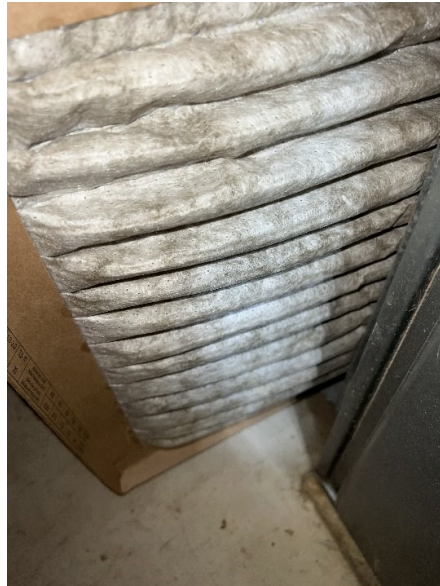
AIR FILTER

IMPR At the time of this inspection the air filter for the forced air heating/air conditioner was dirty. I recommend that the air filter be checked every month the system is in use and changed as needed. This will prevent dirt from building up on the internal components and and reduce the amount of dirt particles that are distributed through the ductwork a.

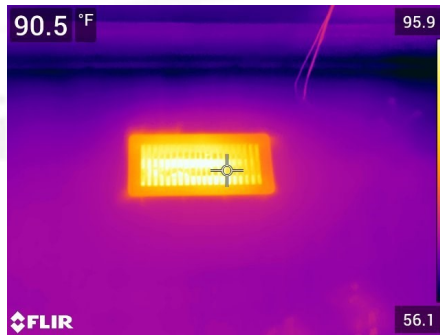
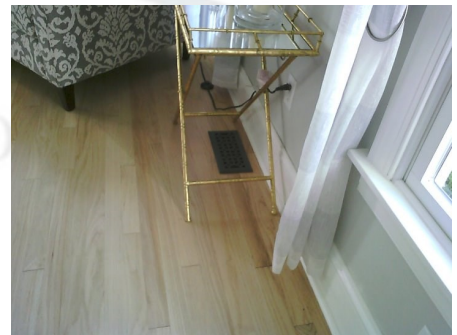
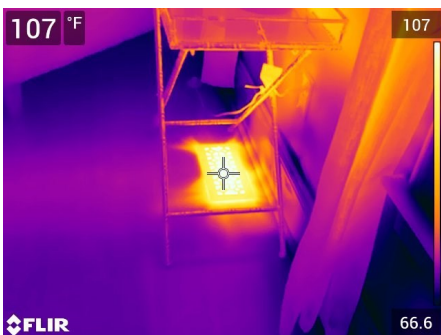
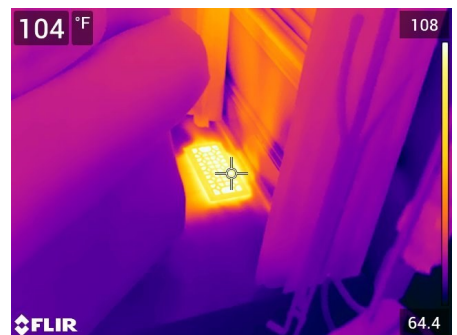
DUCT WORK

A thermal imaging camera was used to check the registers. All the HVAC registers where getting conditioned air at the time of the inspection.

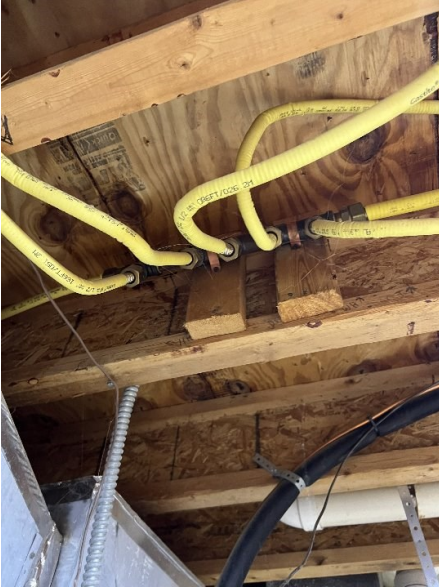
GAS LINE

The gas lines in the home are corrugated stainless steel tubing (CSST). The gas manifold was well mounted. There were no gas leaks detected at the manifold.

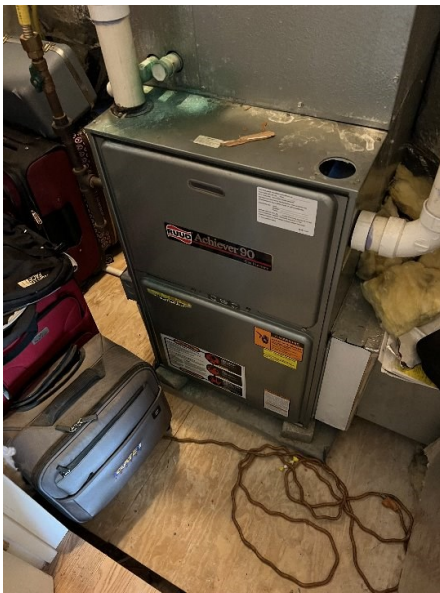
INSP The second floor of the home is heated with a gas furnace. Using the thermostat I turn the heating system on. The heating system functioned normally at the time of the inspection.

Heating and air conditioning systems require regular maintenance. There is no visible service tag on the HVAC system. I recommend asking the seller for recent service records. Prior to taking custody of the home, I recommend having the heating system cleaned and serviced by a qualified HVAC professional. Need service call

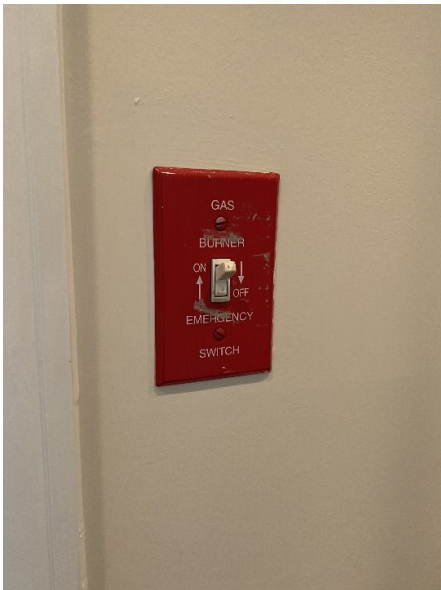
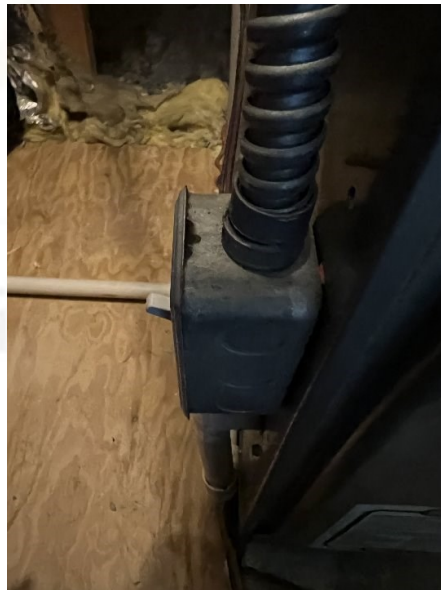
SWITCHES & VALVES

The shut-off switches for the heating system function when tested. Testing fuel shut-off valves is outside the scope of the home inspection.

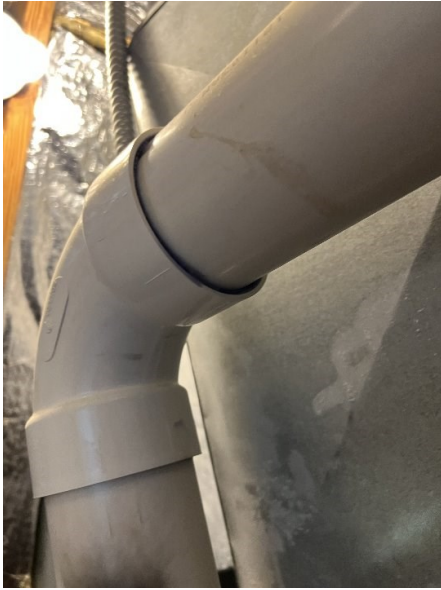
FLUE PIPE

The flue pipe was intact and in good condition.

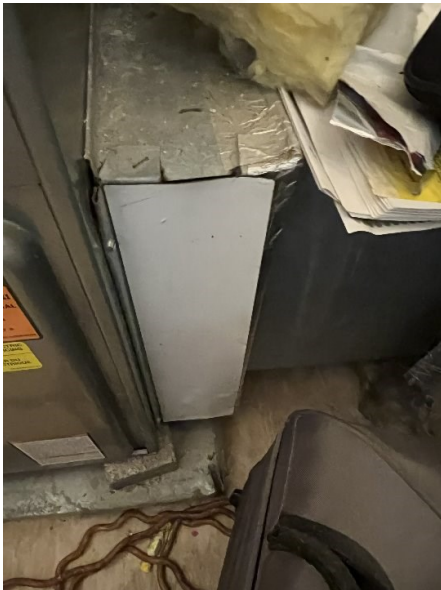
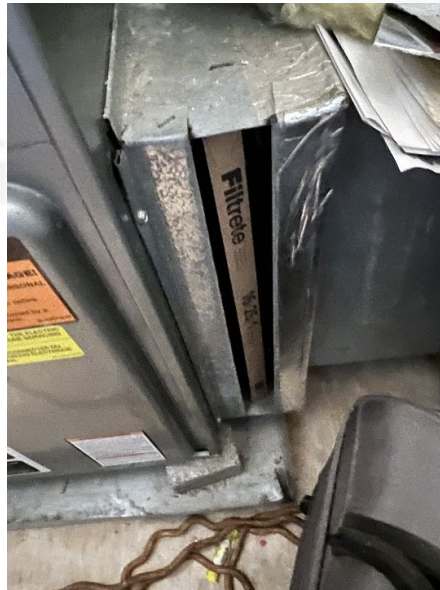
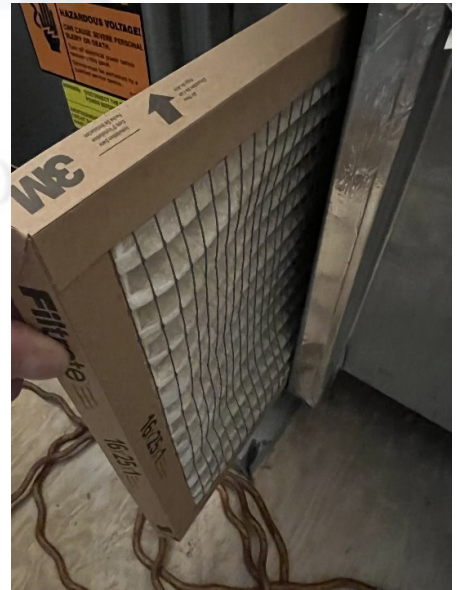
AIR FILTER

At the time of this inspection the air filter for the forced air heating/air conditioner was clean. I recommend that the air filter be checked every month the system is in use and changed as needed. This will prevent dirt from building up on the internal components and and reduce the amount of dirt particles that are distributed through the ductwork a.

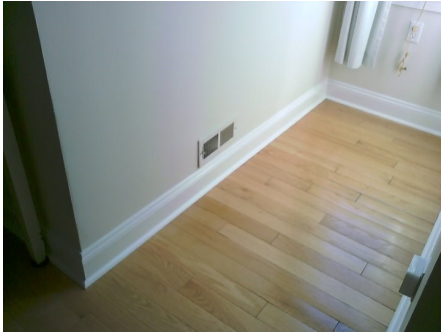
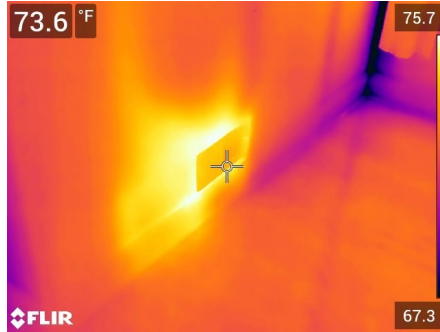
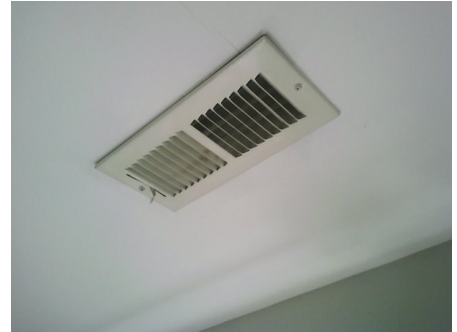
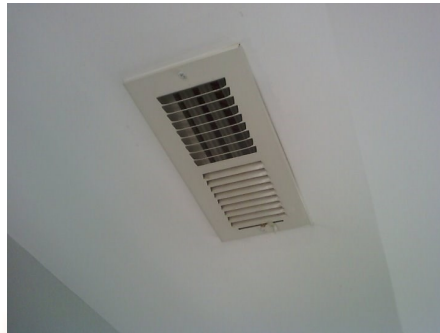
DUCT WORK

A thermal imaging camera was used to check the registers. All the HVAC registers where getting conditioned air at the time of the inspection.

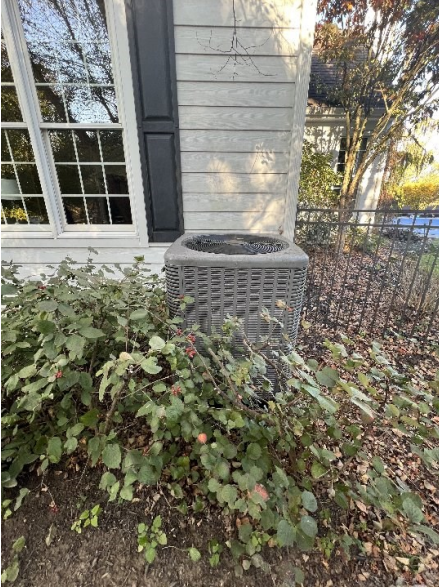
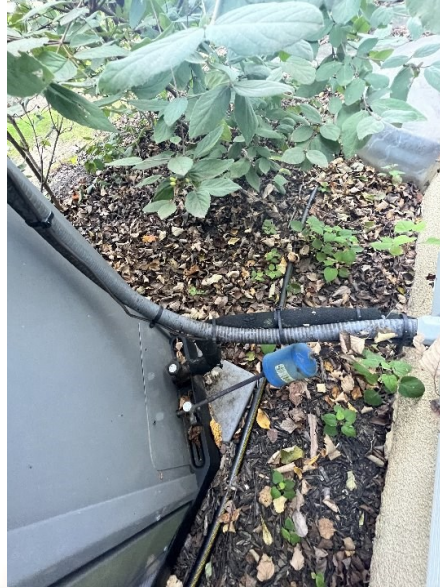
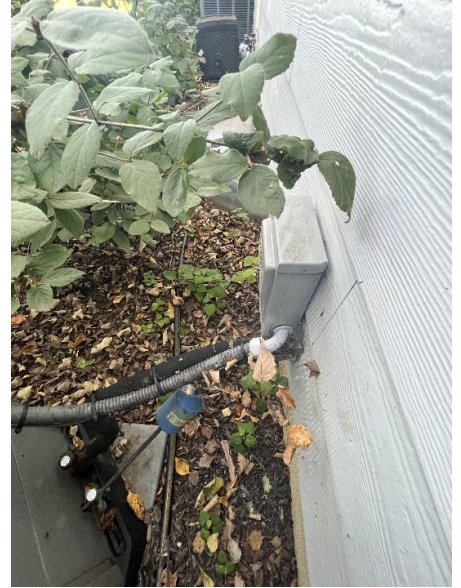
CONDENSER

The condenser for the air conditioner is located on the right side of the home. The condenser unit appears level and was securely mounted on a base. The insulation around the condenser's suction line was in good condition. There is an electrical service disconnect for the condenser unit. The fins on the condenser appeared clean. No rust or corrosion was noted.

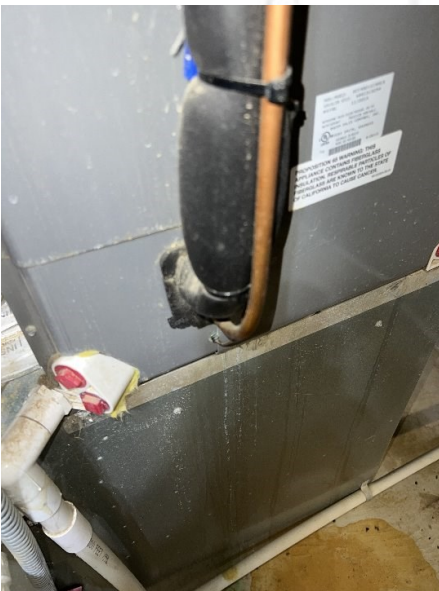
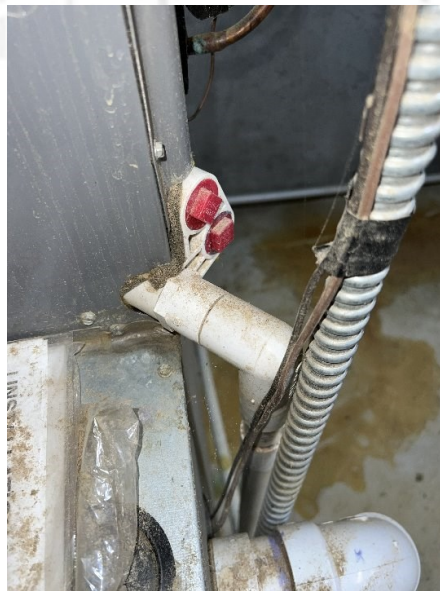
AIR HANDLER

The air conditioning is distributed through the house using the same ductwork as the furnace. The refrigerant lines that carry the liquid coolant to the unit appeared to be in good order. The insulation around the return line was in good condition. The fan was heard operating. No rattling or vibration.

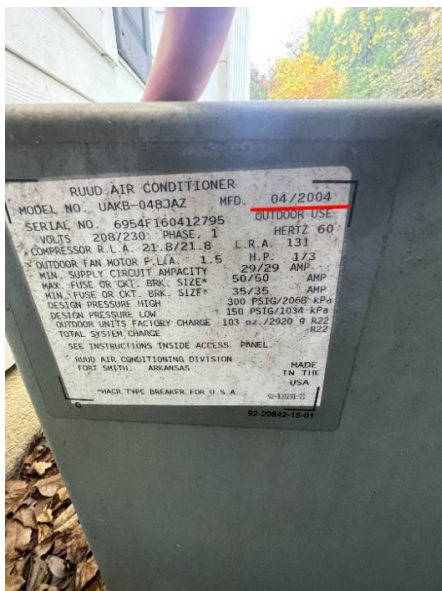
INSP The second floor central air conditioning was not operationally tested during this inspection. To avoid damaging the compressor most manufacturers of air conditioning systems recommend that these units not be tested if the ambient temperature for the previous 24 hours was below 60 degrees. It is recommended that a service company check the unit when ambient temperatures permit. If this is during the winter months and temperatures are not expected to rise to this level there is an alternative option. You may wish to contact a qualified licensed HVAC contractor, who can bring special equipment to heat up the crankcase of the compressor in order to safely test the equipment. This method of testing is beyond the scope of this visual inspections

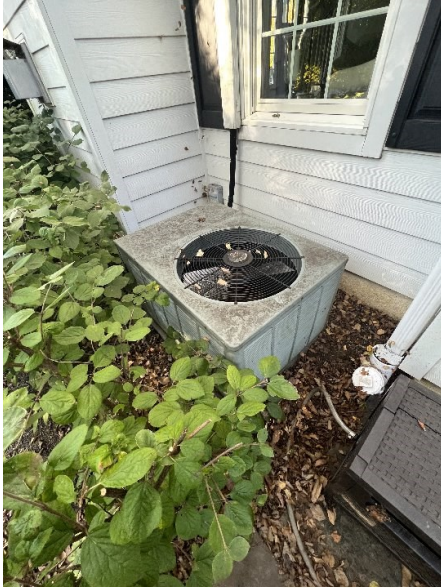
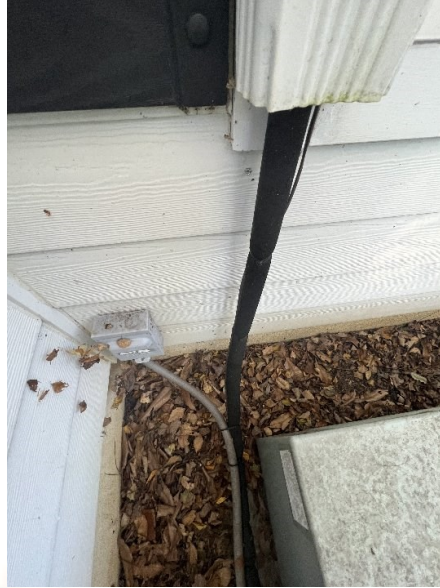
CONDENSER

The condenser for the air conditioner is located on the right side of the home. The condenser unit appears level and was securely mounted on a base. The insulation around the condenser's suction line was in good condition. There is an electrical service disconnect for the condenser unit. The fins on the condenser appeared clean. No rust or corrosion was noted.

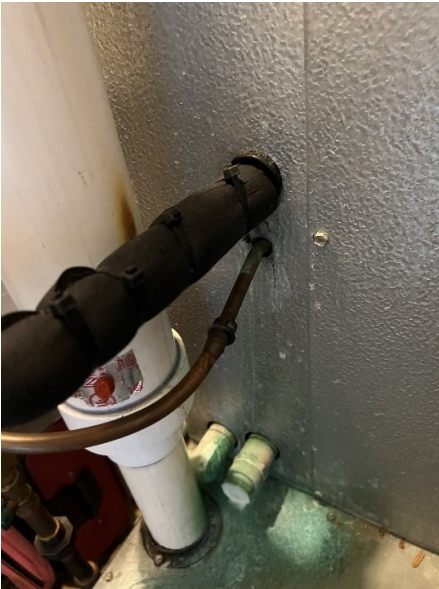
AIR HANDLER

The air conditioning is distributed through the house using the same ductwork as the furnace.

The insulation around the return line was in good condition.

The fan was heard operating. No rattling or vibration.

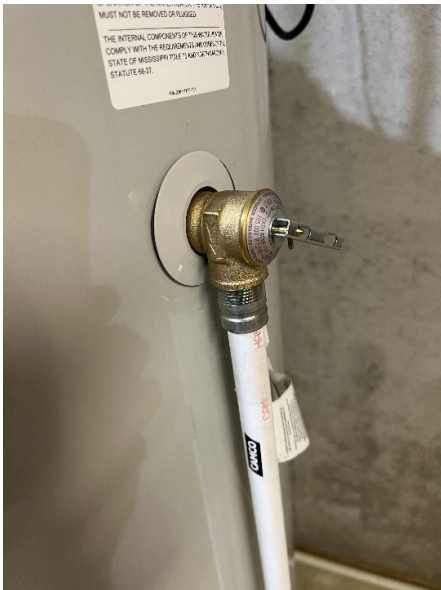
TEMPERATURE & PRESURE RELIEF VALVE

The T&P valve (Temperature and Pressure Relief) for the water heater is present and its discharge pipe is extended to the floor.

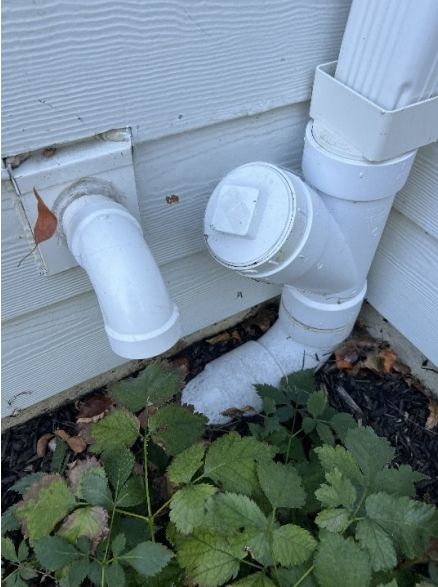
FLUE PIPE

SAFE The flue pipe for the water heater was too low on the exterior of the house. The flue pipe should be at least 12' above the ground. The low flue pipe could be blocked by snow during the winter months. A qualified HVAC contractor should raise the flue pipe.

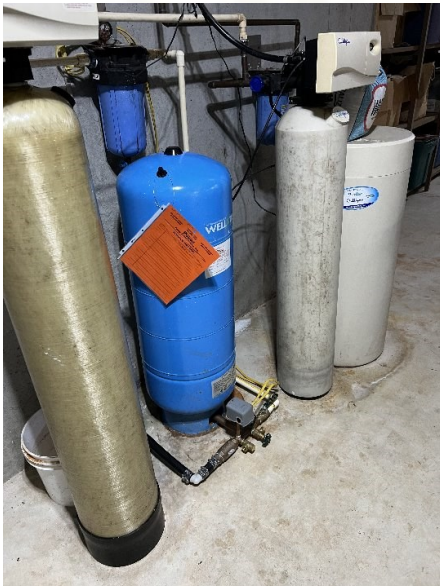
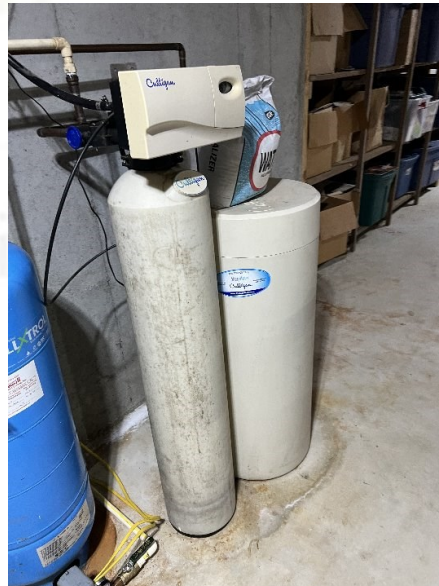
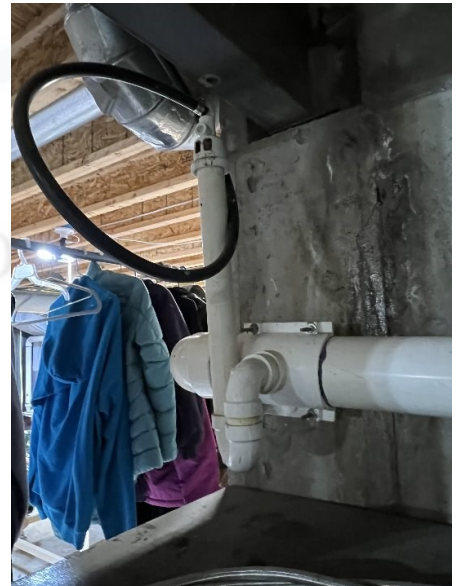
There is a water treatment system installed in the home. The function and adequacy of the water treatment system is beyond the scope of this inspection. Recommend asking the seller for information about the water treatment system. when was it last serviced? who has been servicing it?
