SUNLIGHT INSPECTION SERVICE

5 Sunny Dr Great Twon, PA 19000
REPORT# 22100000D

Saturday, October 22, 2022

Introduction

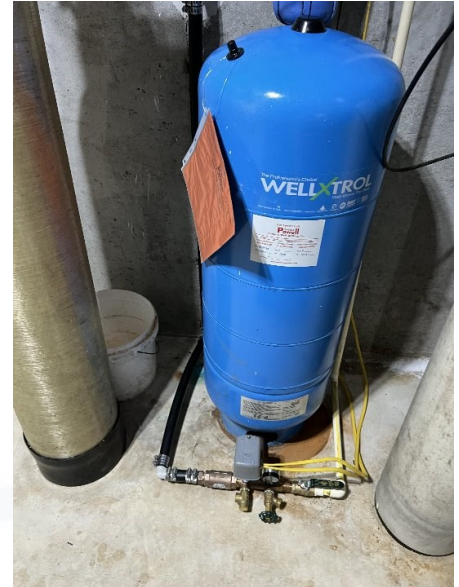
REC A water leak was found at the pressure gauge on the water treatment system. A qualified plumber should repair as needed.

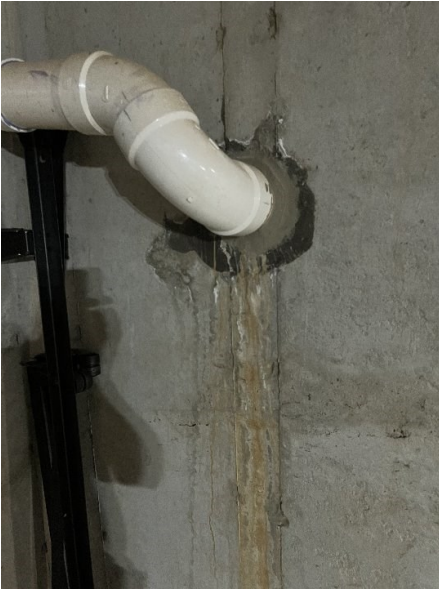
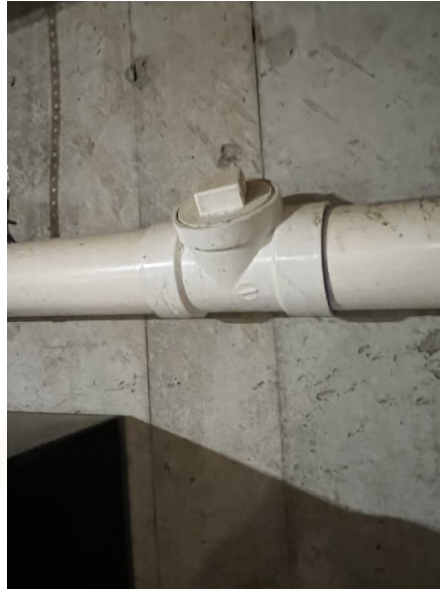
DRAIN & WASTE SYSTEM

The pipes are well supported with no visible cracks in any of the lines.

Water was run at all the plumbing fixtures in the house there were no leaks observed in any of the visible sewer lines.

The clean out is visible

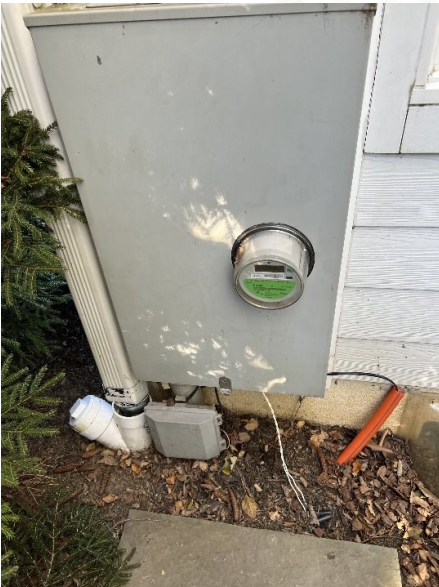
ELECTRICAL METER

With normal hand pressure, the electric meter felt securely attached to the house.
There is no major rust or corrosion visible on the meter box.

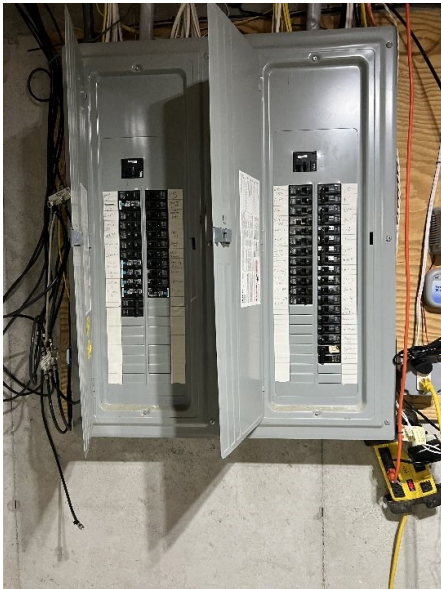
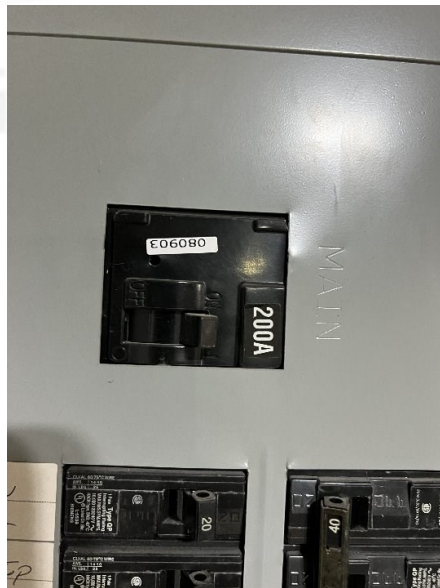
MAIN ELECTRICAL PANEL

Two 200 amp services at the electrical panels.

No rust or corrosion is visible inside the panels, on the wires, breakers, or metal boxes.

There is room for expansion in the panels.

For safety remember to keep proper clearances around the panel.

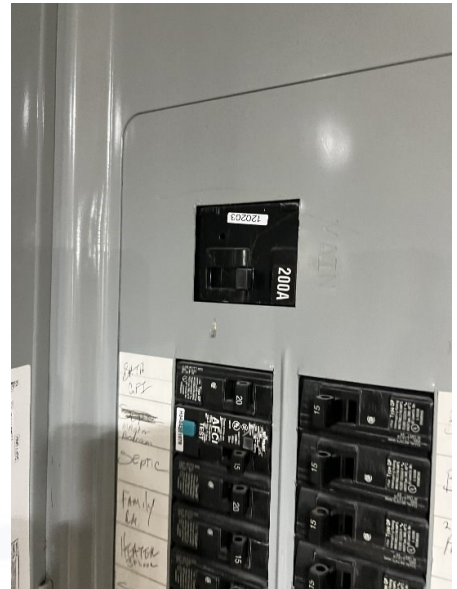
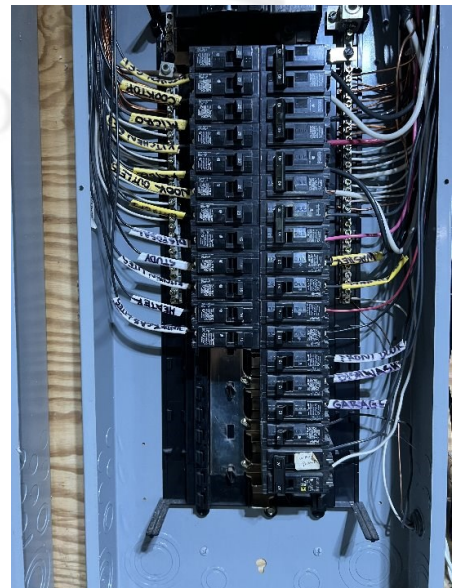
REC I observed one circuit within the left main electrical panel doubled up (referred to as a "double tap"). A double tap is when two circuit wires are connected to only one breaker. The circuits should be separated so that each circuit is serviced by its own circuit breaker. A qualified electrician should make the necessary corrections.

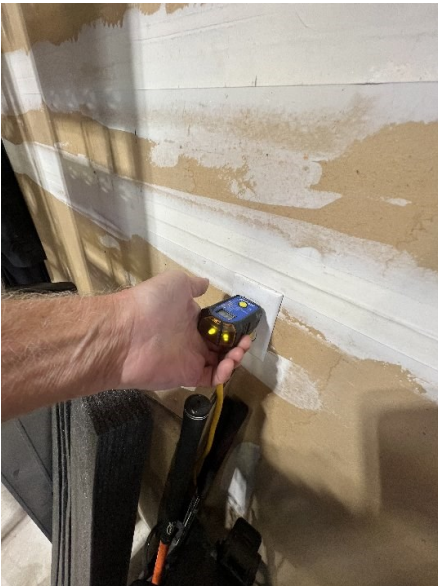
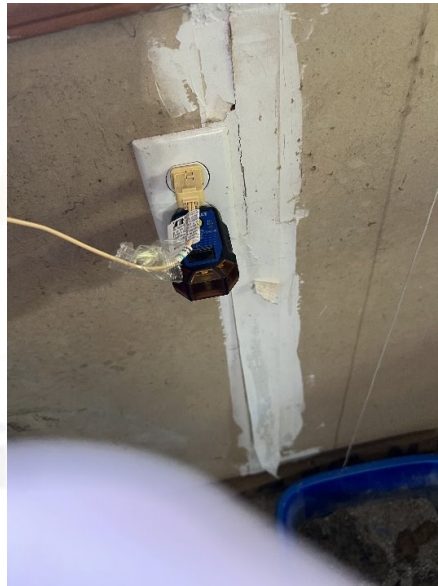
SAFE The receptacles in the garage were not GFCI (ground Fault Circuit Interrupter) protected. Current accepted standards recommend that all garage receptacles be GFCI-protected. For increased safety, I recommend having a qualified electrician install GFCI protection for the garage receptacles.

Note: the GFCI receptacle near the electric panel did not trip when tested and needs to be replaced. This receptacle may protect the receptacle in the garage near the door. The GFCI receptacle underneath the laundry room window did not trip when tested and needs to be replaced. This receptacle is most likely protecting the receptacles under the garage windows.

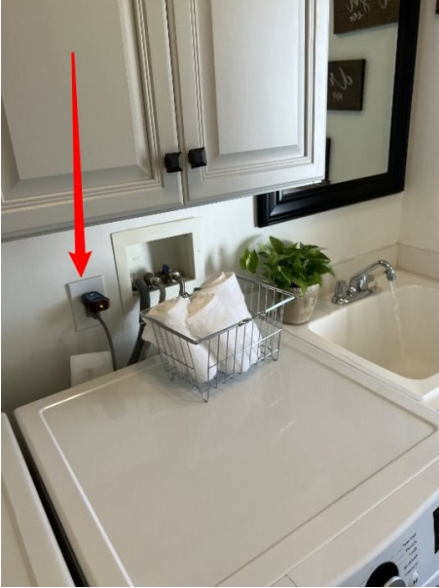
SAFE The two receptacles in the laundry area are not GFCI protected. Current accepted standards recommend GFCI protection for receptacles in laundry areas. For increased safety, I recommend having a qualified electrician GFCI protect for the laundry area receptacle.

Note: The GFCI receptacle under the window is protecting the two receptacles under the garage windows.

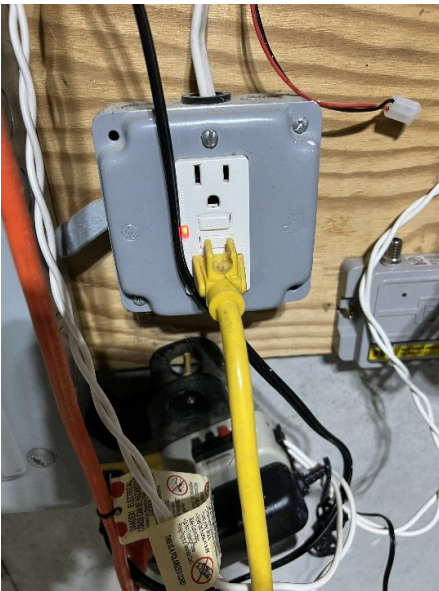
GFCI receptacle does not trip, shows open ground

SAFE The GFCI receptacle near the electrical panel does not trip when tested. The receptacle should be replaced by a qualified electrician.

Note: This receptacle may protect the receptacle in the garage.

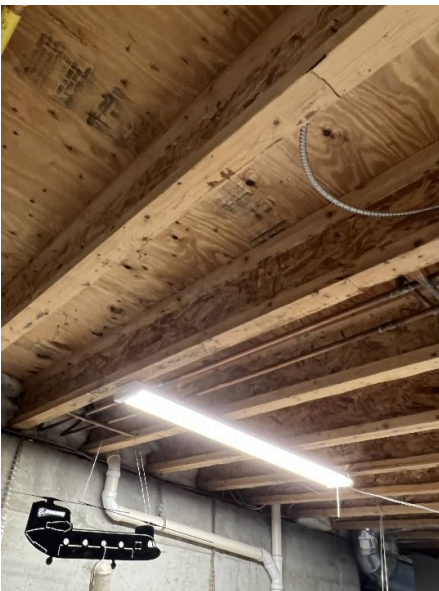
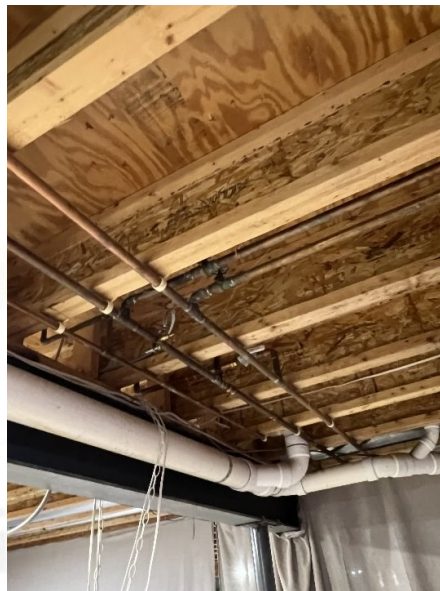
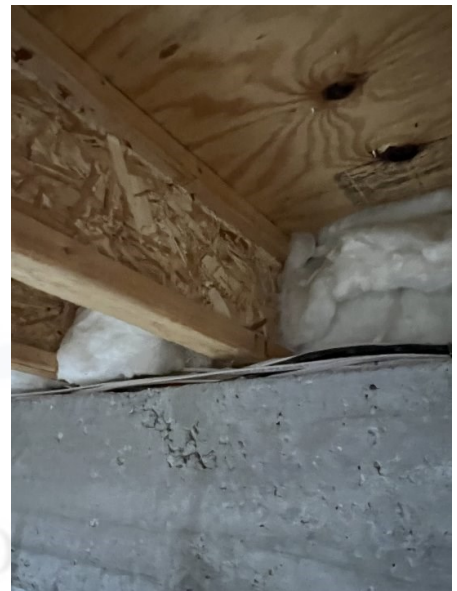
FLOOR STRUCTURE

The floor joists are constructed of Manufactured I Joists. Readily accessible areas were inspected. No visible deficiencies observed.

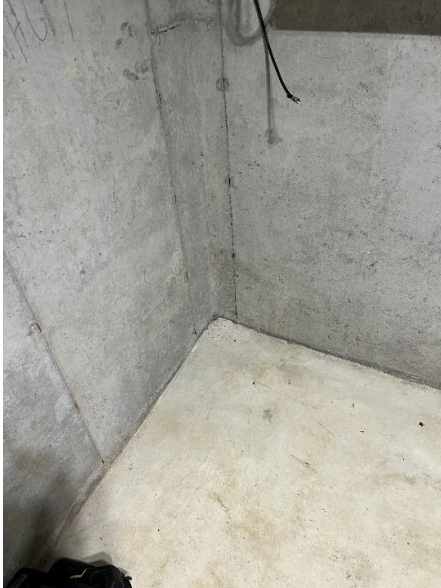
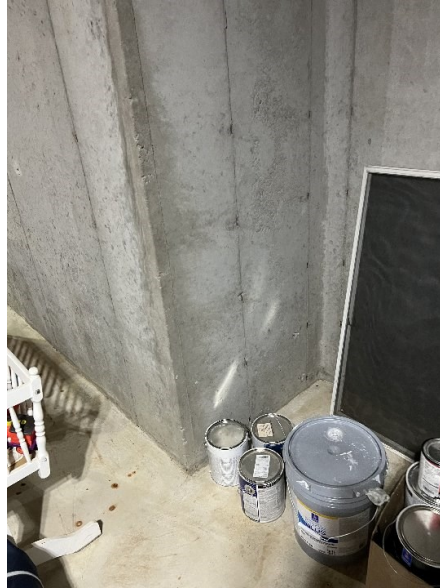
FOUNDATION

The foundation is constructed of poured concrete.

Readily accessible areas were inspected. There are no indications of significant structural deficiencies apparent.

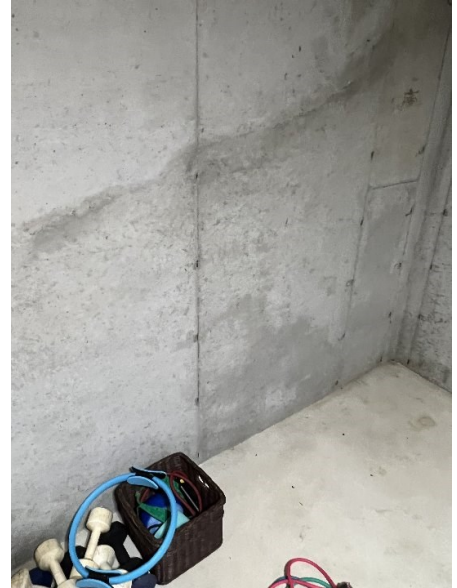
INSP A repaired crack in the poured concrete foundation was noted underneath one of the steel beams. The repairs appear to be holding up. I recommend asking the seller for more information about the repairs; When were they done? , Who performed the repairs? , Is there any documentation and/or warranty for the repair(s).

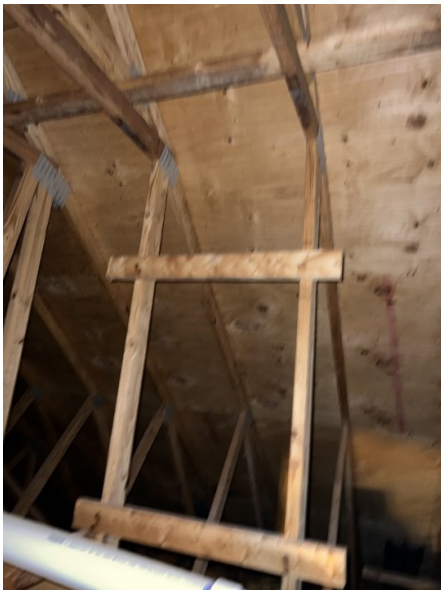
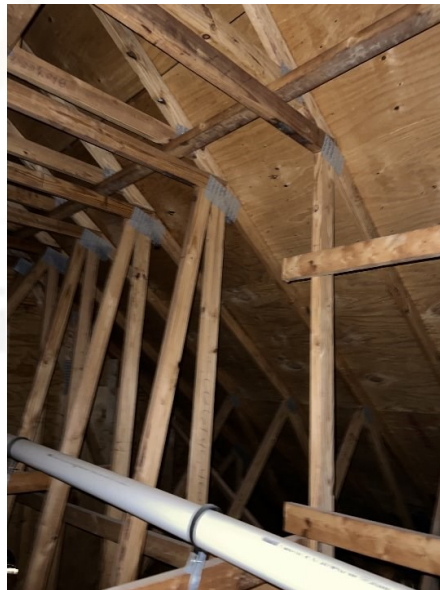
Visual inspection only of the attic spaces. Limited access. No major structural defects are readily visible from the access. There were no cut, damage, missing, or loose components of the rafter boards readily visible.

There were no signs of active roof leaks observed from the access. Recommend asking the seller to disclose of any prior roof leaks.

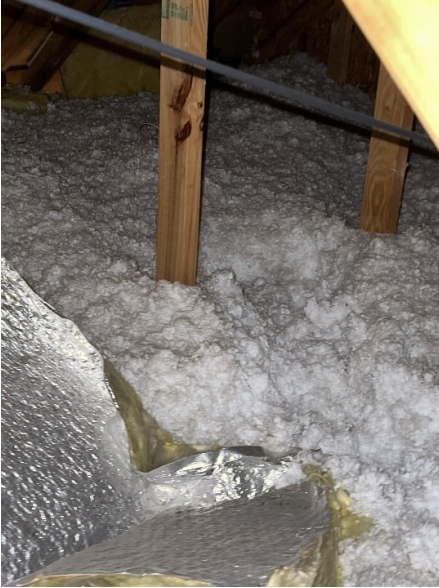
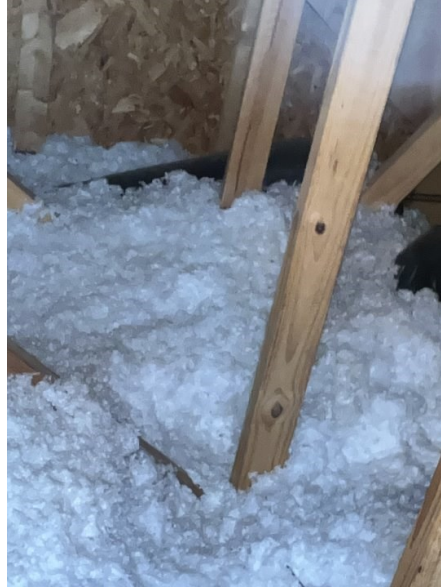
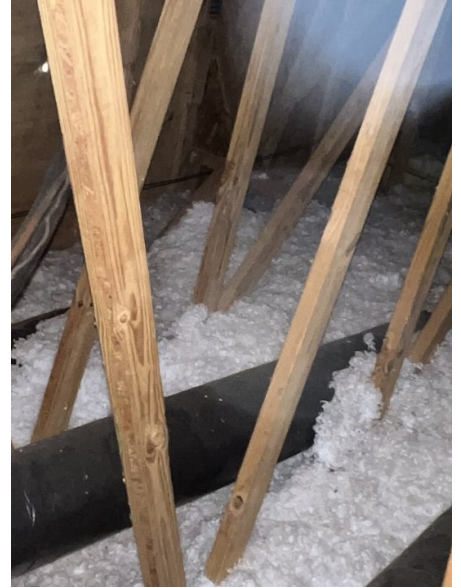
INSULATION

I inspected the attic insulation. The attic floor area was insulated with approximately 10 to 12 inches of insulation. Providing an approximate R-value of R30

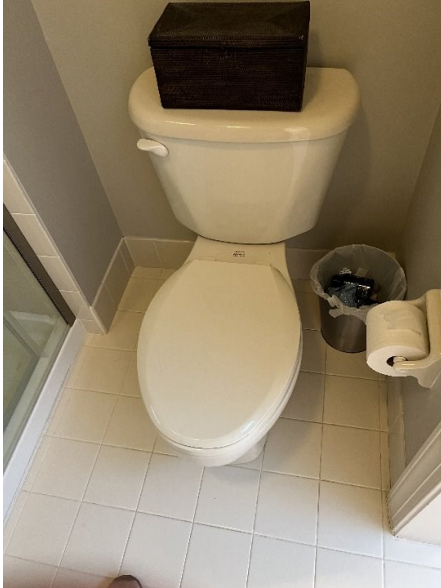
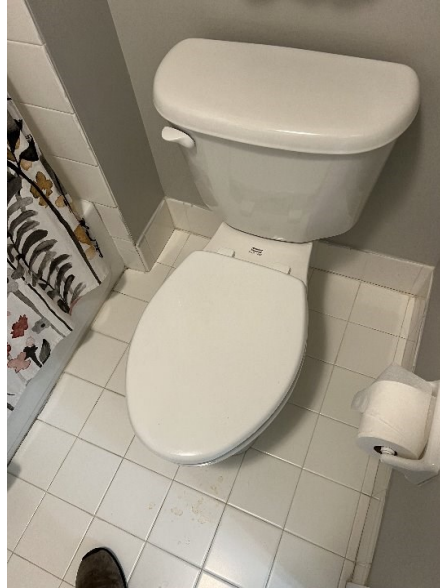
TOILETS

All the toilets flushed and appeared to be operating fine.
The toilets were secure to the floor.
There were no soft spots of flooring detected around the toilets.

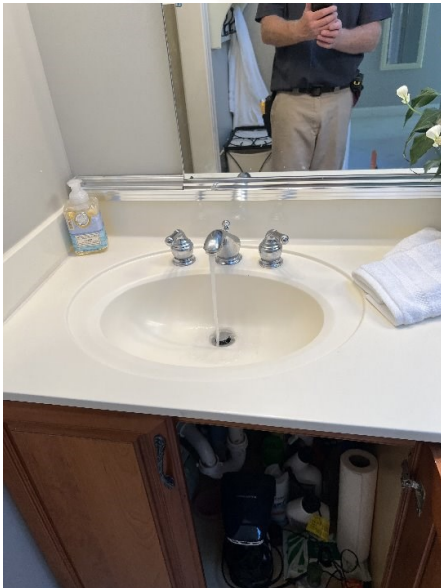
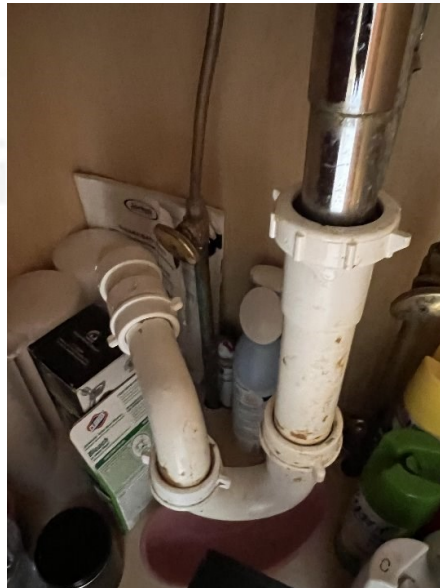
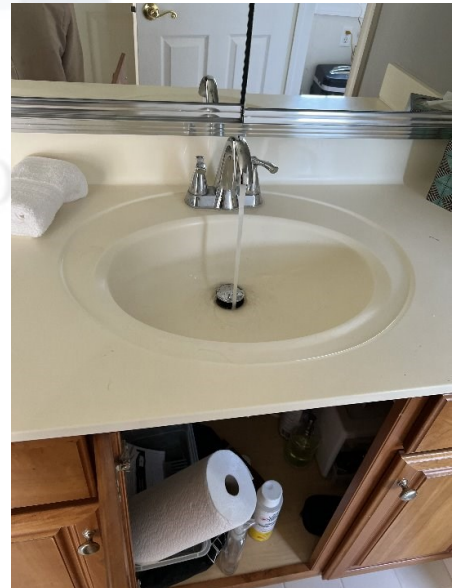
SINKS

All the bathroom sinks had hot and cold water running to them.
All the bathroom sinks drained with no visible leaks at the drain pipes

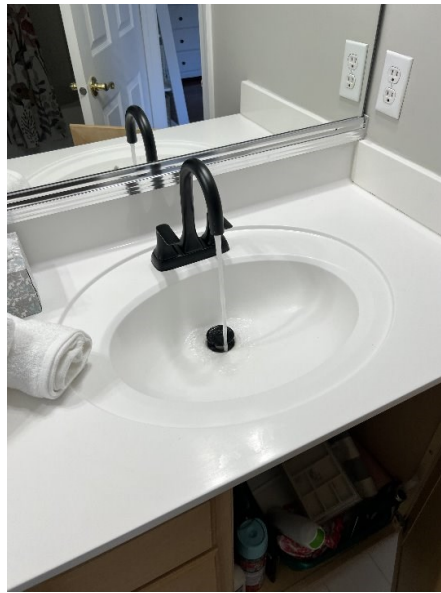
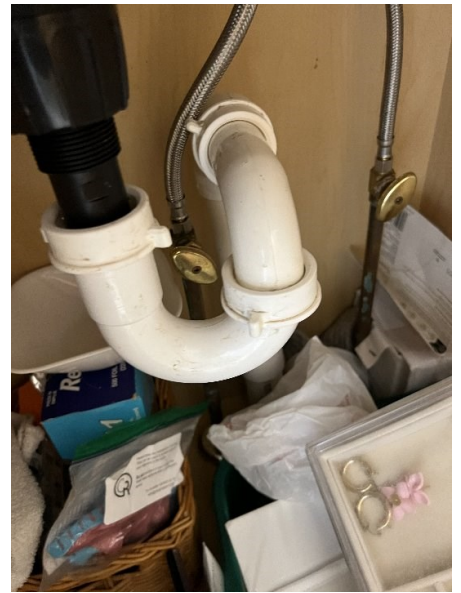
IMPR The front Jack & Jill bathroom sink drained slowly. The drain trap should be cleaned out. This is a minor repair that should be done by a qualified person.

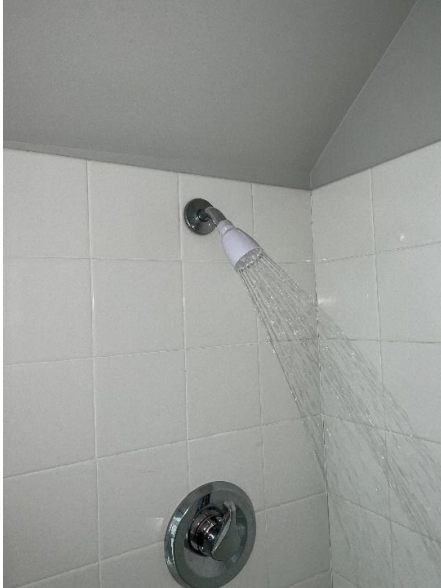
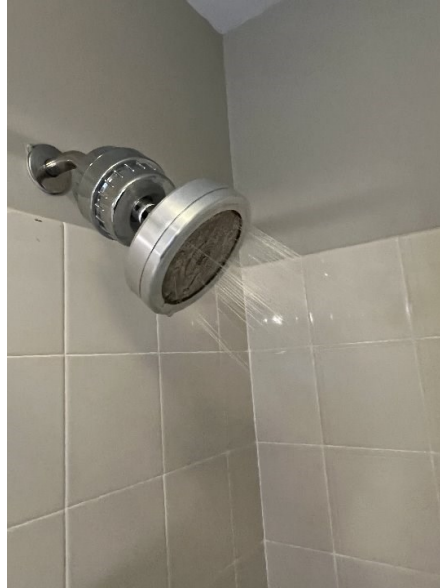
TUBS & SHOWERS

All the tubs and showers drained with no visible leaks.

There were no soft spots of flooring detected around the tubs and showers.

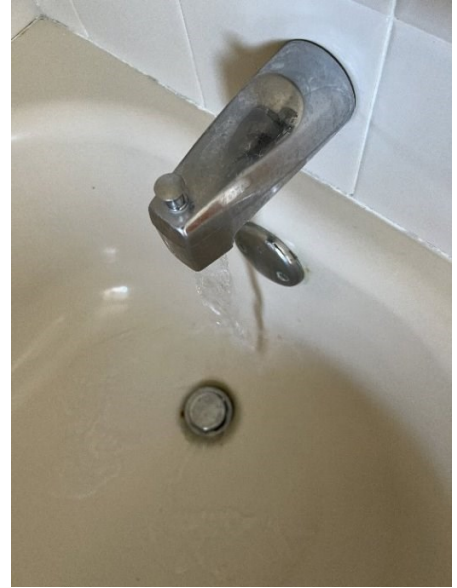
IMPR Grout or caulk is needed at the corner of the third-floor shower. This is a simple repair that should be done by a handyman or qualified person.

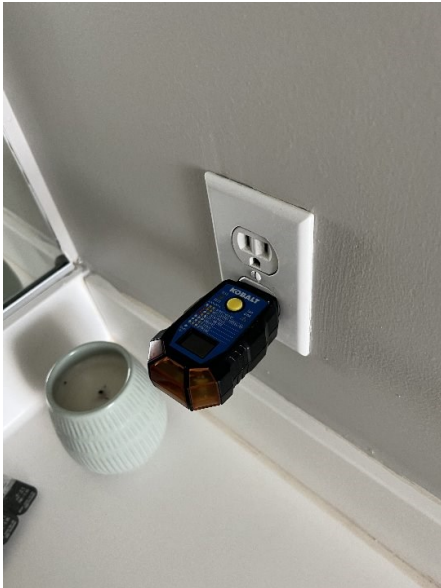
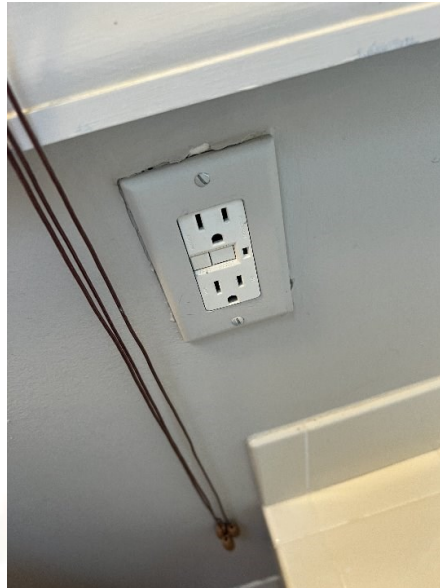
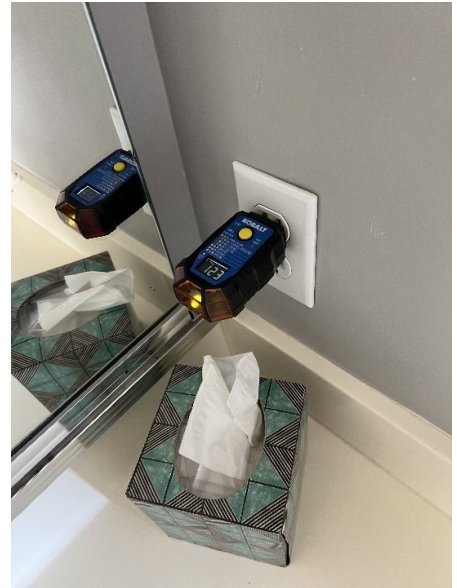
OUTLETS

All the bathroom receptacles had functional GFCI protection.

The bathroom electrical receptacles are all tied together and are protected by the GFCI receptacle located in them master bathroom. If you find one of the bathroom receptacles without power the master bathroom GFCI receptacle needs to be reset. Over time GFCI receptacles can fail. There is a spring in the receptacle that can break and an electronic chip that can wear out. If the GFCI receptacle can not be reset with the reset button it should be replaced.

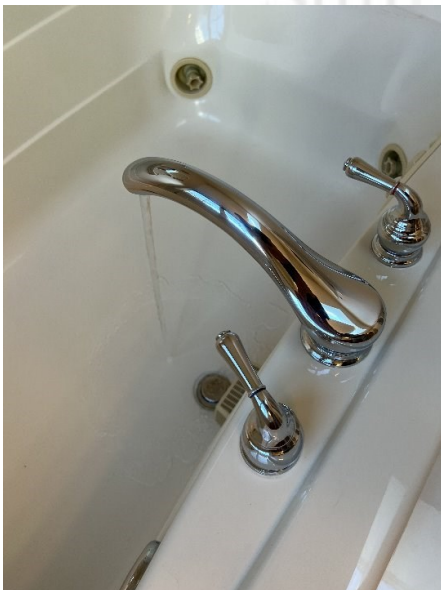
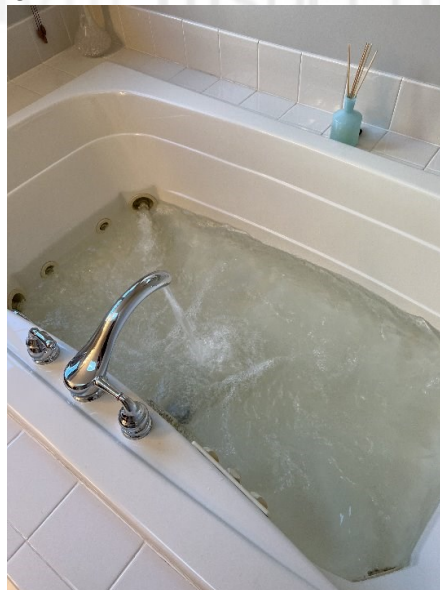
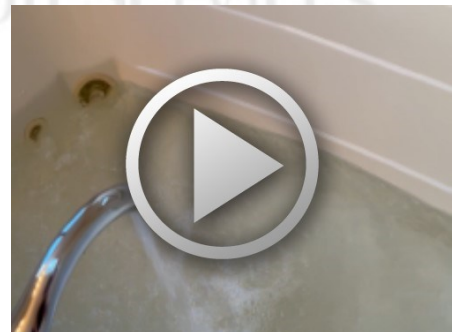
JETTED TUB

The jetted bathtub in the master bathroom was filled up with water and was turned on. The water circulated.

There was hot and cold water running at the faucets. The tub was drained.

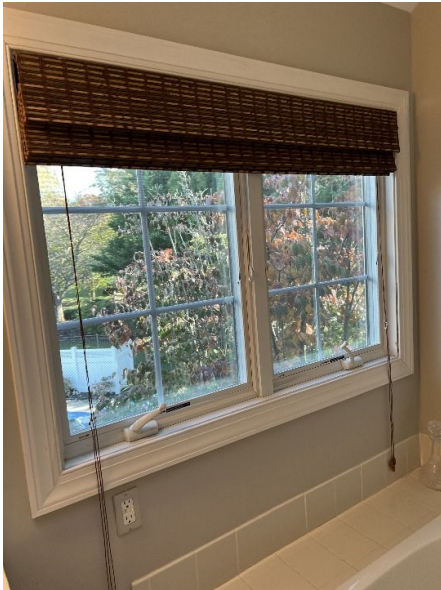
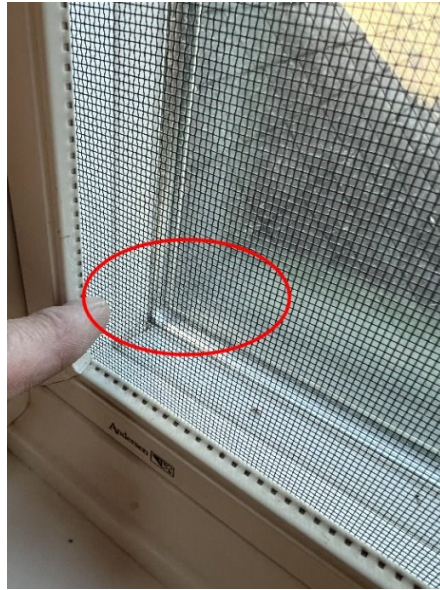
The jetted bathtub is on a GFCI circuit.

The window(s) above the tub are glazed with tempered glass, good.

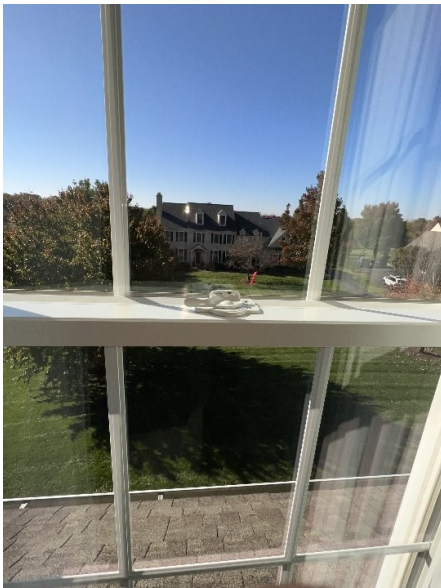
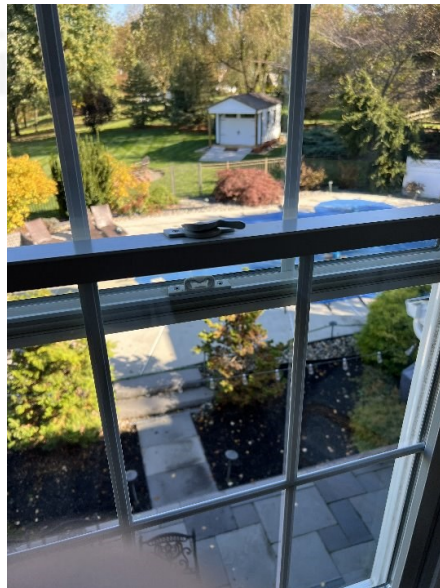
Windows are inspected for proper operation, condition of sill, sash, hardware and the condition of weather-sealing components.

The windows that were inspected were functional with no significant defects observed

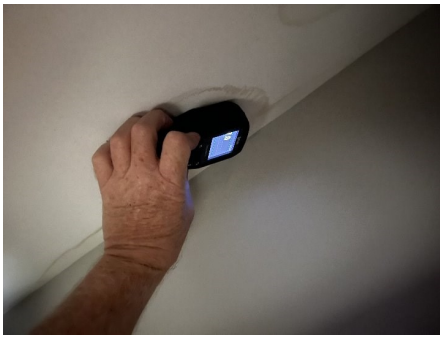
INSP A water stain was observed on the third floor closet ceiling. A moisture meter was used to probe the water stain. The meter did not detect elevated levels of moisture in the ceiling. The stain appears to be from a past roof leak.

A dry-water stain does not necessarily mean that there is not a leak. Water dries in 3 to 5 days in sheetrock. So, if the source of water has not been present recently the stain may have dried.

I recommend asking the seller for more information about the water stains. What corrective action was taken (if any to correct the water issue).

If a repair has been confirmed, the stained areas should be cleaned and/or repainted as necessary.

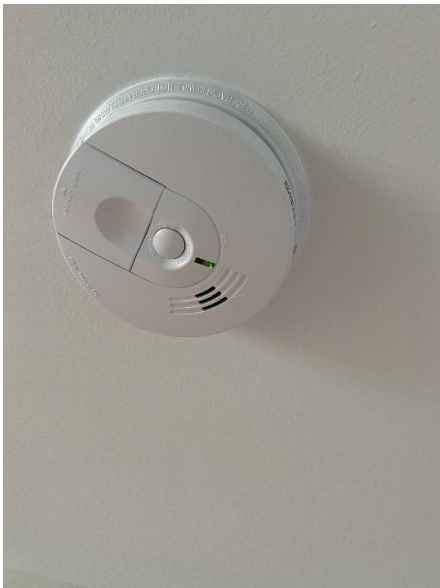
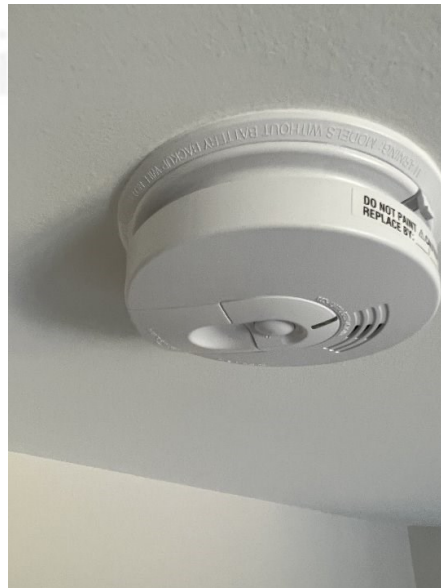
The smoke alarms in the home were Hardwired with battery back-up.

At the time of the inspection the installed smoke alarms sounded when the test button was pushed.

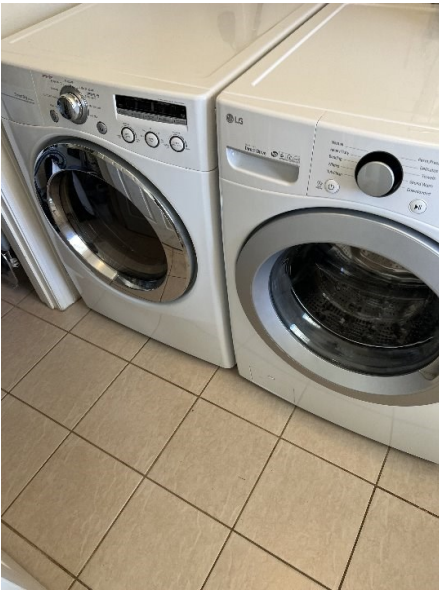
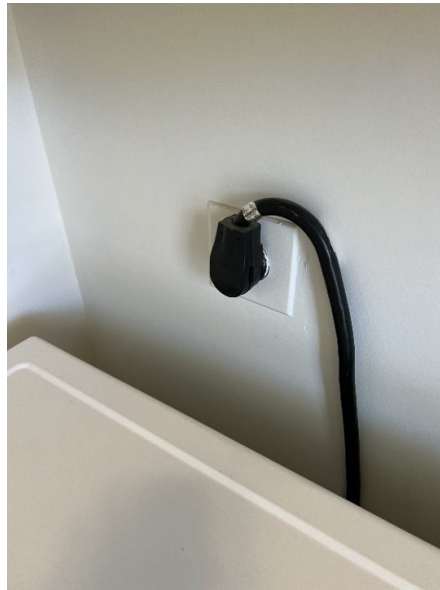
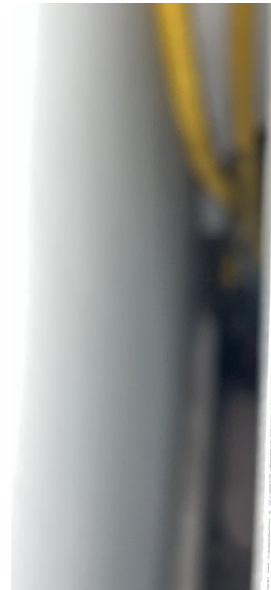
The dryer is hook up is both gas and electric. The dryer duct should be cleaned and inspected once or twice a year.

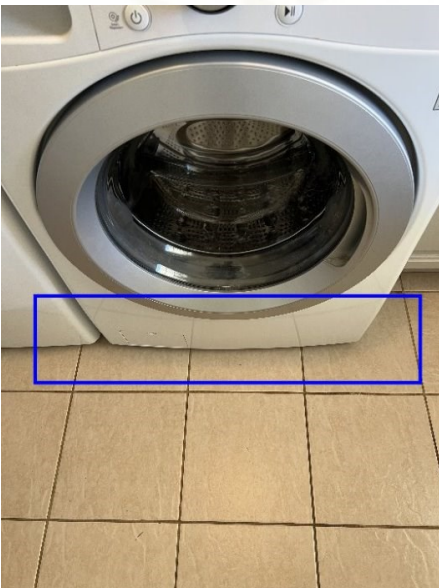
IMPR There was no overflow pan for the washing machine. There is no requirement for an overflow pan under the washing machine however since a leak from the washing machine could cause damage to the home I recommend that an overflow pan with a drain line to the exterior, or other location that would not ruin interior finishes, be installed under the washing machine.

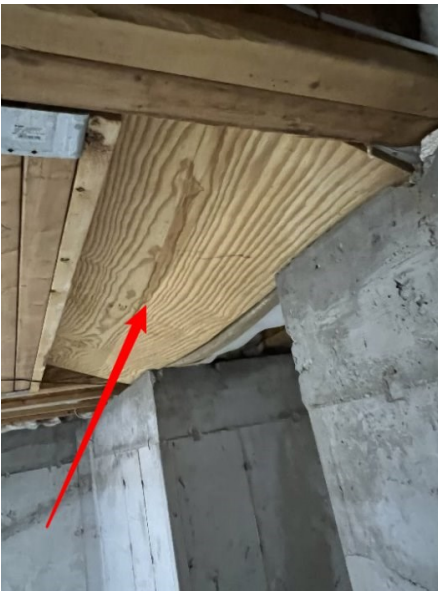
SAFE The wooden form under the fireplace should be removed. This is often over looked when a home is built. According to the National Fire Protection Association (NFPA) the wood form under the hearth poses a potential fire hazard and should be removed after the hearth is built. The form is relatively easy to remove. A qualified carpenter or hand person should remove the form.

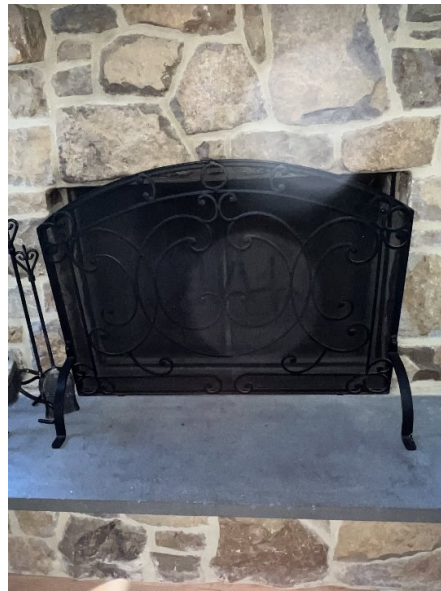
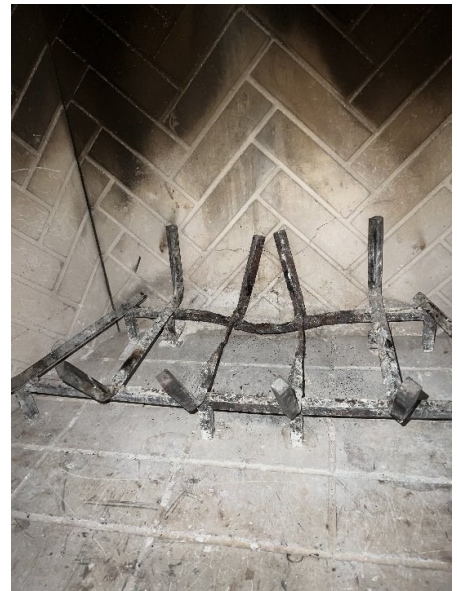
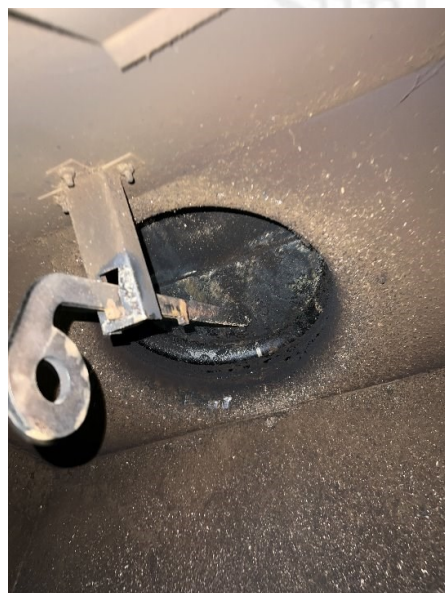
The home has a factory-built fireplace installed.

The fireplace damper door opened and closed by hand.

The fire box appeared to be in good condition, with no major cracks in the refractory panels. No major warping observed. No major rust or corrosion was visible on the interior and exterior of the fireplace.

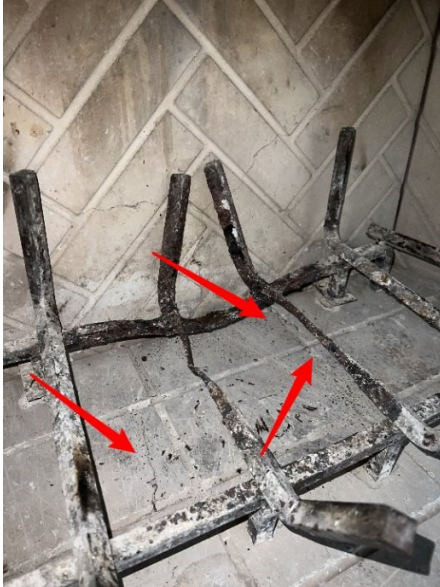
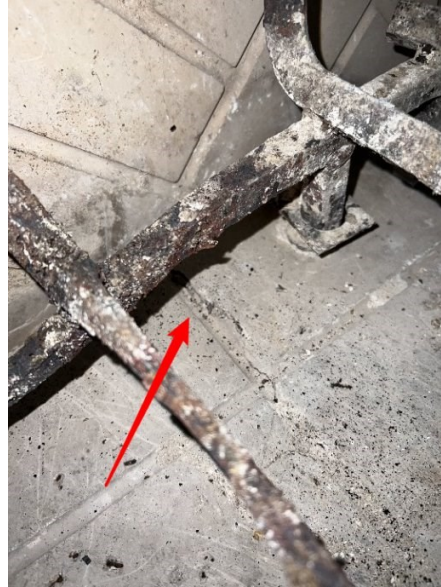
REC I observed two cracks in the bottom refractory panel. The refractory panel is no longer reliable and should be replaced. Refractory panels are designed to protect the steel firebox and deflect heat into the room. The broken panel should be replaced with the appropriate panel for this make and model fireplace.

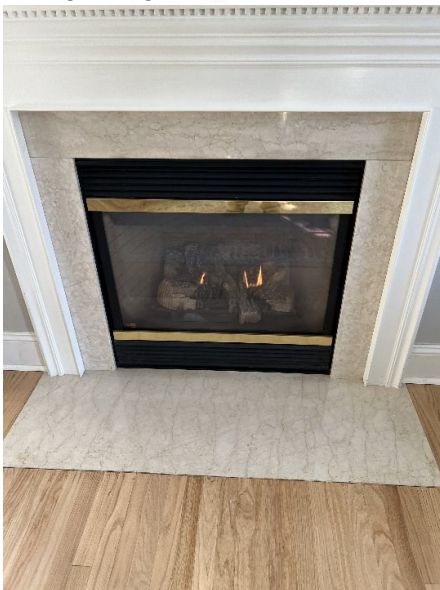
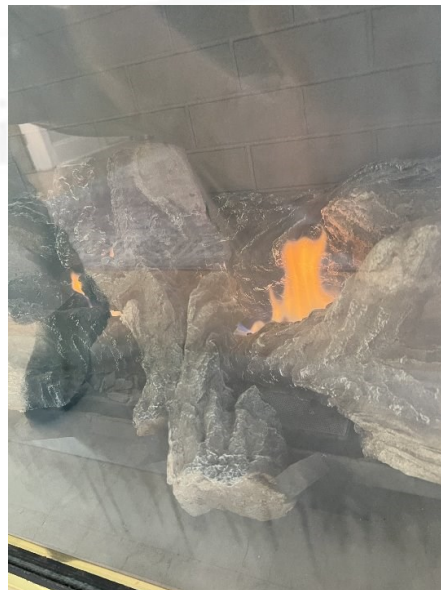
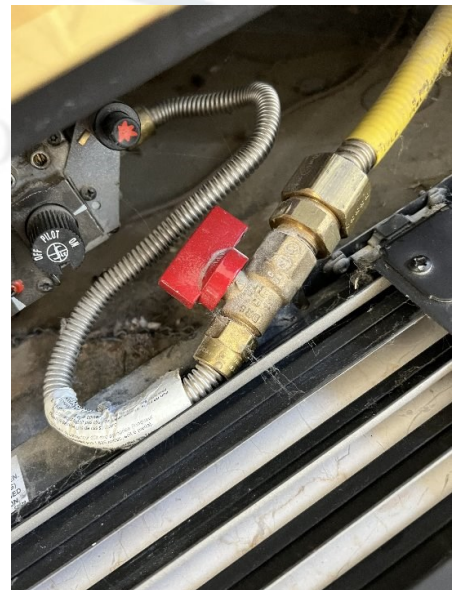
The home has a direct-vent factory-built fireplace in the living room. The firebox appears in good condition, with no major cracks in the refractory panels or rust on the interior of the box observed.

The gas log set came on when tested.

General over view of a direct vent fireplace.

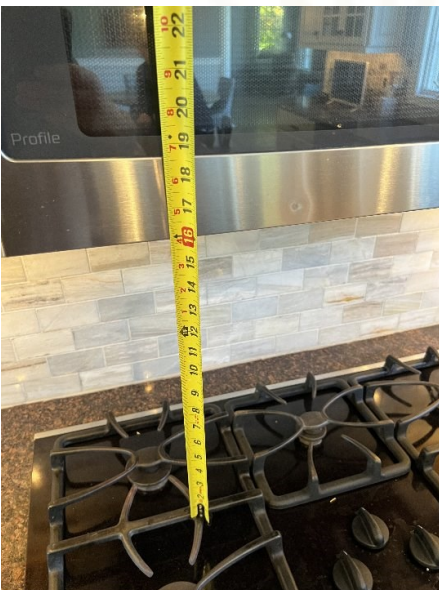
SAFE The bottom of the microwave was too close to the cooktop. There should be at least 18" from the cooktop to the bottom of the microwave. If there were a flare-up on the stovetop it could burn the microwave.

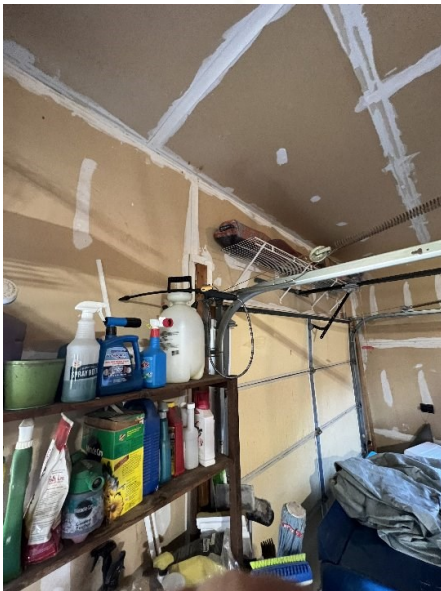
REC The smaller garage door opener did not operate properly. The door opener needs adjustment. The door returned to the fully open position when it reached the bottom. The door would not stay down without hitting the wall button. The tension screws on the back of the door opener should be adjusted so that the door functions properly. This is a simple repair that should be done by a handyman or qualified person. The rough operation of the door prevented me from testing the auto return eye beam function. This should be tested after the door has been properly adjusted.

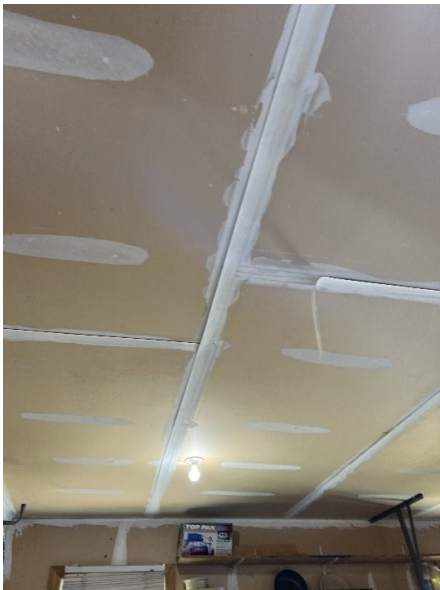
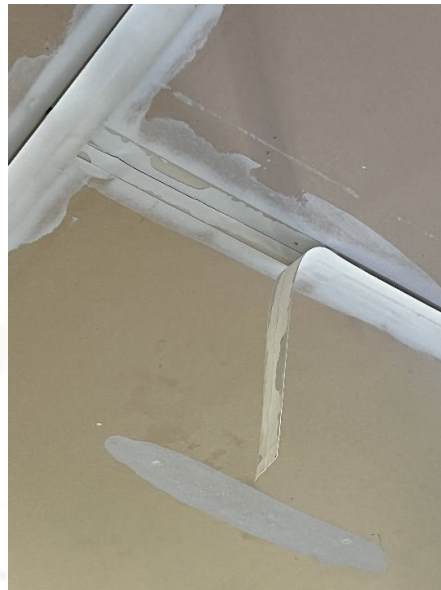
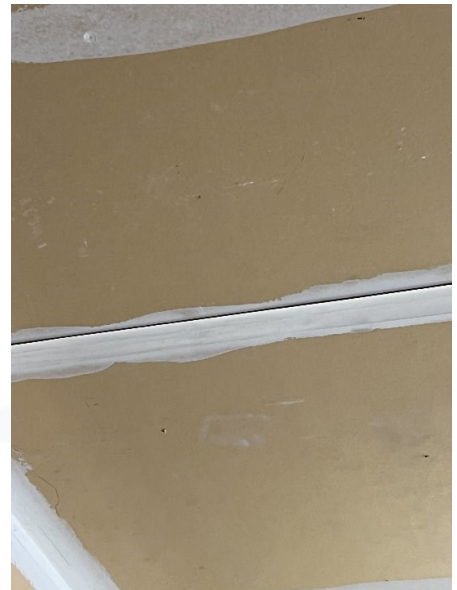
REC Failing sheet rock seems were noted in the garage. The tape is loose and falling down. In order to maintain the fire separation between the house and the garage sheetrock seems should be re-taped by a qualified contractor.

The standard for garage fire separation: Fire separation between the house and the garage. A fire separation usually consists of a 1/2 inch sheetrock wall with no holes in it and all the seams and nails tapped and sparkled. A 5/8 inch sheetrock ceiling if there is living space above the garage, 1/2 inch sheetrock otherwise. The door from the house to the garage should be a solid wood door 1 3/8" thick, a steel door not less than 1/3/8 inches thick, or a 20-minute fire-rated door. Openings in HVAC ducts or vents are not permitted. Plastic flex duct is not permitted to be run through the garage. If attic steps are added they should be (or should be made to be) fire-rated.
