SUNLIGHT INSPECTION SERVICE

123 Sunny Street Nice Town, PA 19460
REPORT# 230600000D

Wednesday, June 14, 2023

Inspector
Daniel Keogh
InterNACHI 212167

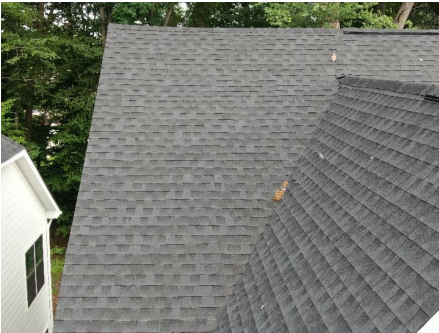
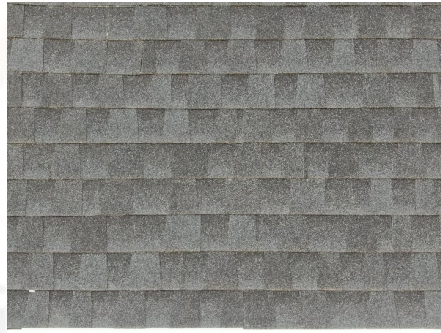
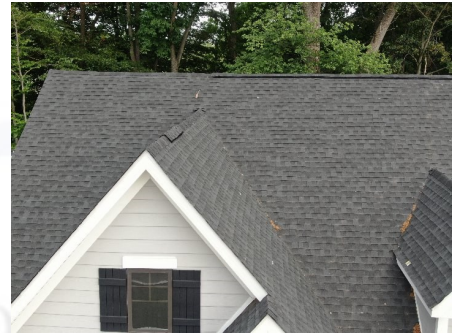
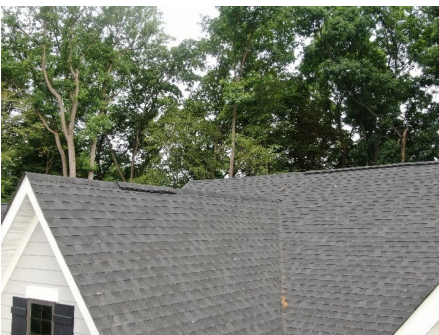
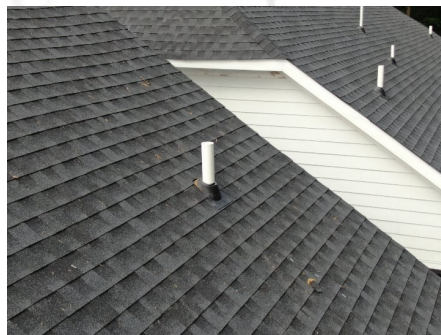
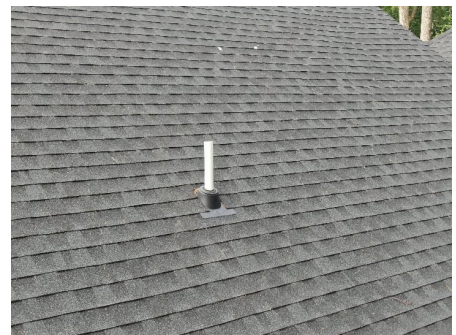
ASPHAT SHINGLES

The asphalt fiberglass shingles on the roof appear to be in functional condition.

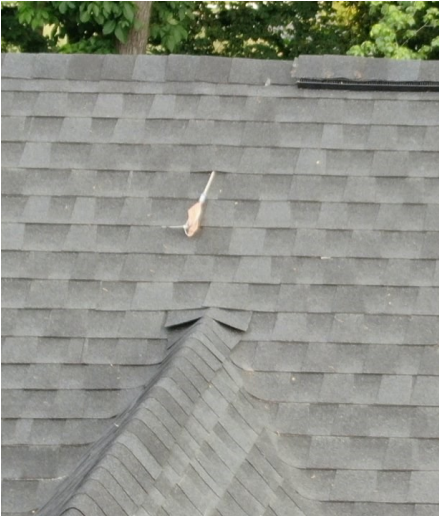
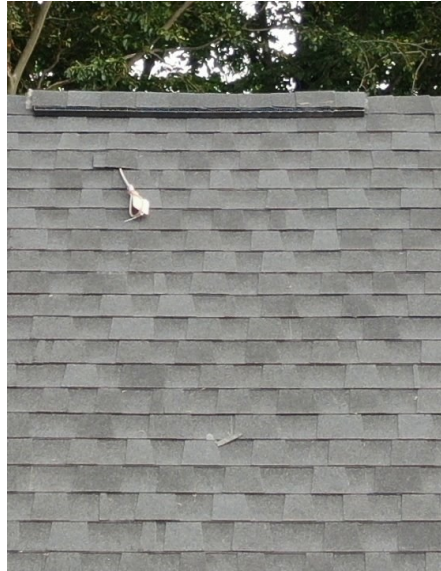
INSP The hooks for the roofer's fall protection harnesses are still in place. When the hooks are removed the shingles under the hooks need to be re-sealed and made water tight.

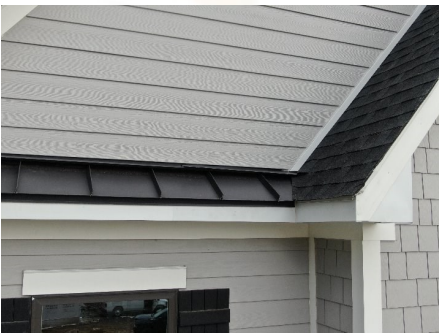
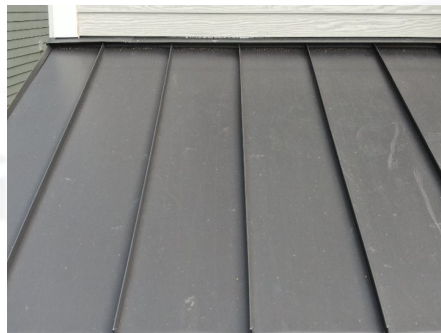
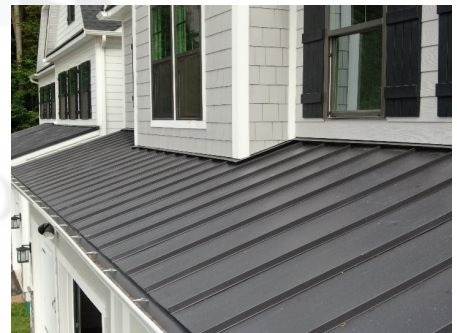
METAL ROOF

I inspected the metal roof. The standing seam metal roof appeared to be in good condition. The surface of the metal was in good condition. The seams are all tight.

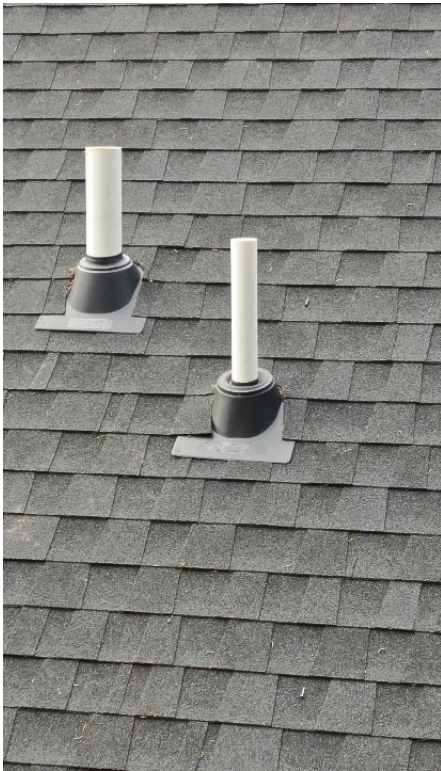
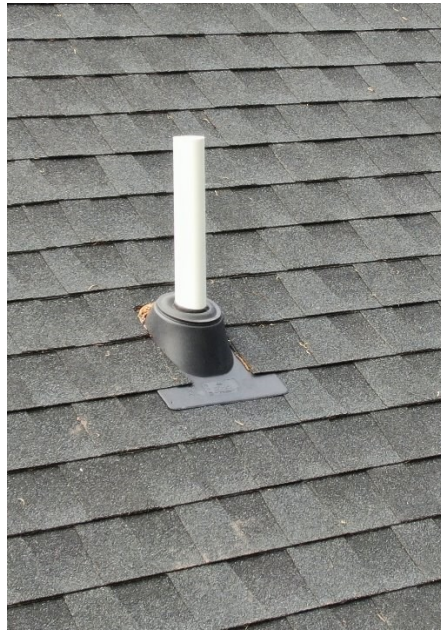
PLUMBING VENTS

There is visible flashing installed around the plumbing stacks. No damage. Good.

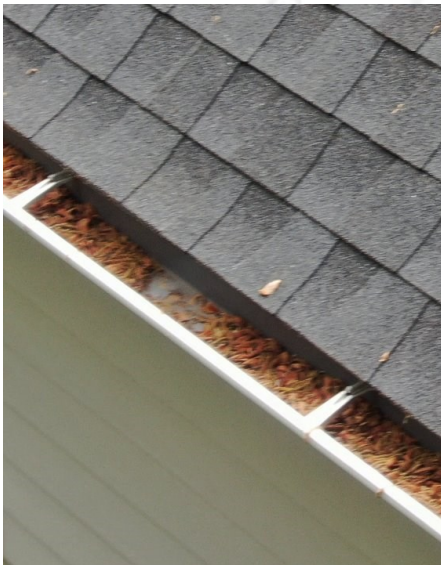
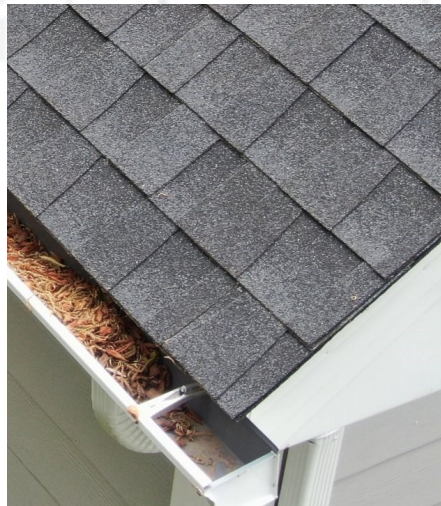
GUTTERS

The gutters appear to be functional but they need to be cleaned.

The gutters appear to be securely attached to the house.

The gutters appear sloped towards the downspouts.

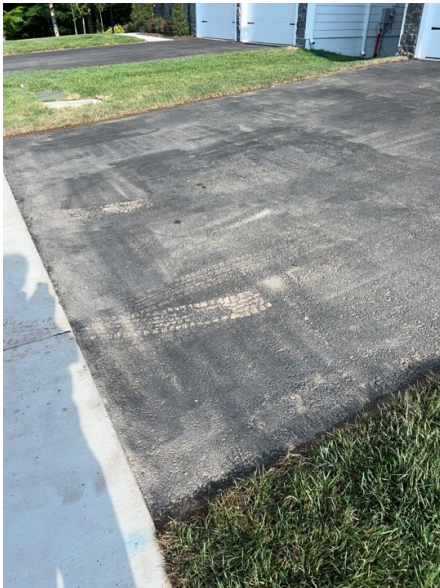
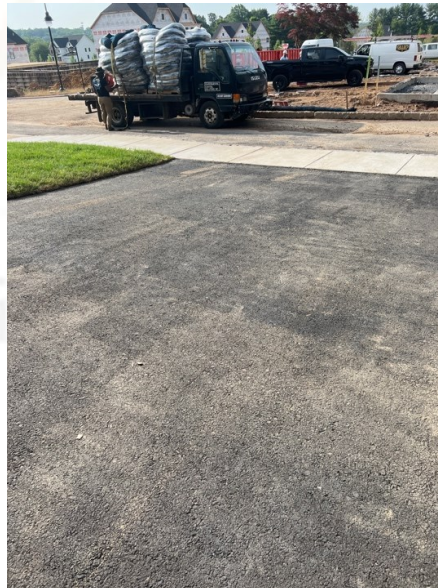
DRIVEWAY & PARKING AREA

INSP The driveway and parking area appeared functional. The final coating of the driveway was not installed yet. Typically in new construction the final finish coat on the driveway does not get installed until after the roads have been dedicated to the Township/Borough. Recommend asking the builder for information about his time table to finish the driveway.

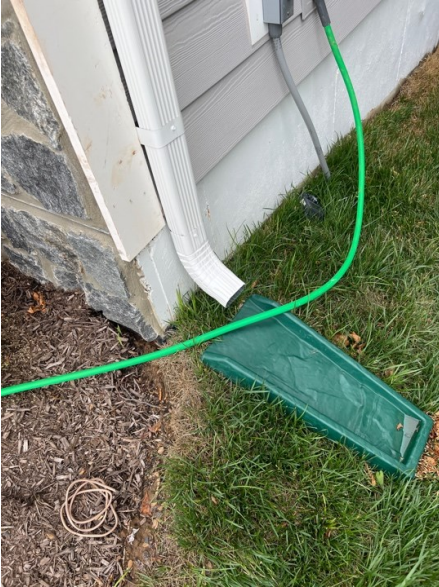
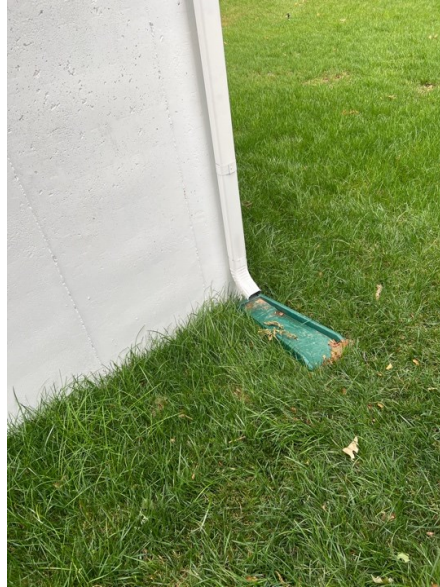
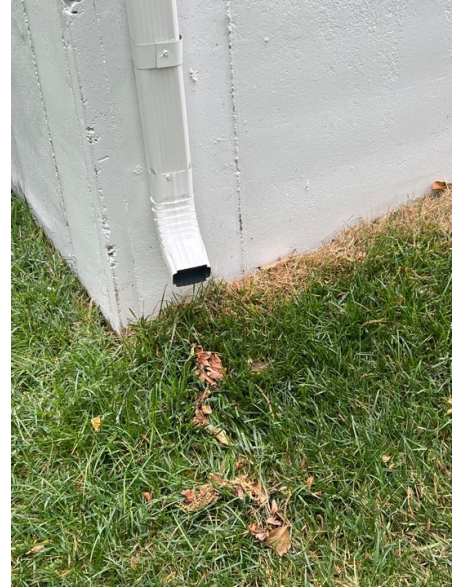
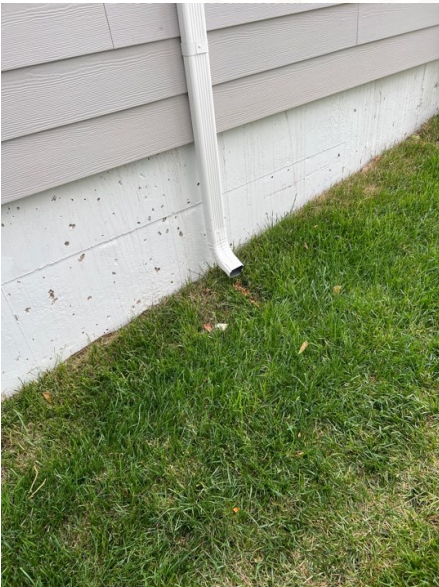
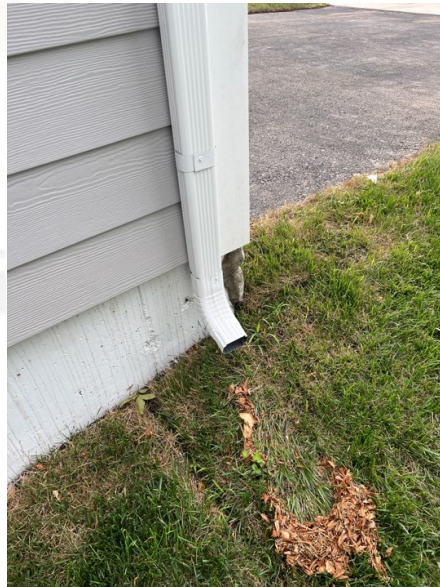
DOWNSPOUTS

The downspouts appeared to be functioning.

Remember to adjust the downspouts, splash-blocks, and drain pipes to divert rain water away from the house foundation. Recommend watching how the rain water is controlled during a heavy rainstorm and adjusting the spouts as necessary.

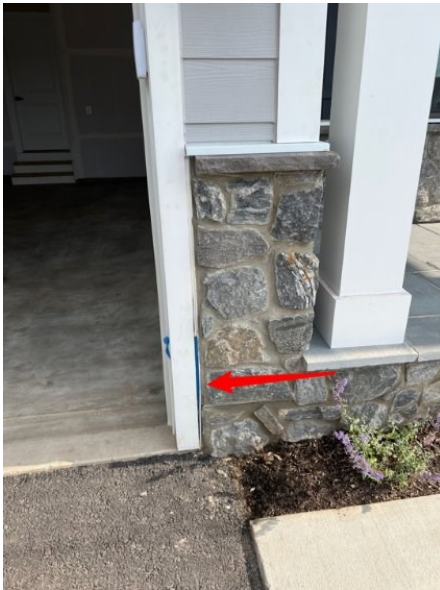
REC The casement bead (E-Z bead) has not been caulked properly. Several of the caulk joints are shallow. There are other transition joints that don't have enough caulk backer in them. The caulk backer must fully fill the space. The caulk backer has a film on it that serves as a bond break and prevents a three-sided bond. Transition joints with a three-sided bond will have an adhesive failure. The adhesive failure typically takes place on the face of the caulk joint.

When stucco or stone veneer runs to any dissimilar material, window frames, door frames, siding, egress, it must be separated by a soft joint (caulked joint) to allow for expansion and contraction between the dissimilar materials. A soft joint can be formed using a stop bead and caulk backer rod or as in this case, a pre-made E-Z bead can be used. E-Z bead is a stop bead and backer rod built together. After the stucco or stone veneer is installed the E-Z bead is sealed (caulked) with exterior caulking that meets ASTM standard 920. The caulking should be pushed into the E-Z bead joint and then tooled with a caulk trowel, not a finger. The built-in backer rod has a silicone release tape on it that prevents the caulking from adhering to the backer rod. This prevents the caulking from forming a three-sided bond which would cause an adhesive caulk failure.

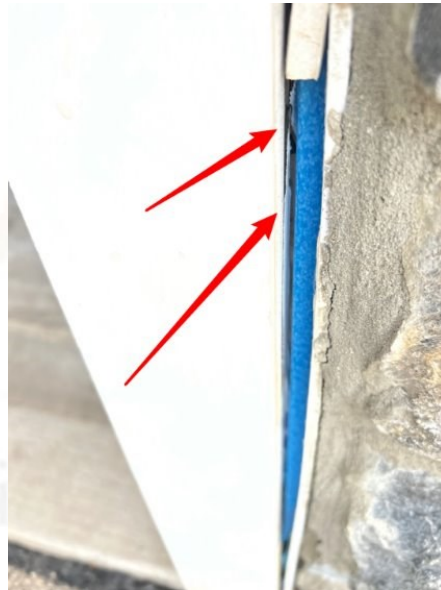
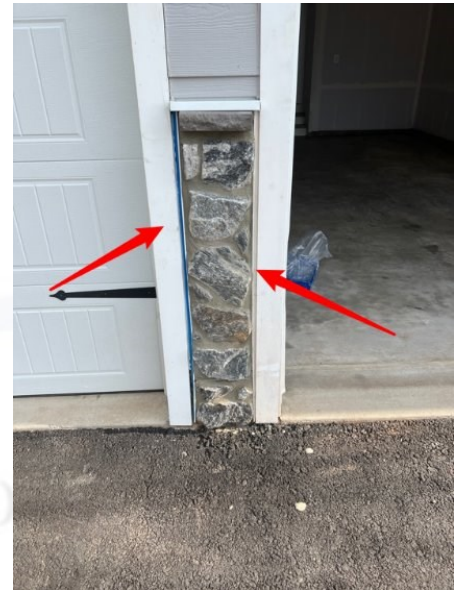
additional caulk backer needs to be installed where there are gaps

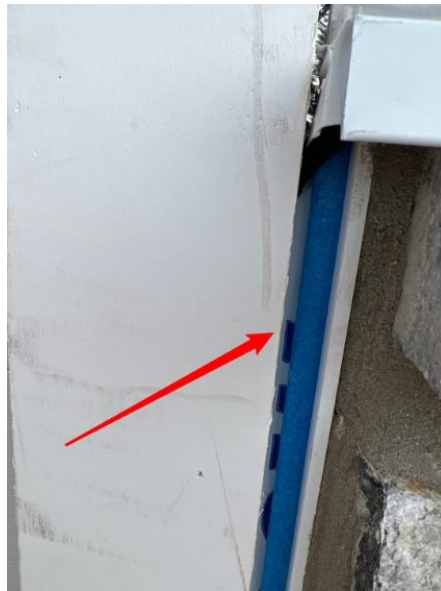
additional caulk backer needs to be installed where there are gaps

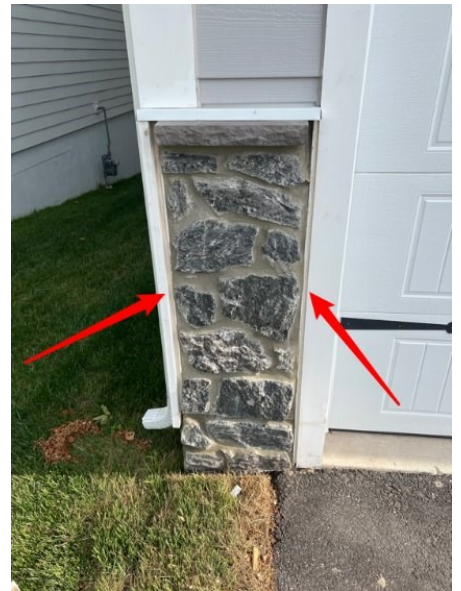
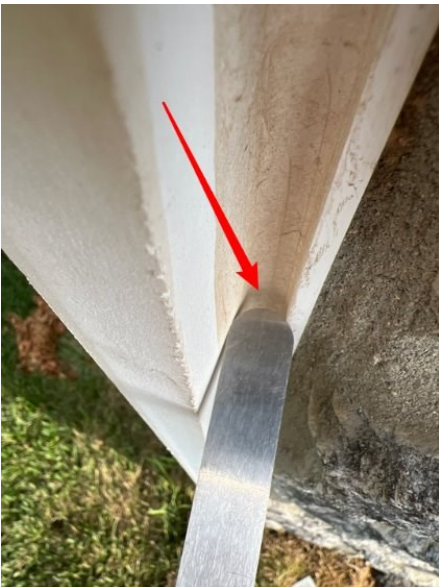
caulk should meet the edge of the caulking knife

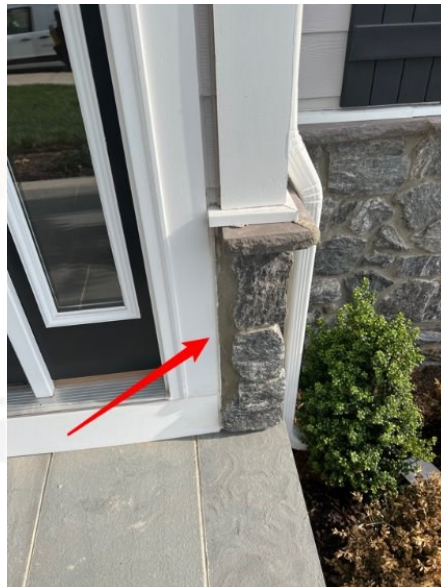
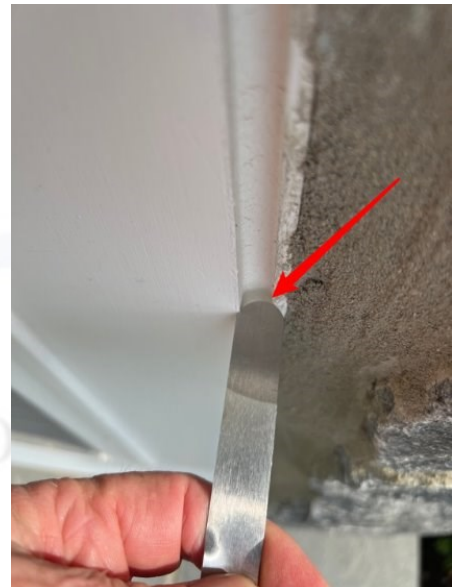
caulk should meet the edge of the caulking knife

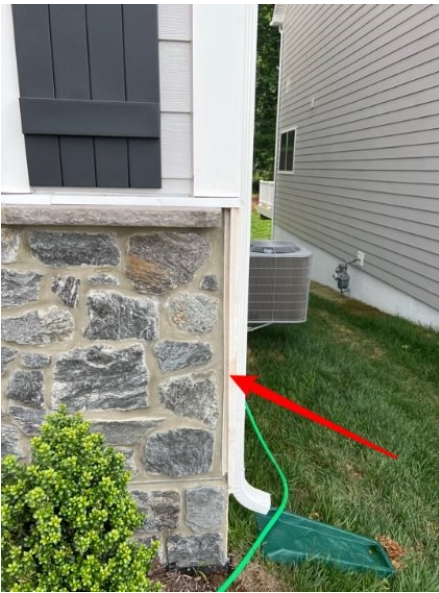
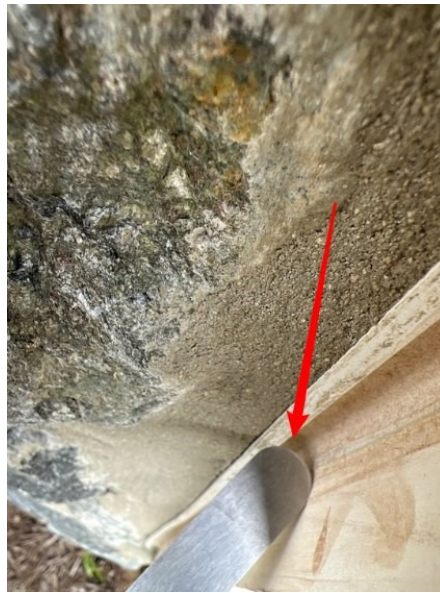
caulk should meet the edge of the caulking knife

R The picture shows what a mechanical caulk joint should look like. The depth of the caulking should be 1/2 the width of the joint. The back of the joint should have a release tape or film to avoid a three-sided bond. A three-sided bond will cause an adhesive failure on one side of the joint.

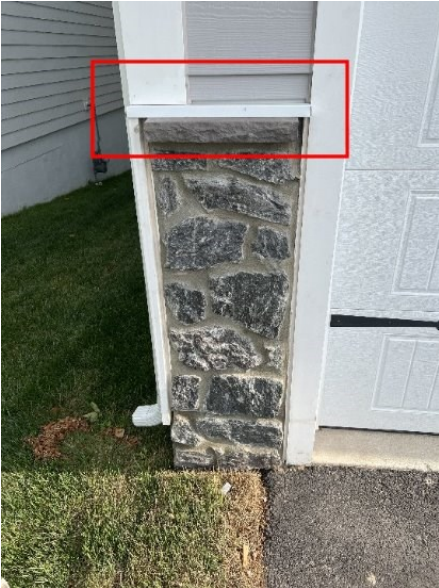
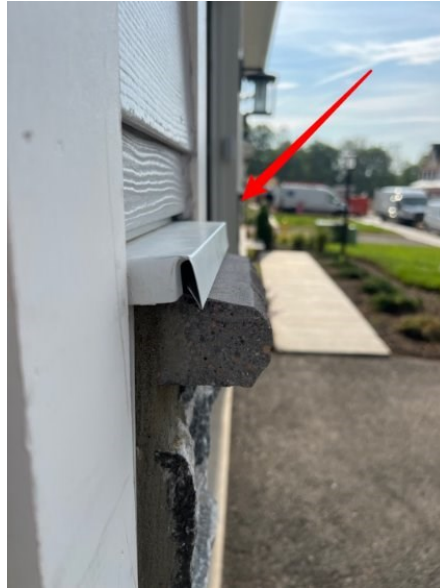
REC Coping flashing sloping the wrong way was noted to the left of the left garage door. The coping flashing should direct water away from the exterior wall.

coping flashing sloped the wrong way.

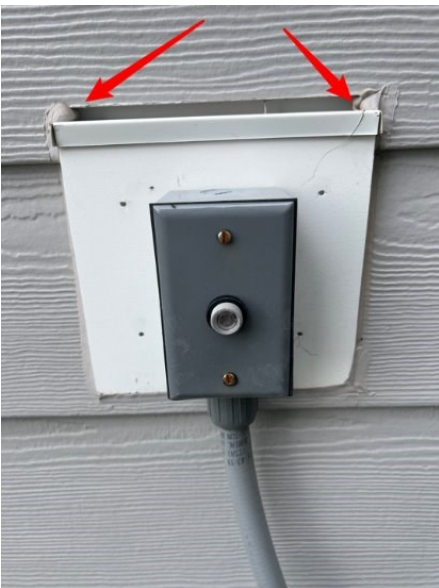
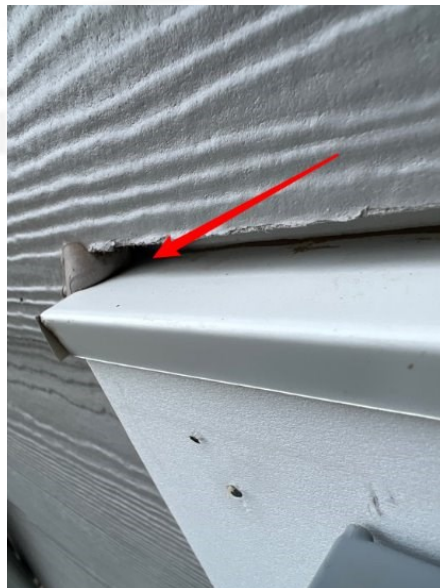
FIBER CEMENT SIDING

REC Missing caulking and incomplete dams were noted at mounting blocks added one of the vent caps. Bulk water should not be permitted to run behind the fiber cement siding. Excessive moisture behind the siding can contribute decay of the siding. Caulking should seal the joints between the siding and trim and around utility penetrations that are mounted to or that pass through the siding.

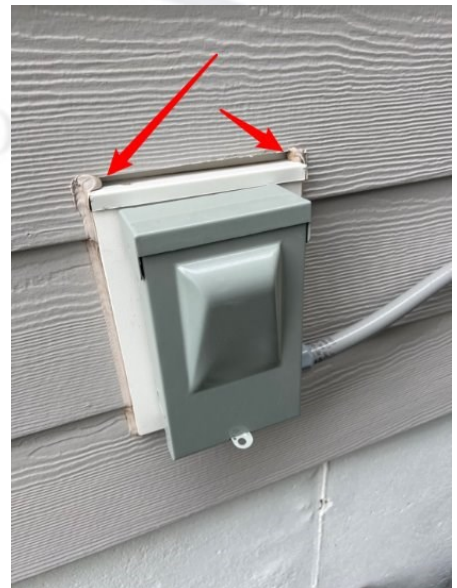
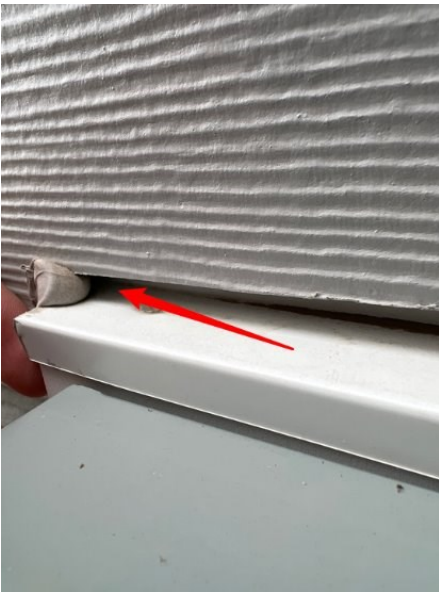
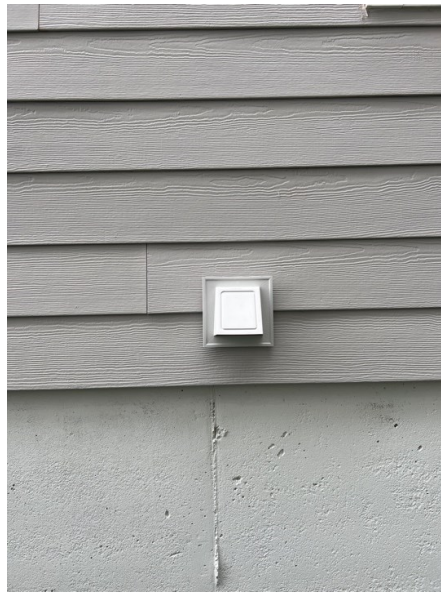
no caulking behind the vent

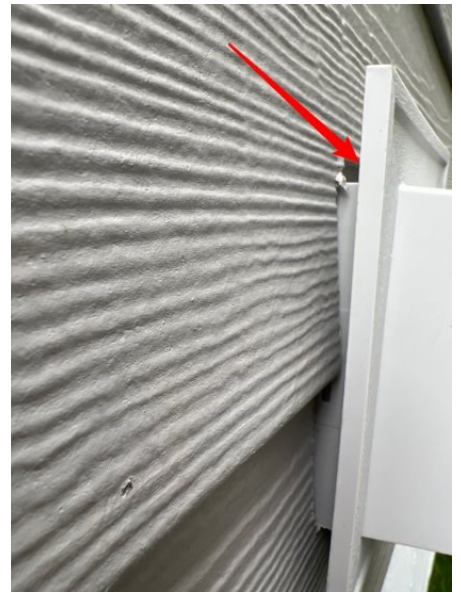
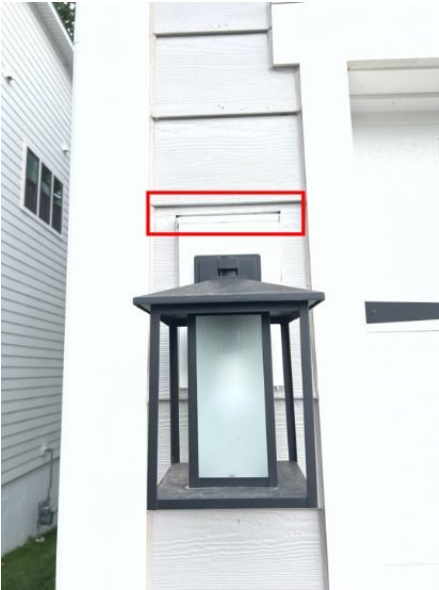
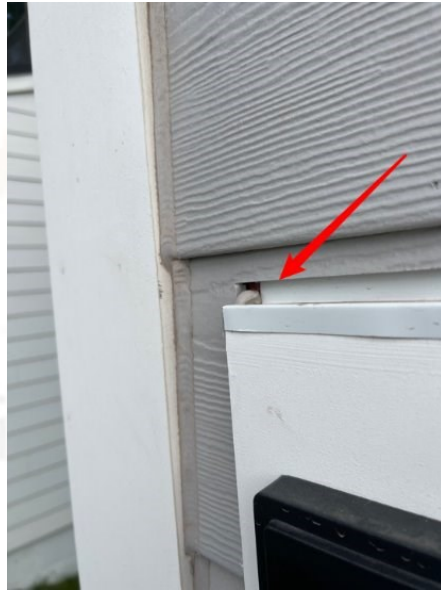
Missing caulking and vent caps were noted on the right side of the house.

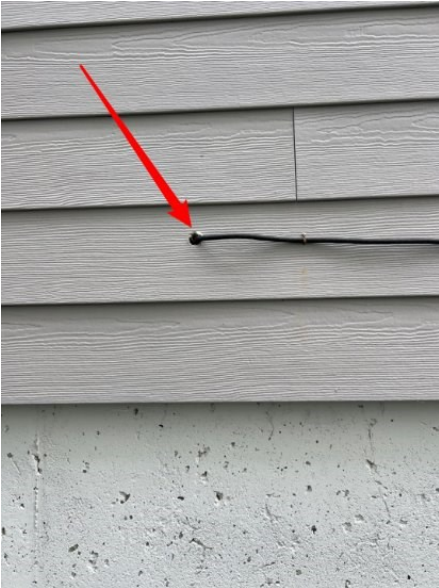
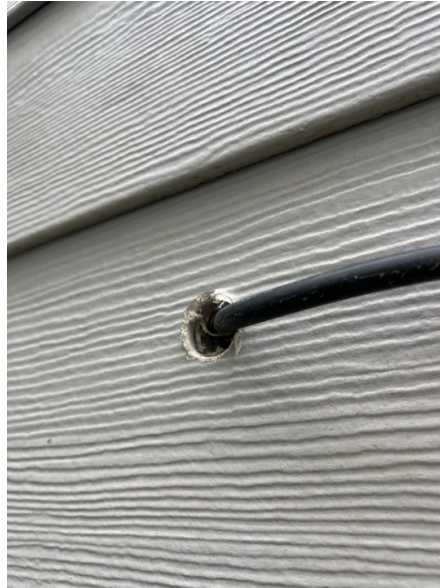
REC The hole where the electrical bonding wire for the gas meter passes through the siding on the left side of the house needs to be sealed with caulking.

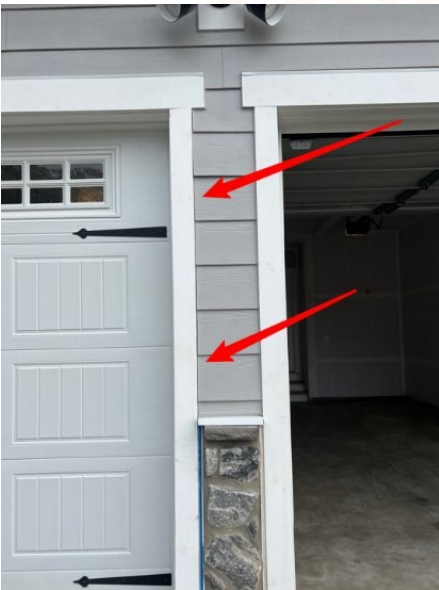
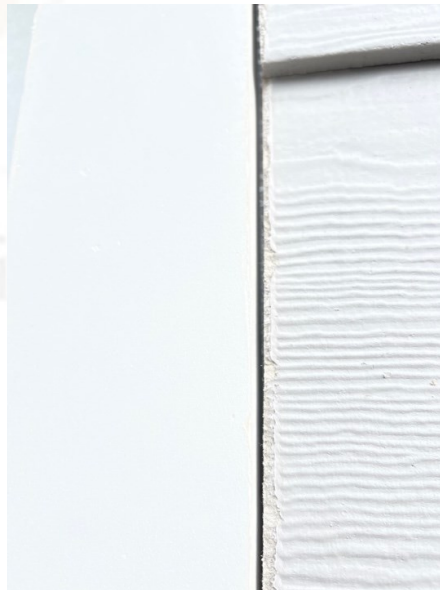
REC Missing caulking was noted where the siding meets the left garage door trim. The siding should be sealed with caulk where it meets trim boards, windows, and door frames.

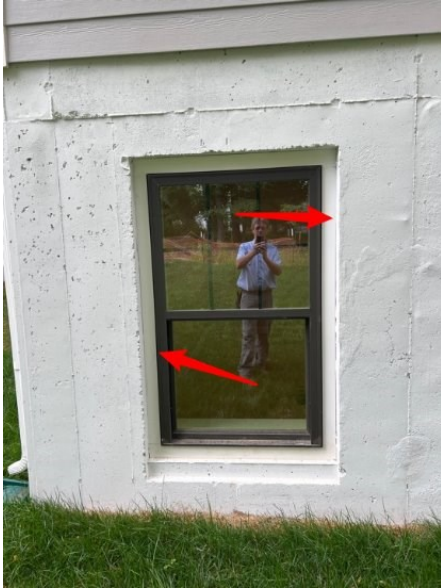
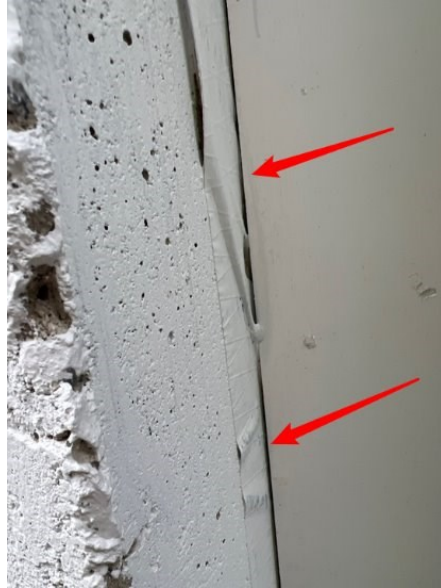
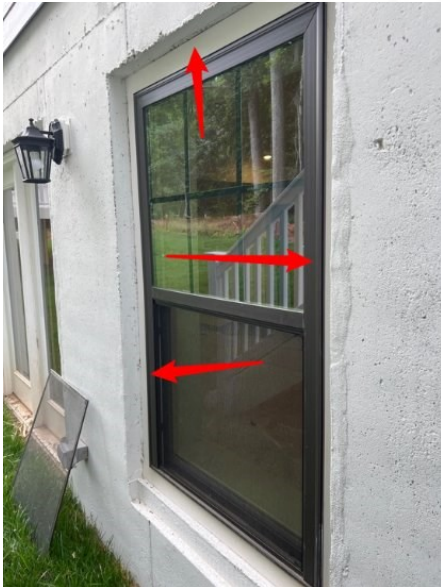
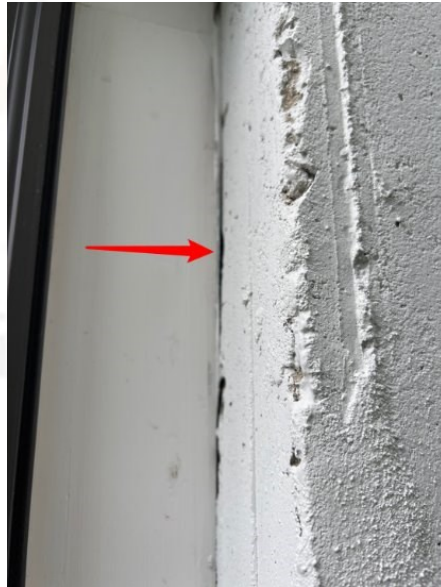
REC Caulking is needed where the basement window trim meets the foundation. The joints between the window trim and the foundation need to be sealed to prevent water intrusion.

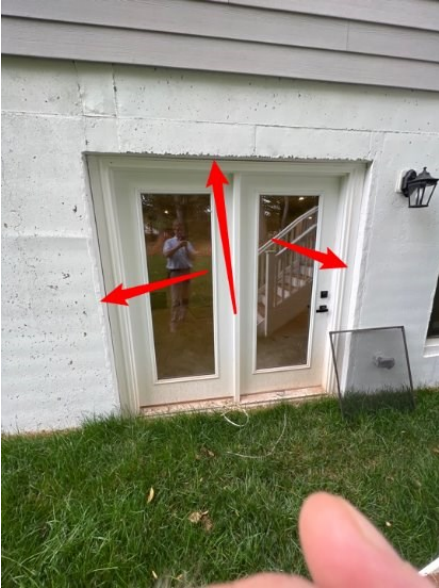
REC Caulking is needed where the basement exterior door trim meets the foundation. The joints between the door trim and the foundation need to be sealed to prevent water intrusion.

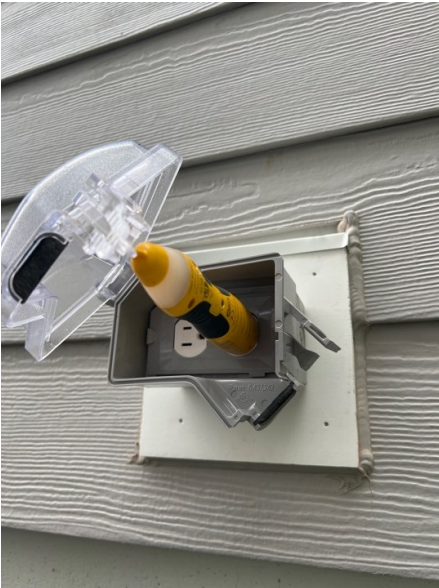
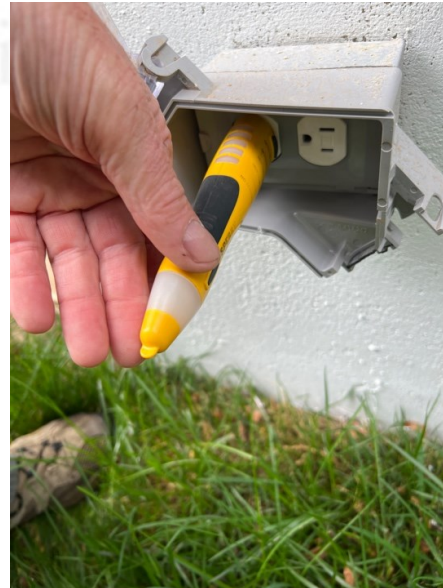
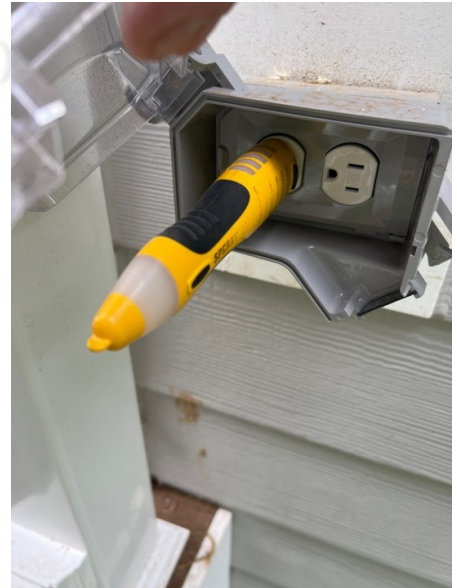
The outside electric receptacles were live and protected by a functional GFCI (or Ground Fault). Good. The exterior electrical receptacles are all tied together and are protected by the GFCI receptacle breaker in the electric panel. If you find one of the exterior receptacles without power the GFCI receptacle breaker in the electric panel needs to be reset. Over time GFCI receptacles can fail. There is a spring in the receptacle that can break and an electronic chip that can wear out. If the GFCI receptacle can not be reset with the reset button it should be replaced.

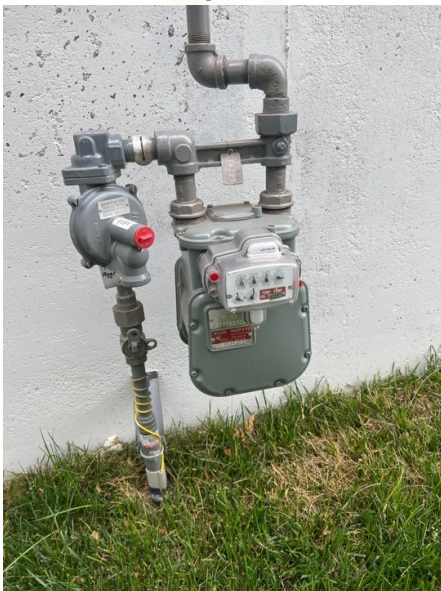
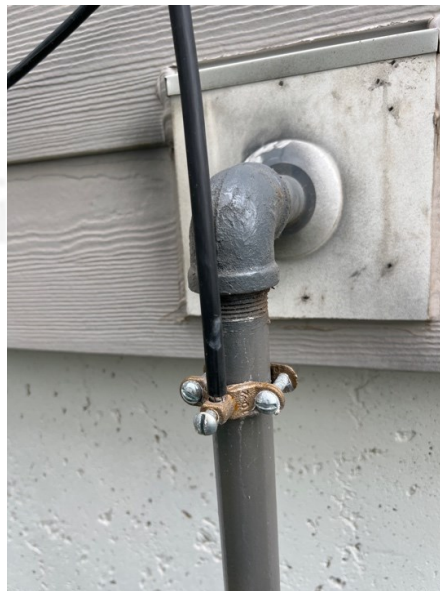
The left side of the house is where the gas meter is located. There were no gas leaks detected at the gas meter. There is adequate clearance between the meter and the ground. The meter is well mounted with no visual damage noted.

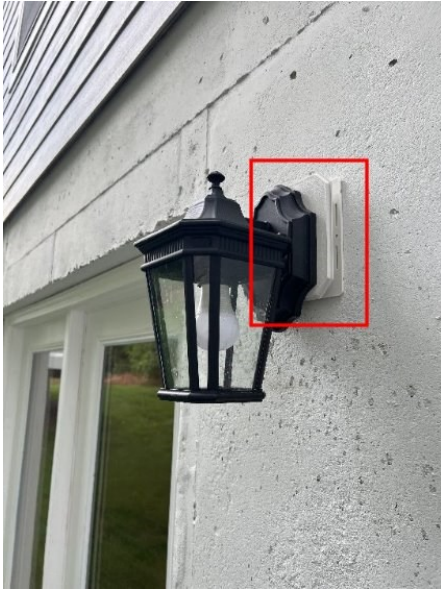
REC A vinyl siding mounting block was used to mount the exterior light fixture near the basement door. This is not the correct use of the vinyl siding mounting block. This will not prevent water from running into the electrical junction box.

Incorrect siding block application

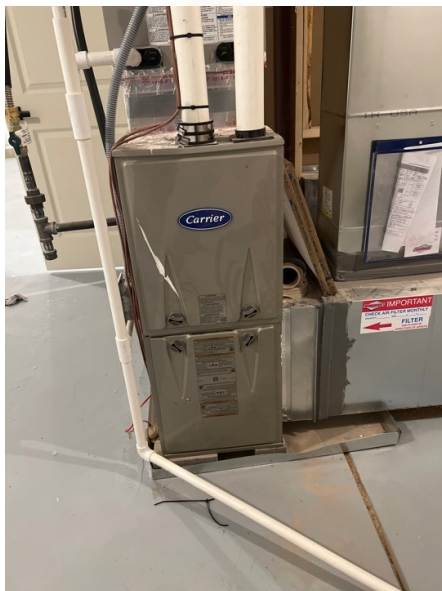
INSP The first floor of the home is heated with a gas furnace. at the time of the inspection, the first-floor furnace was not operable. The draft fan's not installed in the furnace. The system was in shutdown condition. I was unable to test the first-floor HVAC system.

The draft fan was missing from the inside of the furnace. The HVAC system was in shutdown condition.

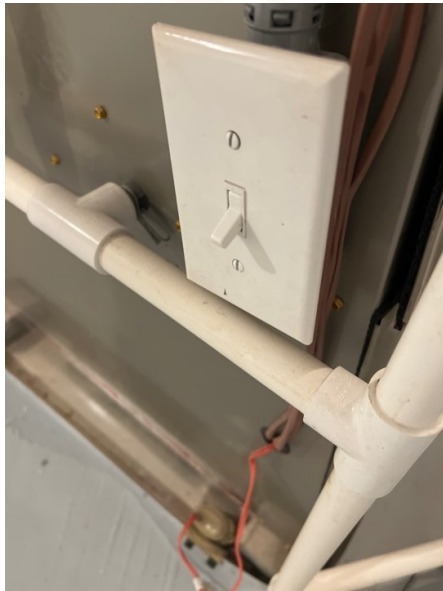
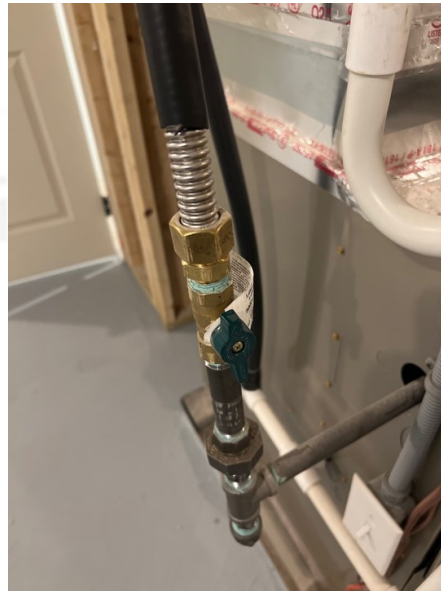
The shut off switch for the heating system function when tested. Testing fuel shut-off valves are outside the scope of the home inspection. The gas shut off valve for the furnace was accessible and appeared to be in functional condition.

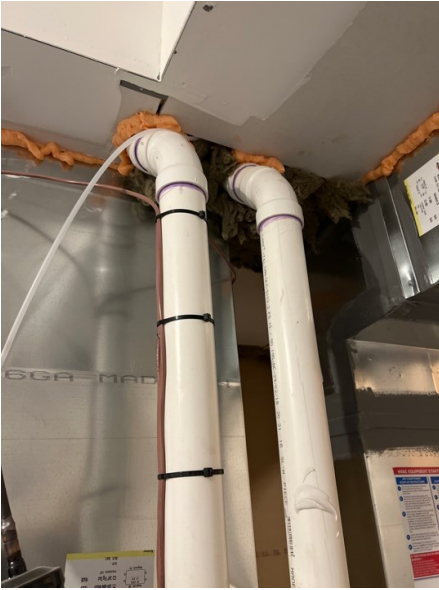
The flue pipe was intact and in good condition.

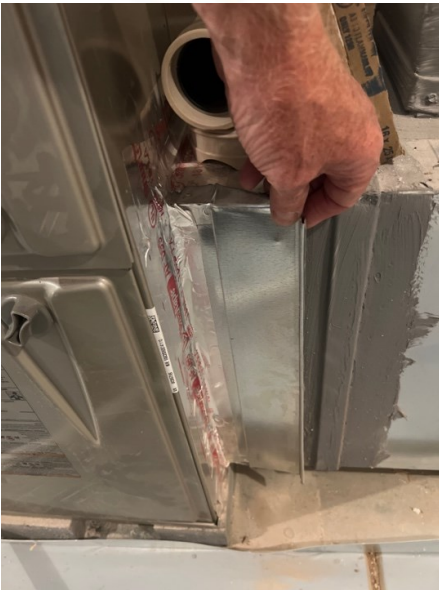
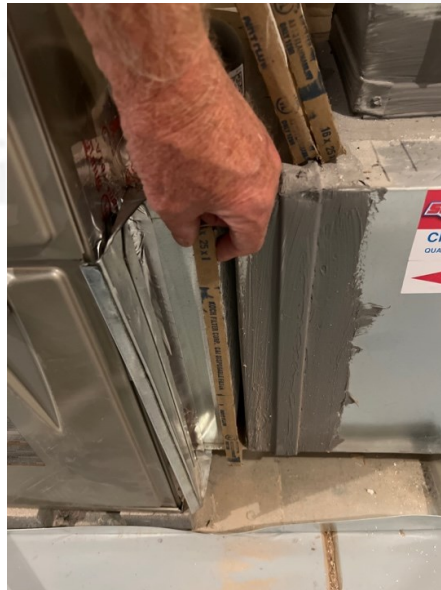
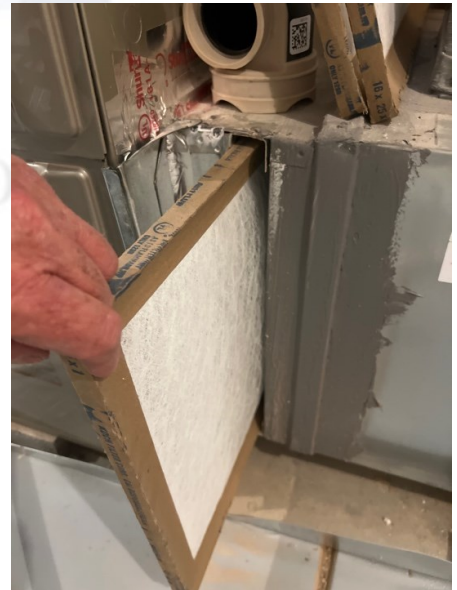
At the time of this inspection the air filter for the forced air heating/air conditioner was clean. I recommend that the air filter be checked every month the system is in use and changed as needed. This will prevent dirt from building up on the internal components and and reduce the amount of dirt particles that are distributed through the ductwork a.

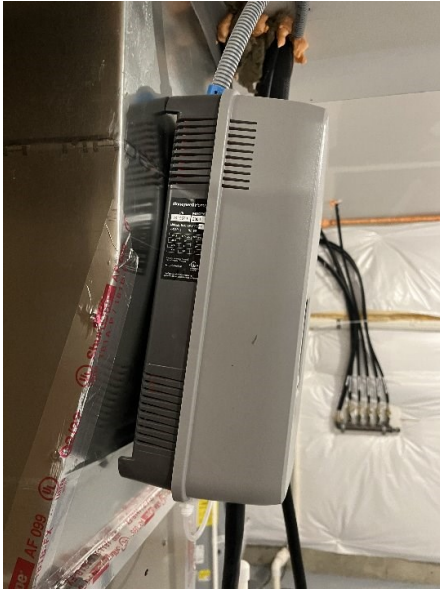
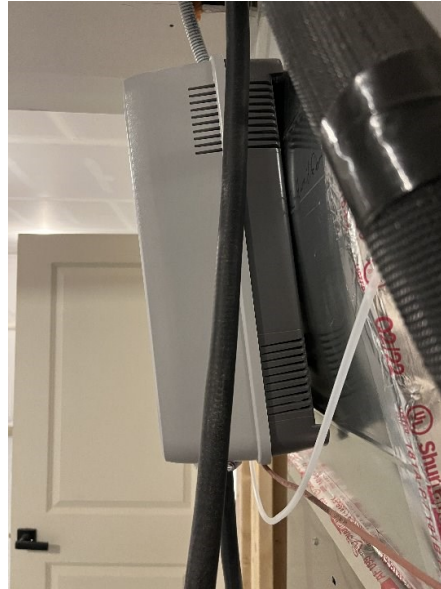
REC The electronic steam humidifier has not been installed plumb as required by the manufacturer. This may have an adverse effect on the unit's function and longevity. The humidifier should be re-installed per the manufacturer's installation instructions.

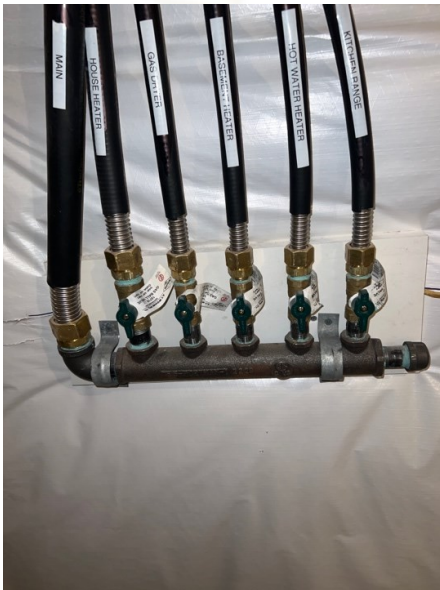
The gas lines in the home are corrugated stainless steel tubing (CSST). The gas manifold was well mounted. There were no gas leaks detected at the manifold.

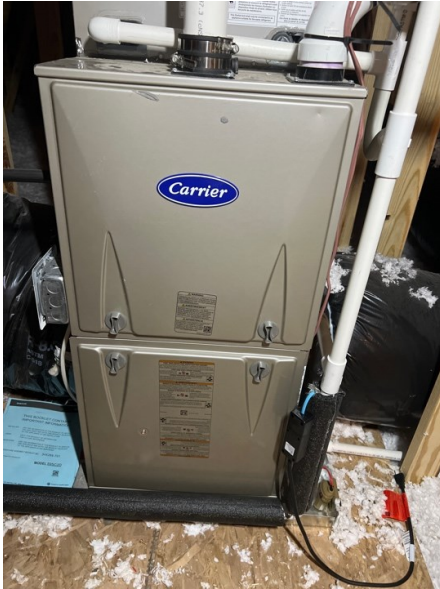
The second floor of the home is heated with a gas furnace.
Using the thermostat I turn the heating system on.
The heating system functioned normally at the time of the inspection.

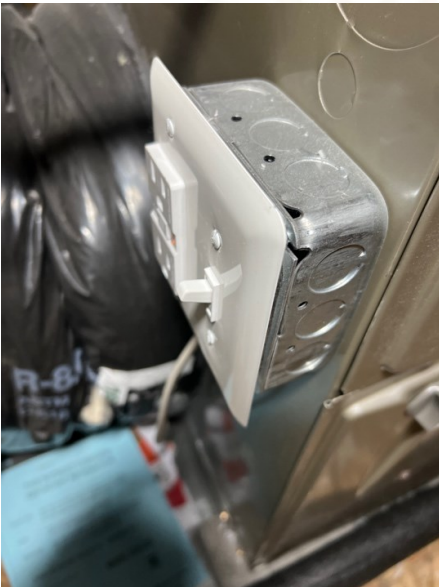
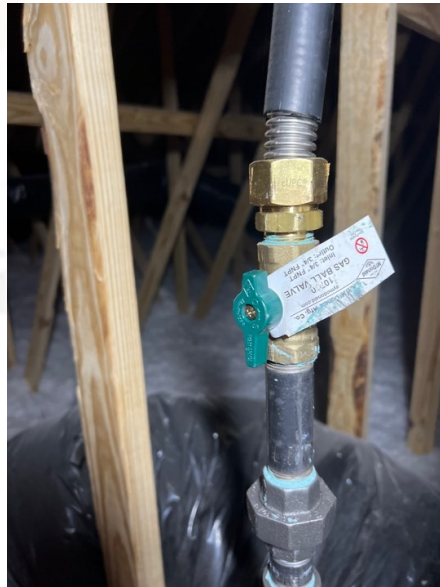
The shut off switch for the heating system function when tested. Testing fuel shut-off valves are outside the scope of the home inspection. The gas shut off valve for the furnace was accessible and appeared to be in functional condition.

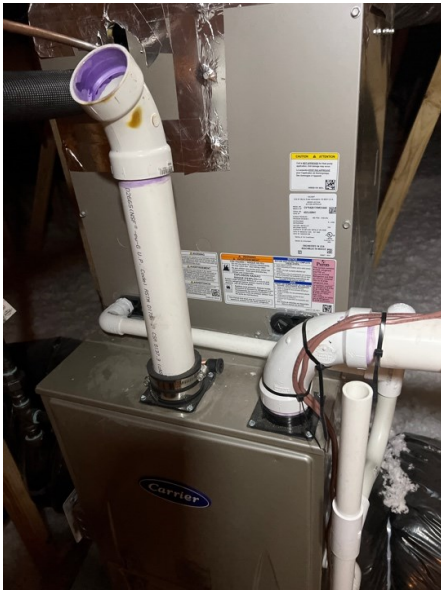
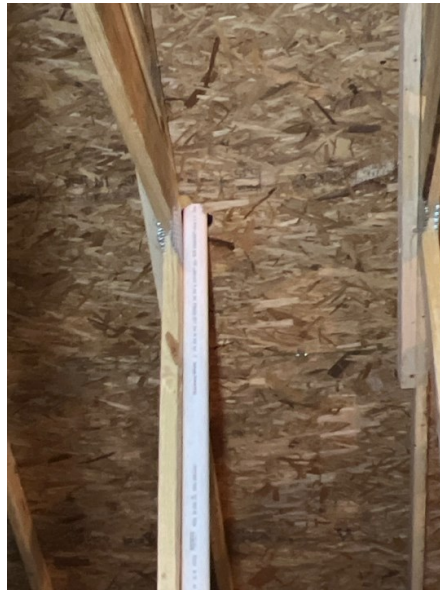
The flue pipe was intact and in good condition.

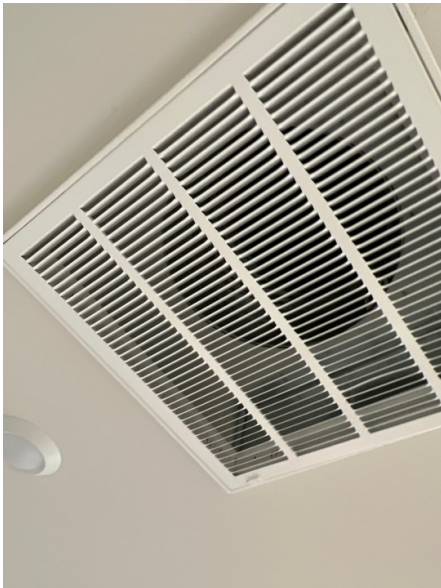
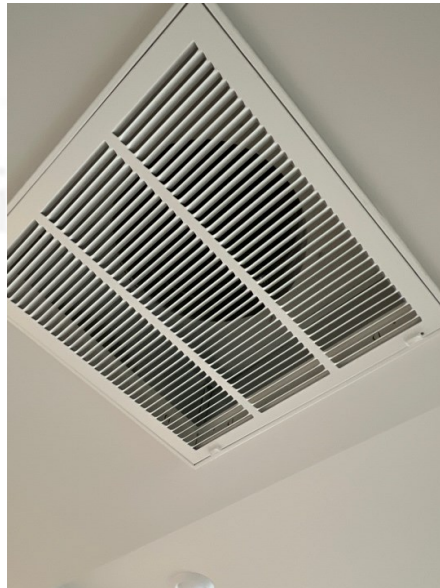
REC At the time of this inspection, the air filters for the forced air heating/air conditioner was missing. The system should never be run without the filters in place. Running the system without the filters in place can allow dirty particles to build up in the ductwork and HVAC equipment.

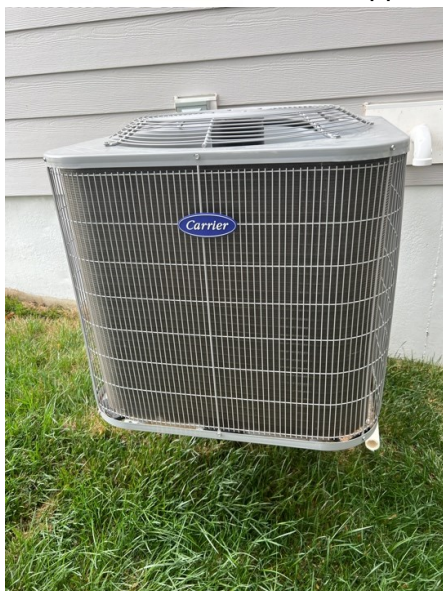
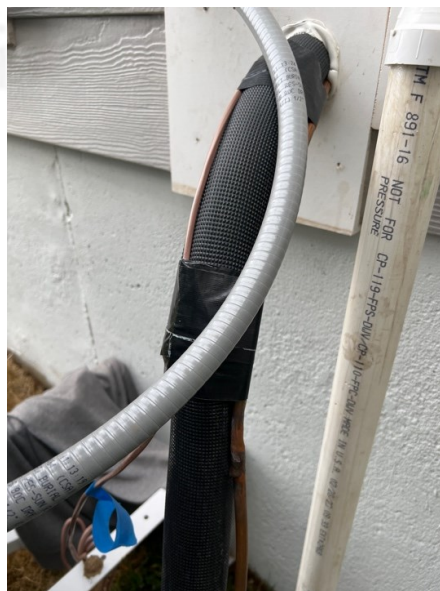
The condenser for the air conditioner is located on the right side of the home.

The insulation around the condenser's suction line was in good condition.

There is an electrical service disconnect for the condenser unit.

The fins on the condenser appeared clean. No rust or corrosion was noted.

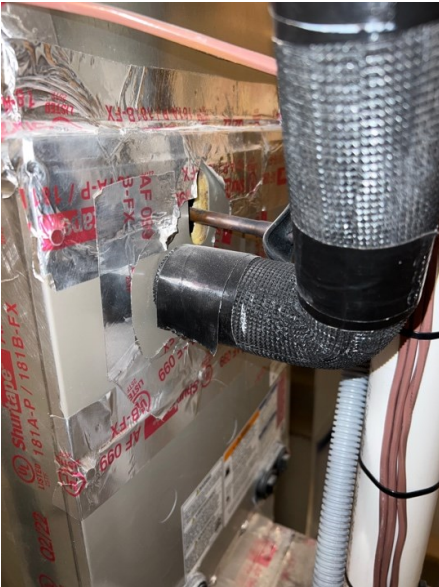
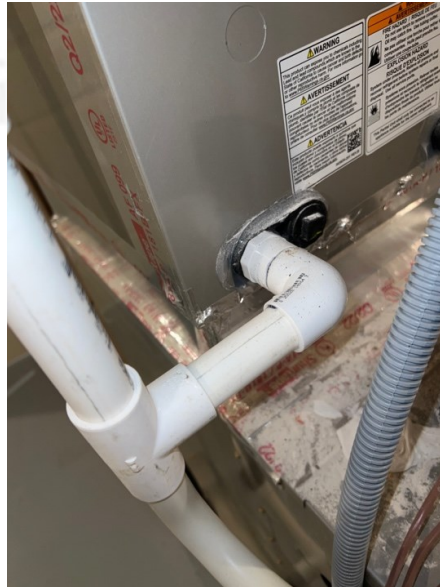
AIR HANDLER

The air conditioning is distributed through the house using the same ductwork as the furnace. The refrigerant lines that carry the liquid coolant to the unit appeared to be in good order. The insulation around the return line was in good condition. The fan was heard operating. No rattling or vibration.

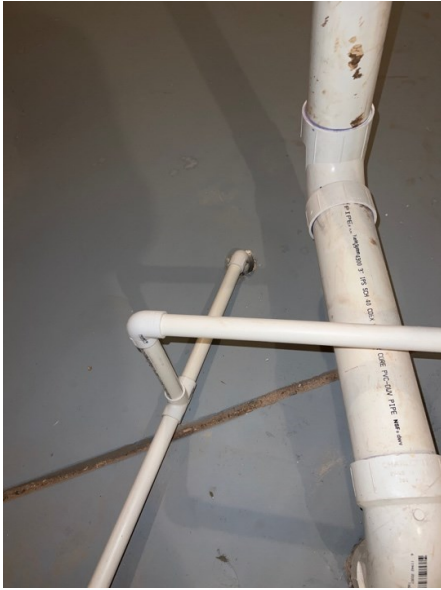
CONDENSATION DRAIN

The condensation line drains from the unit to the basement floor drain.

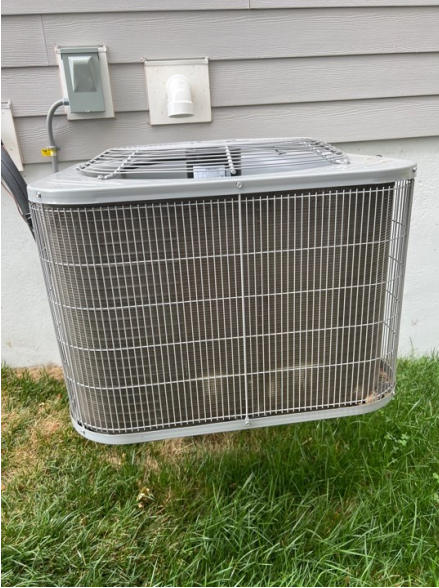
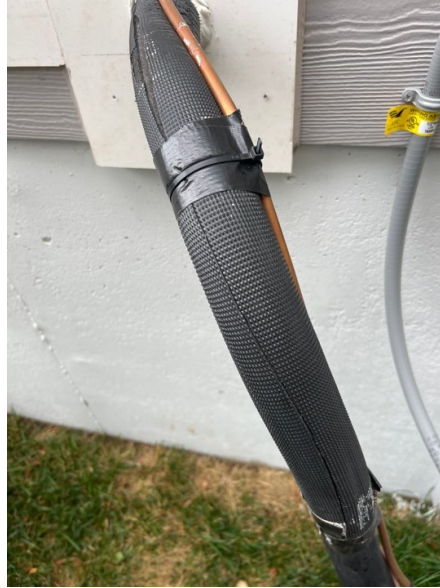
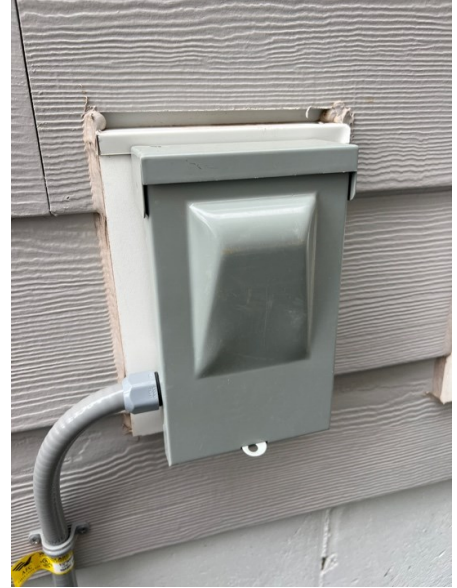
The condenser for the air conditioner is located on the right side of the home.

The insulation around the condenser's suction line was in good condition.

There is an electrical service disconnect for the condenser unit.

The fins on the condenser appeared clean. No rust or corrosion was noted.
