SUNLIGHT INSPECTION SERVICE

123 Sunny Street Nice Town, PA 19460
REPORT# 230600000D

Wednesday, June 14, 2023

Inspector
Daniel Keogh
InterNACHI 212167

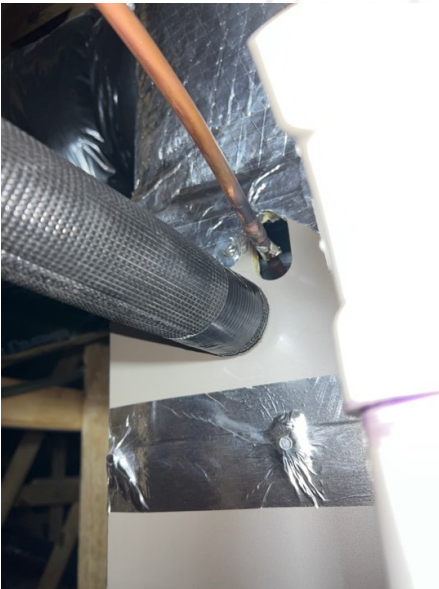
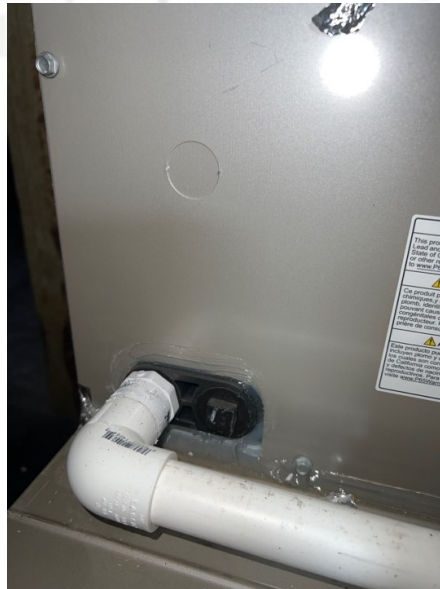
AIR HANDLER

The air conditioning is distributed through the house using the same ductwork as the furnace.

The insulation around the return line was in good condition.

The fan was heard operating. No rattling or vibration.

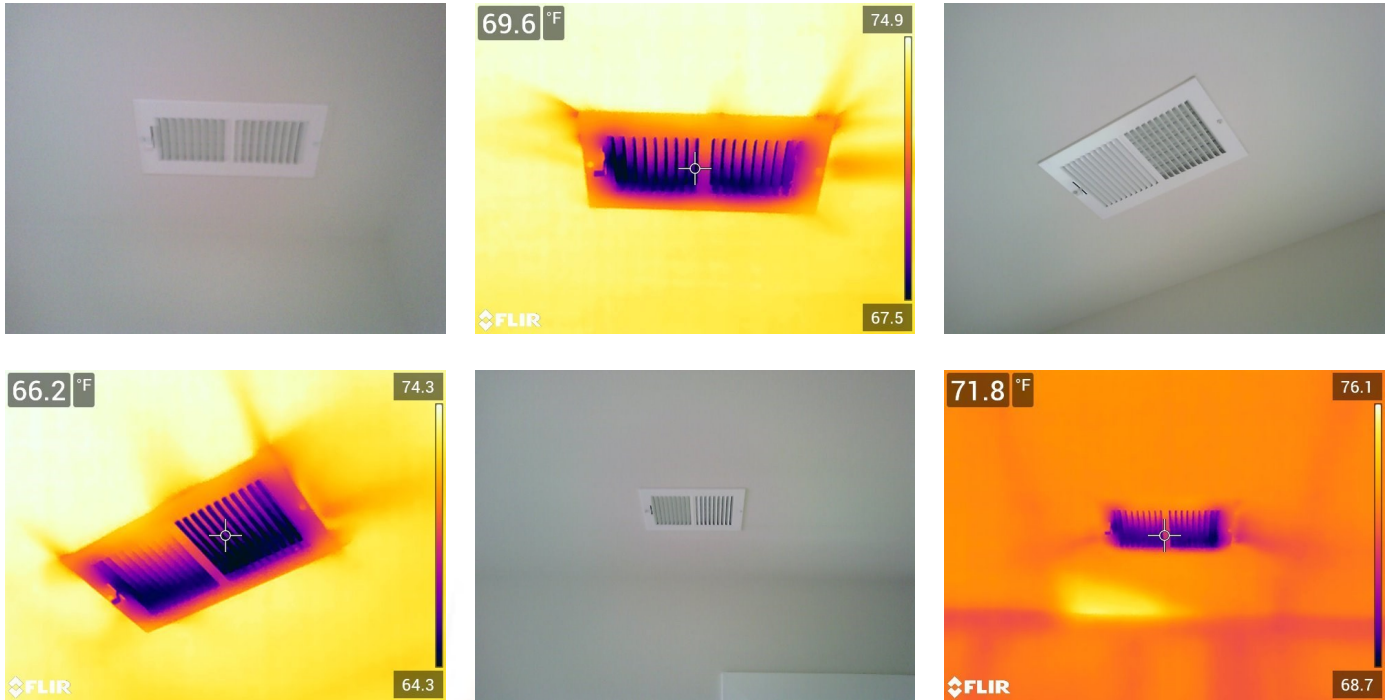
DUCT WORK

A thermal imaging camera was used to check the air conditioning registers. All the registers were getting conditioned air at the time of the inspection.

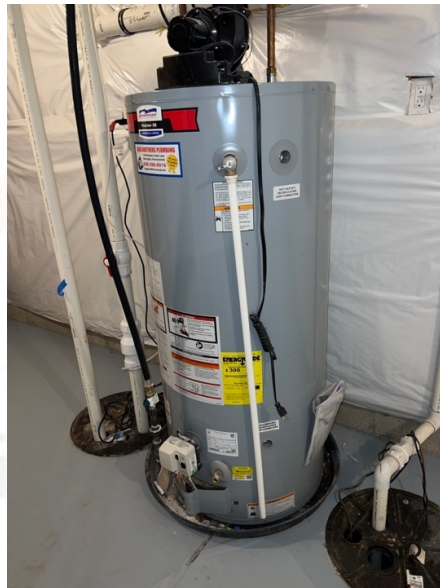
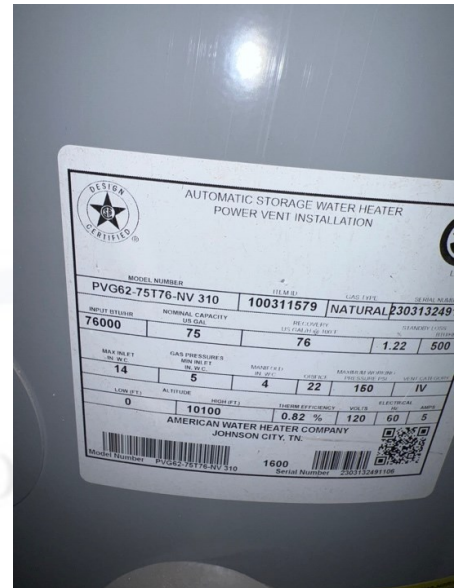
The gas shut off valve is installed on the gas line next to the water heater.

The drip leg on the gas line is present, good.

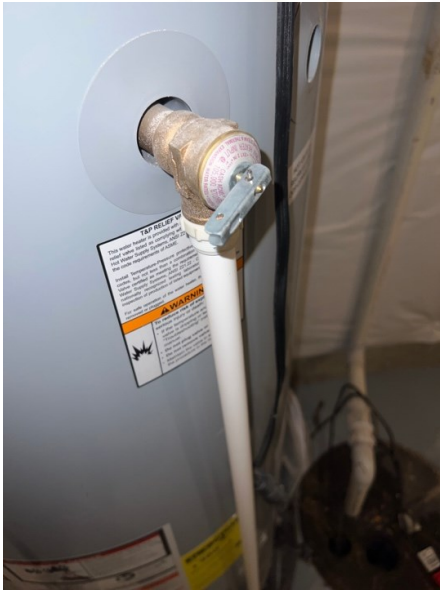
TEMPERATURE & PRESURE RELIEF VALVE

The T&P valve (Temperature and Pressure Relief) for the water heater is present and its discharge pipe is extended to the floor.

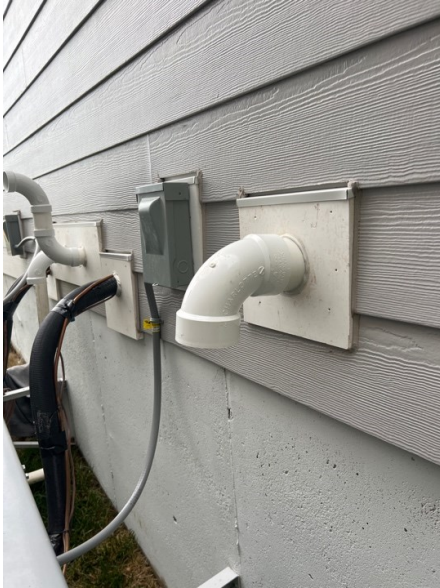
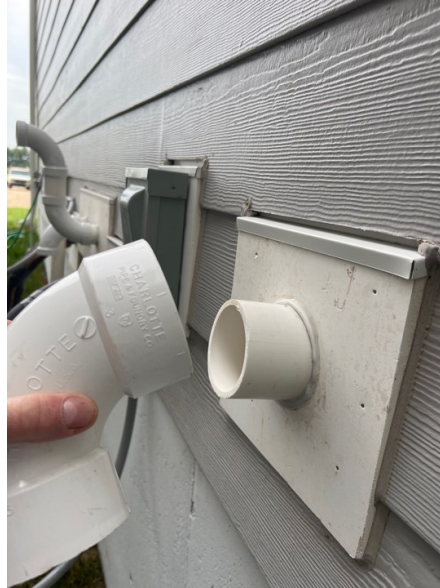
FLUE PIPE

REC The flue pipe for the water heater was not glued together on the exterior of the house. The elbow can easily be removed.

The elbow should be glued in place

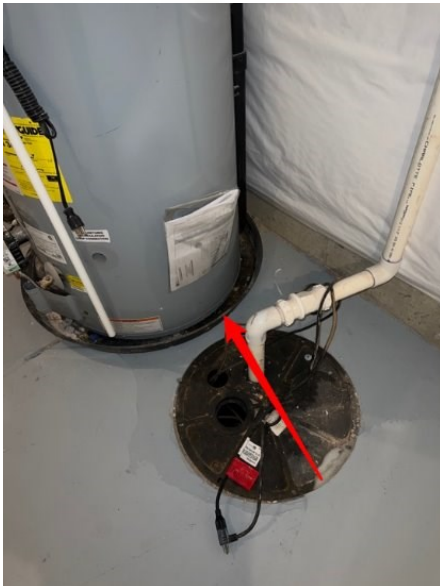
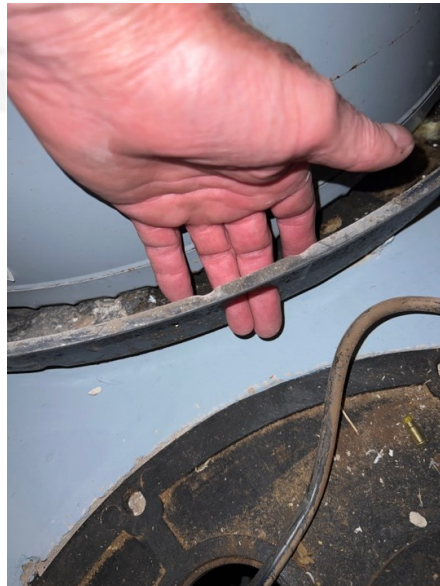
DRAIN PAN

REC The overflow pan under the water heater was noted without a drain line. The overflow pan should have a drain line installed on it that runs to a suitable location. In this case, the sump that is right next to it. When a water heater is installed in a location where a leak could cause damage, current accepted standards recommend that a drain pan (overflow pan) be installed under it. The pan should have a drain line installed on it that runs to a suitable location.

P2801.6 Required pan. Where A storage tank type water heater or hot water storage tank is installed in the location or water leakage from the tank will cause damage, tank shall be installed in a pan constructed of one of the following:

P2801.6.1 Pan size and drain. The pan shall be not less than 1 1/2 inches (38 mm) deep and shall be of sufficient size and shape to receive all dripping or condensate from the tank or water heater. The pan shall be drained by an indirect waste pipe having a minimum diameter of 3/4 inch (19 mm). Piping for safety pan drains shall be of those materials indicated in Table P2906.5. Where pan drain was not previously installed, a pan drain shall not be required for replacement water heater installation.

P2801.6.2 Pan drain termination. The pan drain shall extend full-size and terminate over a suitably located indirect waste receptor or shall extend to the exterior of the building and terminate not less than 6 inches (152 mm) and not more than 24 inches (610 mm) above the adjacent ground surface.

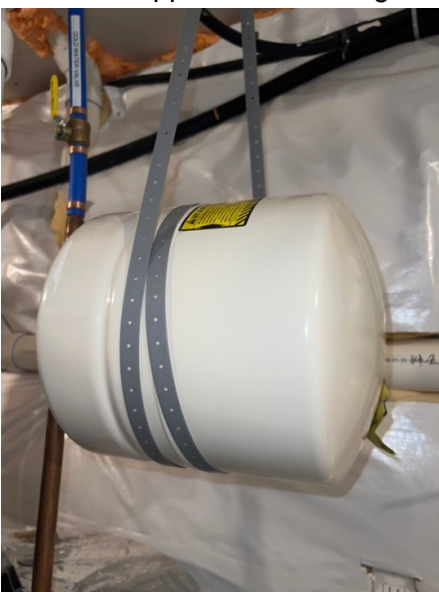
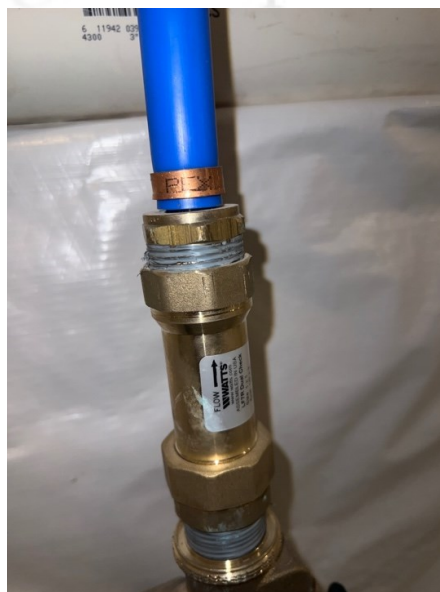
THERMAL EXPANSION TANK

The water heater has an expansion tank installed above it. There is a back flow valve installed on the water supply line coming into the house. The back flow valve allows water to enter the home and prevents water from flowing back out to the street. This is to prevent water being pulled out of the home if there were a back siphoning event were to accrue in the public water supply and it makes the homes plumbing system a closed water system. When the water heater makes hot water the water in the homes plumbing system expands. The expansion of water increases the pressure in the homes water pipes. The expansion tank absorbs the extra pressure. The action of the expansion tank reduces knocking of the pipes and ware and tear on the faucets and shut off valves due to the increased pressure.

This tank appeared to be in good order.

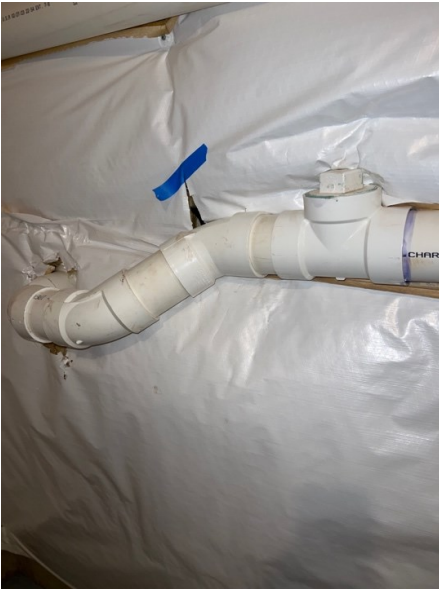
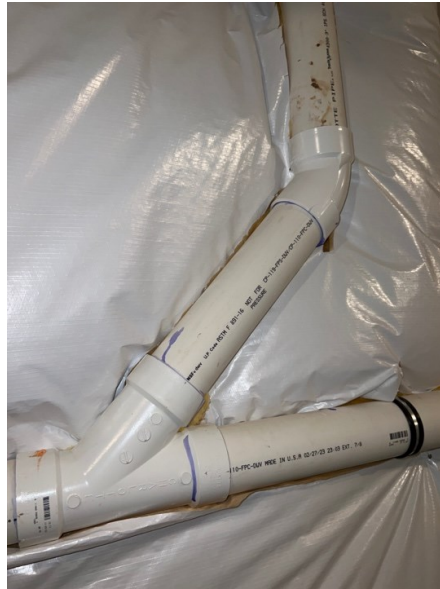
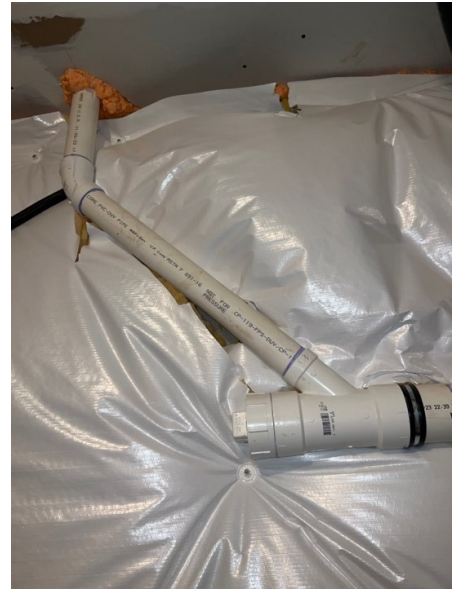
DRAIN & WASTE SYSTEM

The waste line pipes were well supported. No visible cracks in any of the lines.
Water was run at all the plumbing fixtures in the house.
The cleanout fitting was visible.

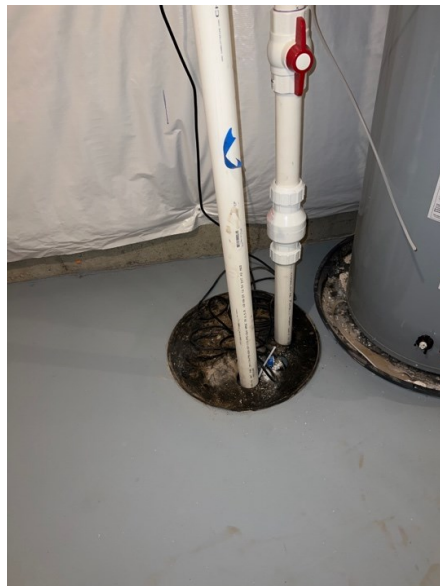
WASTE EJECTOR

There is a sewage ejector installed in the basement. The sewage ejector receives the wastewater from the plumbing fixtures in the basement and pumps the wastewater up into the sewer lines.
There is a gate valve on the discharge line.
There is a check valve on the discharge line.
Water was run at the basement fixtures. The pump could be heard turning on and wastewater could be heard running through the discharge pipe.

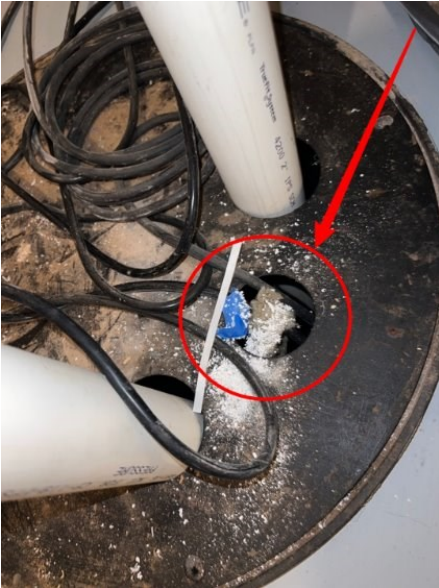
REC The top of the sewage basin is not sealed airtight. The rubber gaskets are missing around the pipes and electrical cord.

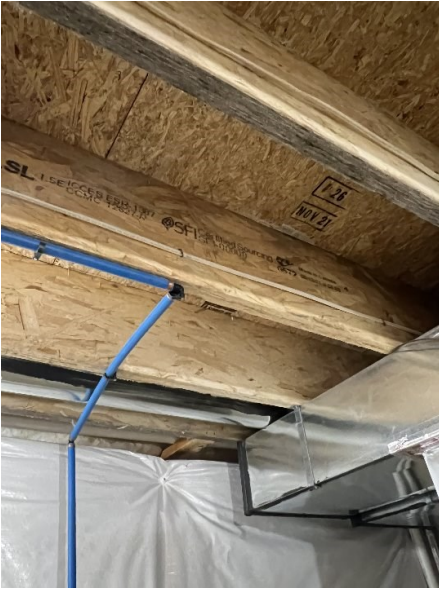
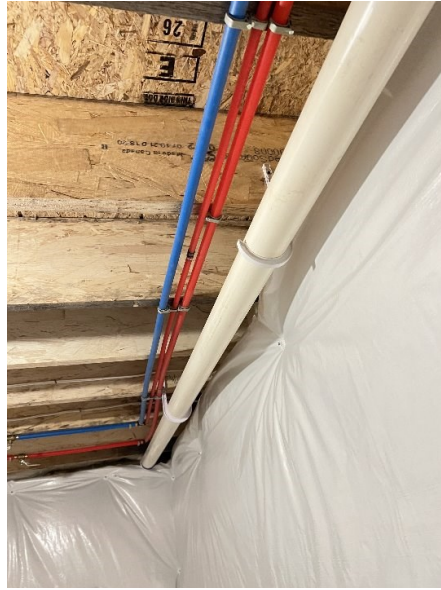
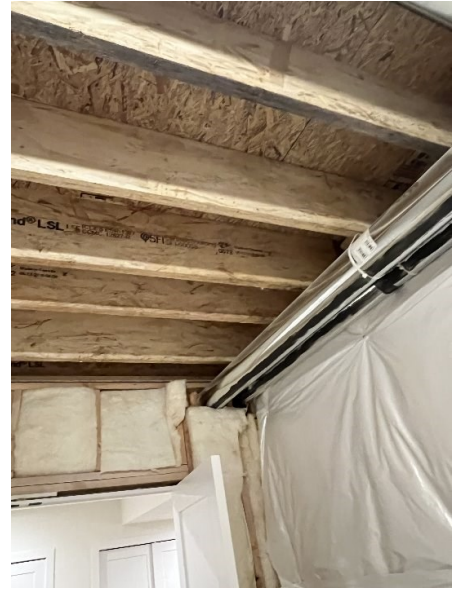
FLOOR STRUCTURE

The floor joists are constructed of Manufactured I Joists. Readily accessible areas were inspected.

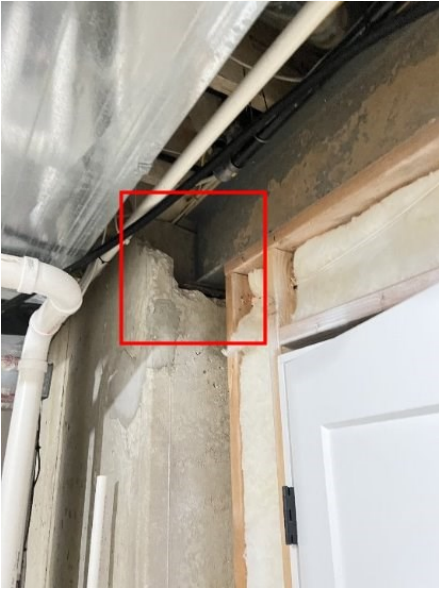
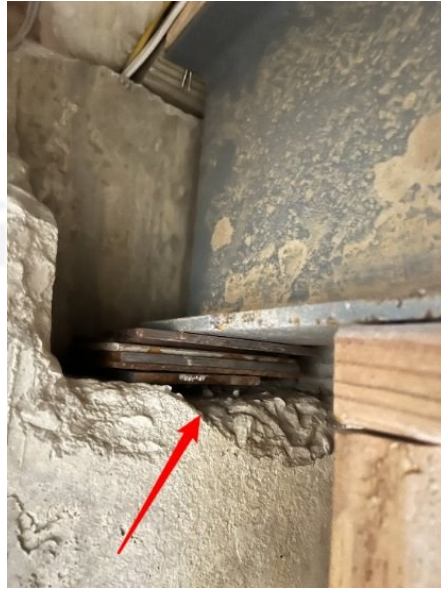
REC The steel beam to the right of the basement furnace is not properly supported on the foundation. The steel beam should be fully bearing on the foundation a minimum of 3 inches. The concrete beam pocket is damaged under the beam. There is a large void under the bottom of the steel plates used to shim the beam in place.

The ends of each joist, beam or girder shall have not less than 1.5 inches (38 mm) of bearing on wood or metal and not less than 3 inches (76 mm) on masonry or concrete except where supported on a 1-inch-by-4-inch (25.4 mm by 102 mm) ribbon strip and nailed to the adjacent stud or by the use of approved joist hangers.

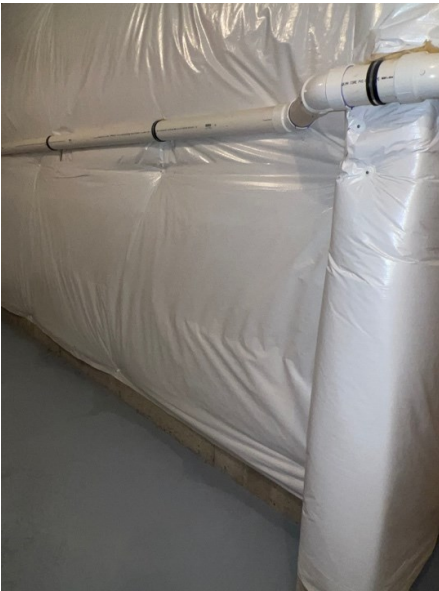
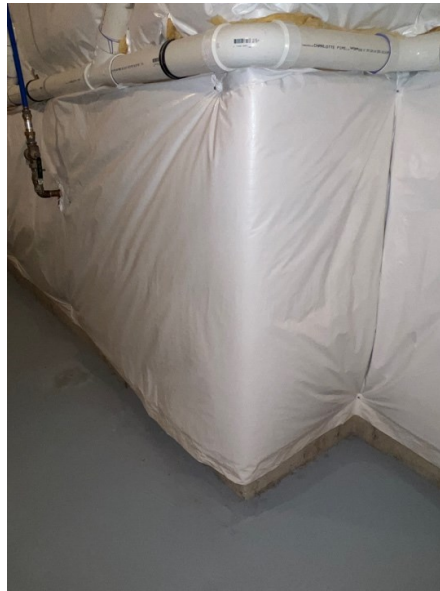
FOUNDATION

The foundation is constructed of poured concrete.

Readily accessible areas were inspected. There are no indications of significant structural deficiencies apparent.

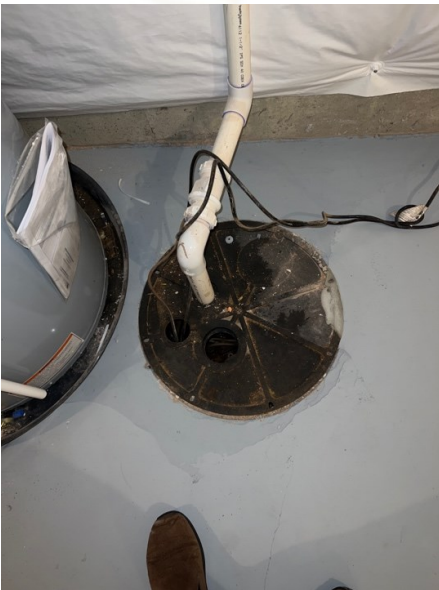
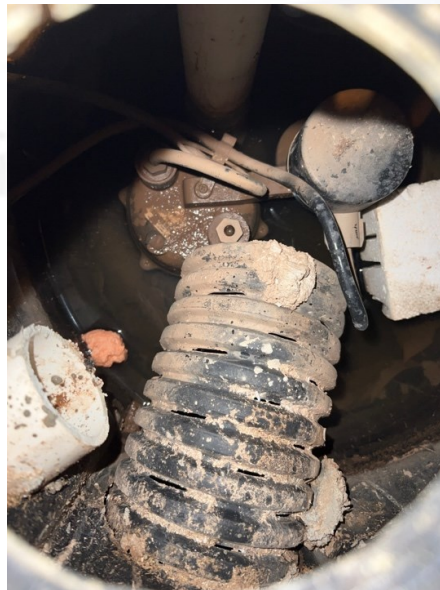
SUMP PUMP

REC The sump pump did not function at the time of the inspection. The pump was getting power but it would not come on. A new pump is needed.

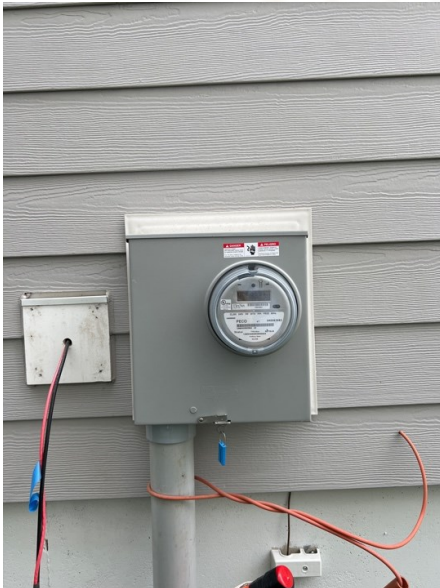
ELECTRICAL METER

With normal hand pressure, the electric meter felt securely attached to the house.

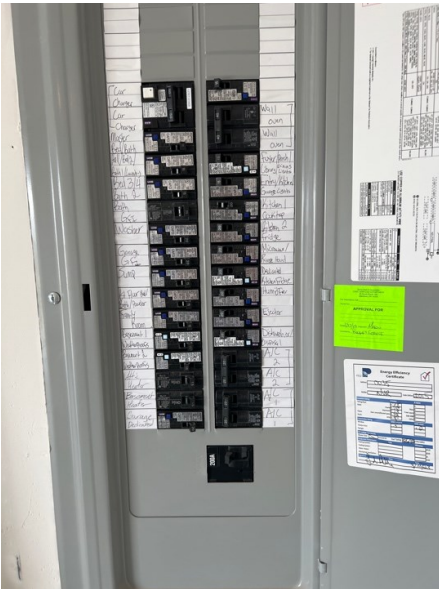
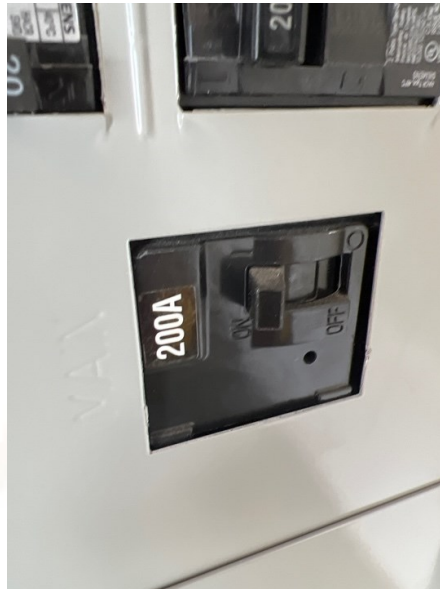
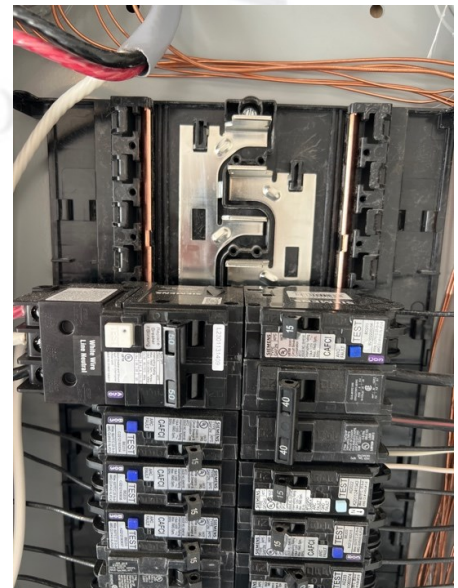
MAIN ELECTRICAL PANEL

200 amp service at the electrical panel.

There is room for expansion in the panel.

For safety remember to keep proper clearances around the panel.

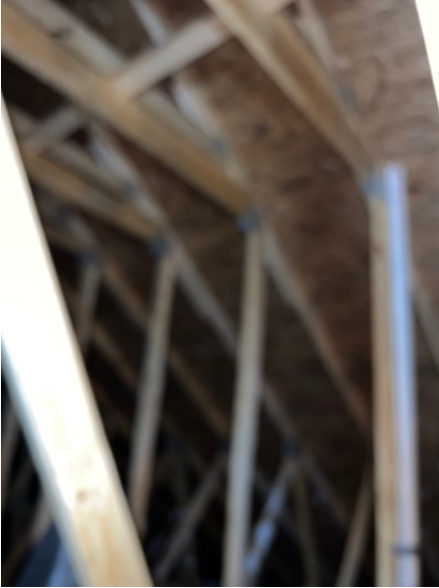
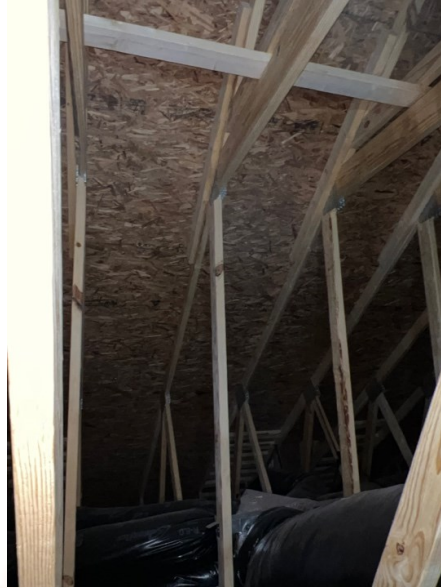
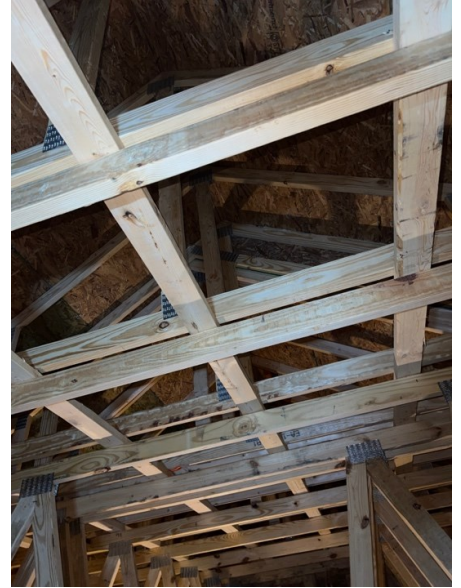
ATTIC ROOF STRUCTURE

Visual inspection only of the attic spaces. Limited access. No major structural defects are readily visible from the access. There were no cut, damage, missing, or loose components of the rafter boards readily visible.

There were no signs of active roof leaks observed from the access. Recommend asking the seller to disclose of any prior roof leaks.

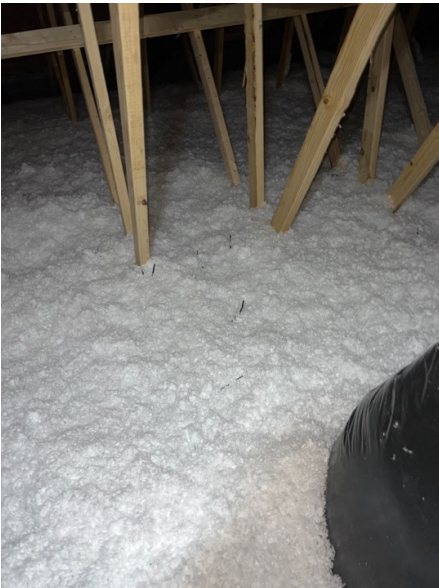
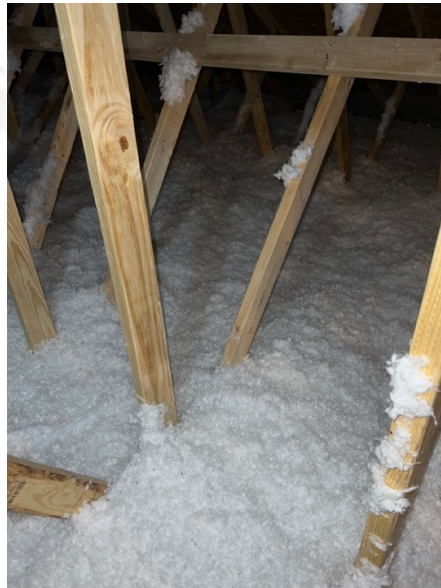
INSULATION

I inspected the attic insulation. The attic floor area was insulated with approximately 14 to 16 inches of insulation. Providing an approximate R-value of R38.

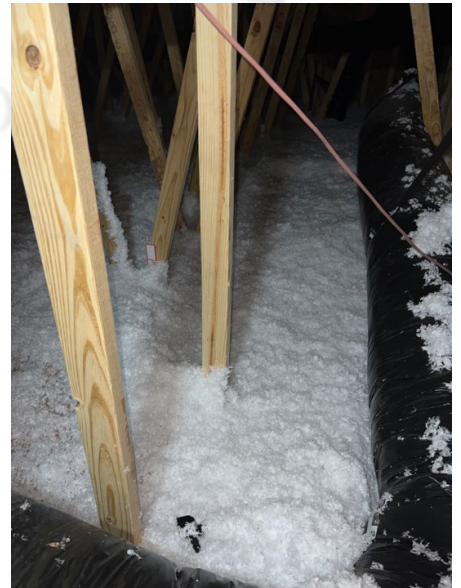
REC There were low levels of insulation on the attic floor where people have moved it to work. Workmen often move the loose fill insulation out of the way while they are working in the attic and then fail to replace it once the work is done. I recommend adding/re-disrupting the insulation to maintain the R value of the attic insulation and reduce energy loss.

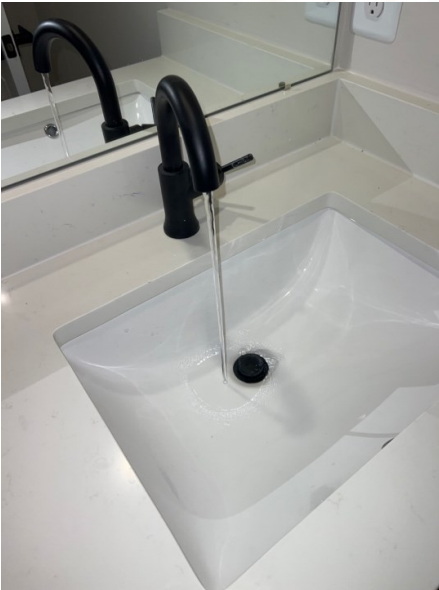
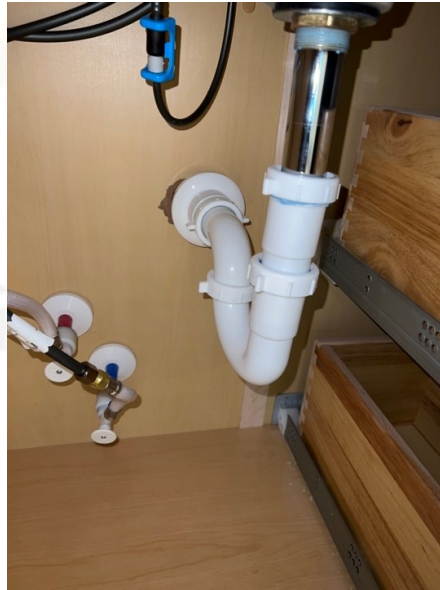
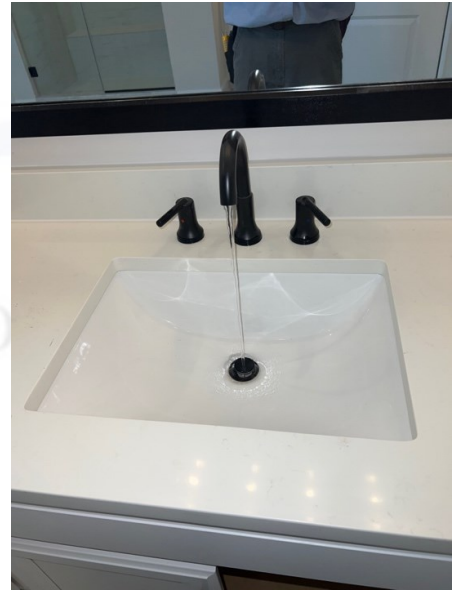
SINKS

All the bathroom sinks had hot and cold water running to them.
All the bathroom sinks drained with no visible leaks at the drain pipes

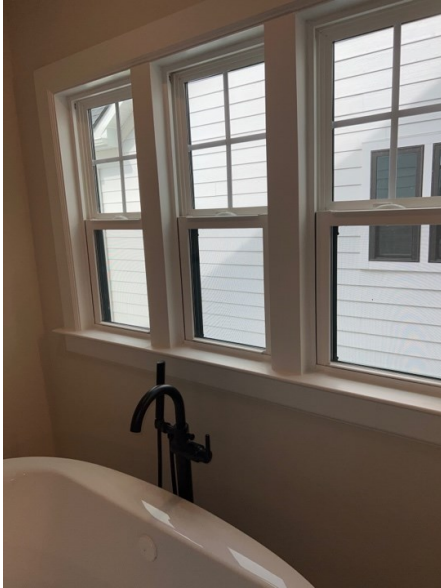
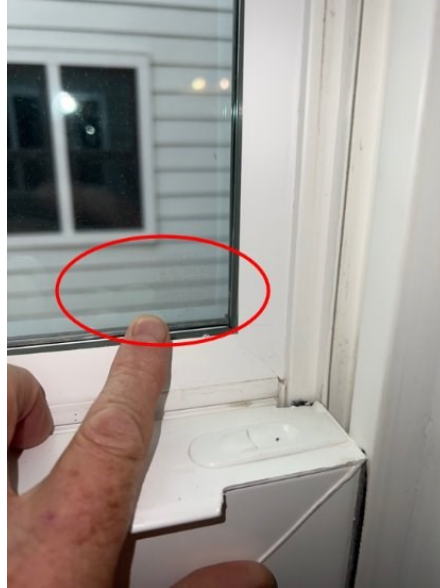
The windows over the tub were glazed with tempered glass, good.

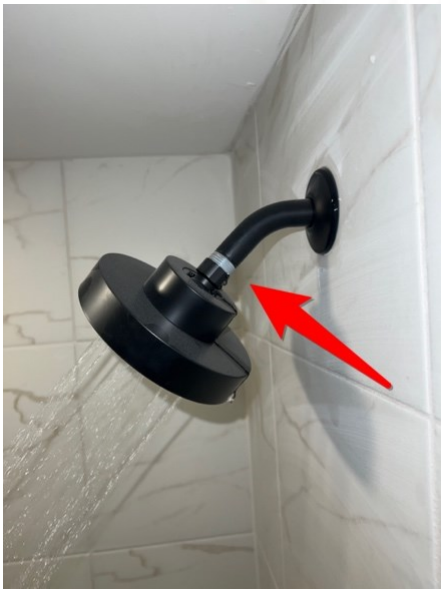
Basement bathroom

REC Leaks were noted at the basement bathroom, master bathroom, and back right bathroom shower head stems. The shower faucets leak at the stems where the shower heads are attached.

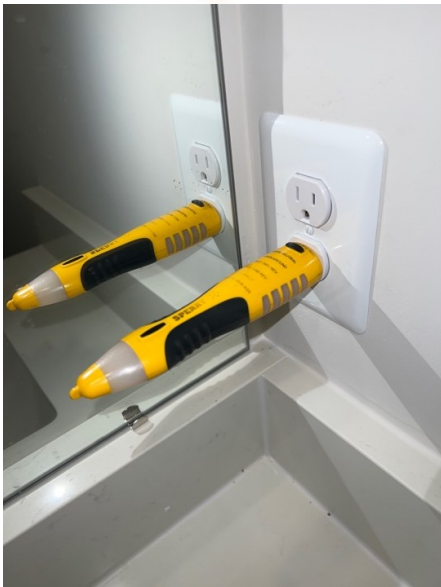
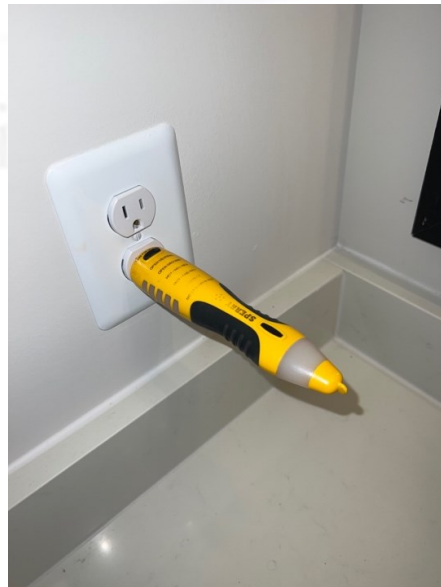
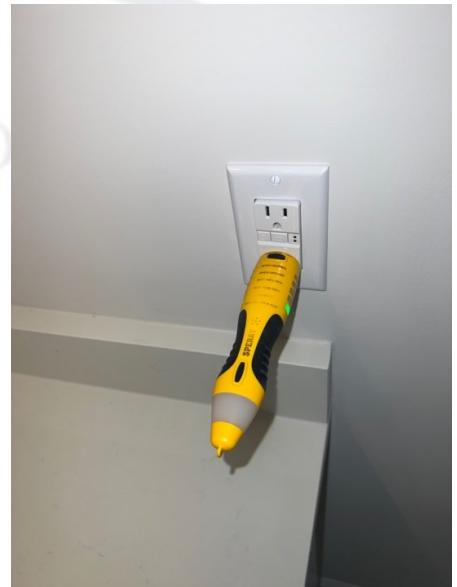
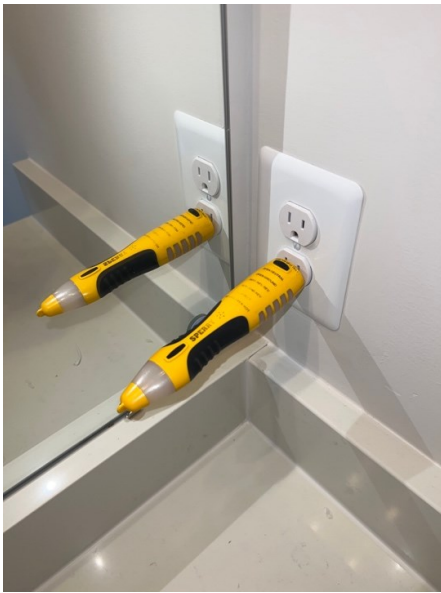
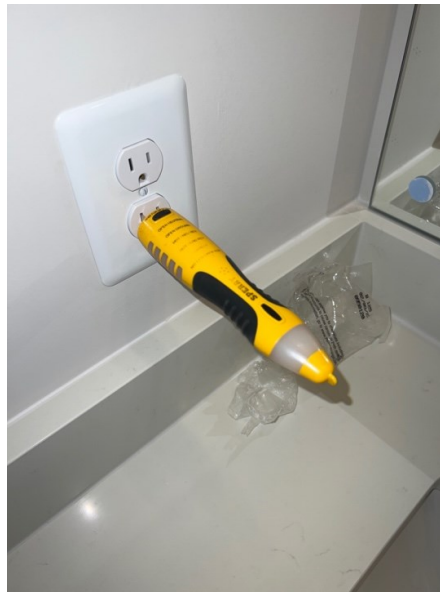
All the bathroom receptacles had functional GFCI protection.

The bathroom electrical receptacles are all tied together and are protected by the GFCI receptacle located in them master bathroom. If you find one of the bathroom receptacles without power the master bathroom GFCI receptacle needs to be reset. Over time GFCI receptacles can fail. There is a spring in the receptacle that can break and an electronic chip that can wear out. If the GFCI receptacle cannot be reset with the reset button it should be replaced.

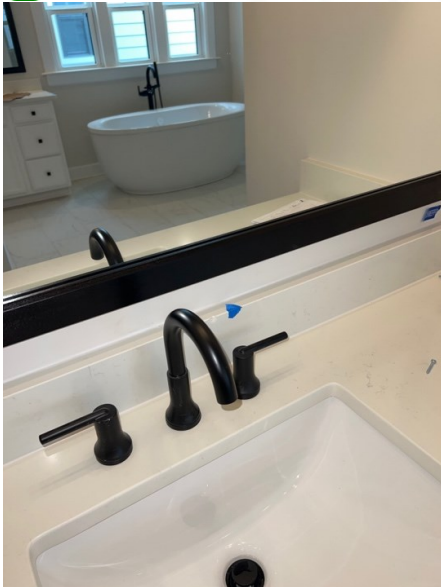
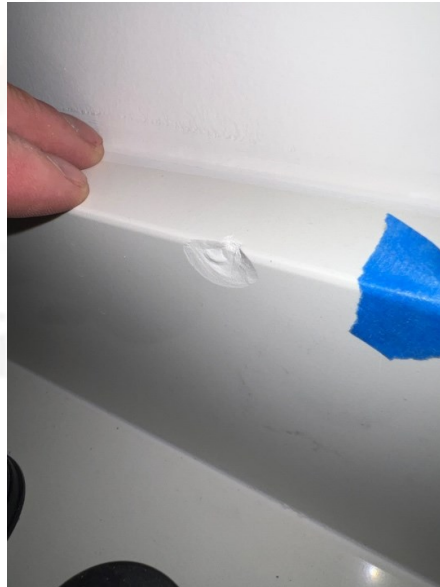
OTHER BATHROOM COMPONENTS

REC A chip was noted at the back splash of one of the master bathroom vanity counters.

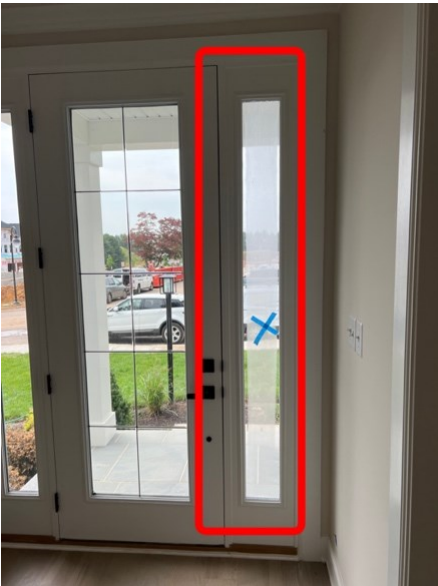
REC A fogged glass panel was noted on the front door.

In order to correct the fogged appearance of the glass replacement of the glass pane or the door panel will be necessary.

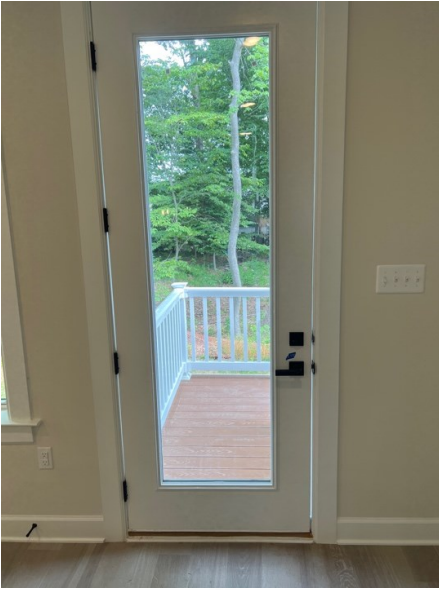
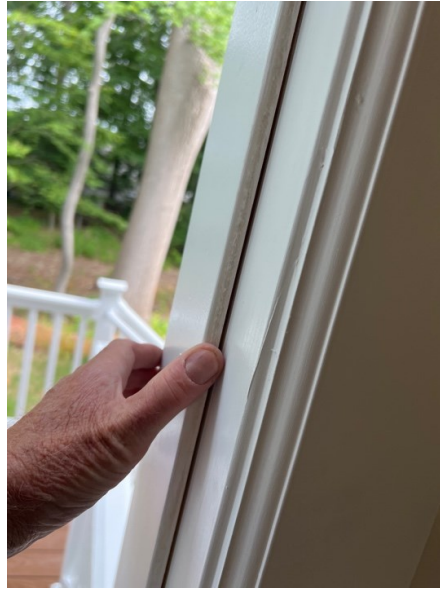
REC Missing weather stripping was noted on the exterior kitchen door.

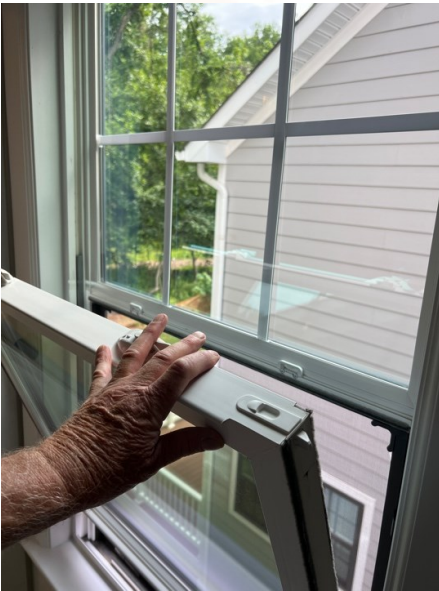
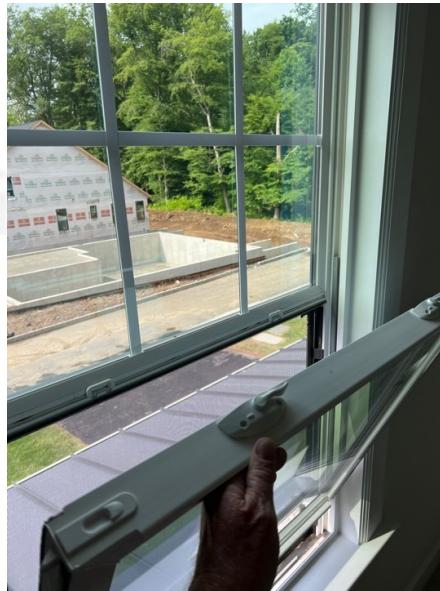
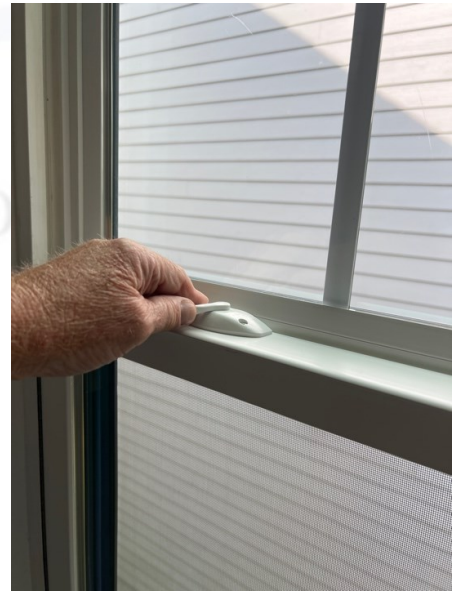
WINDOWS

The windows that were inspected were functional with no significant defects observed

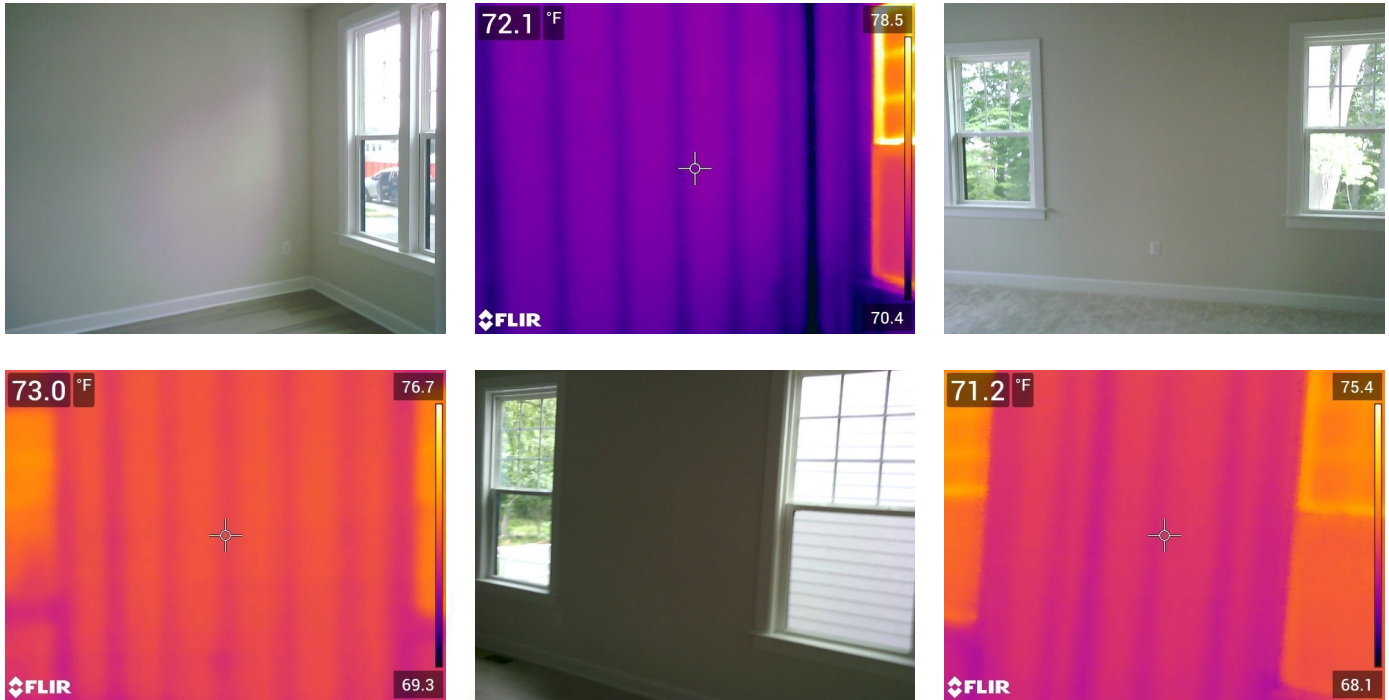
WALLS

The exterior walls were scanned with an infrared camera to check for voids in insulation. No voids were noted.

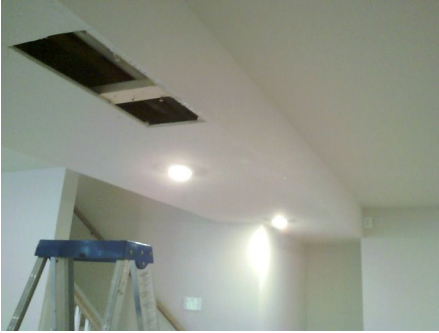
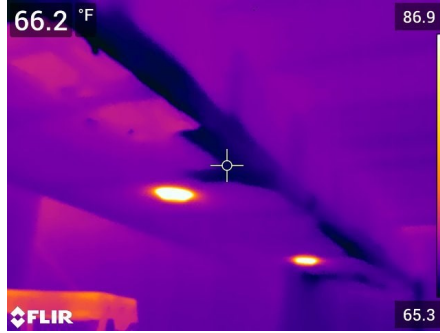
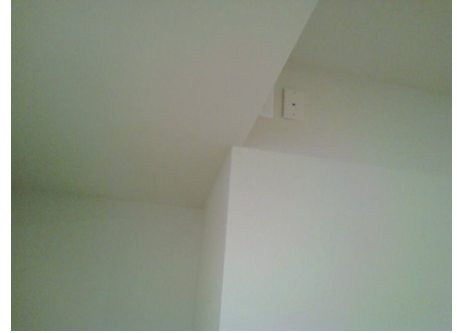
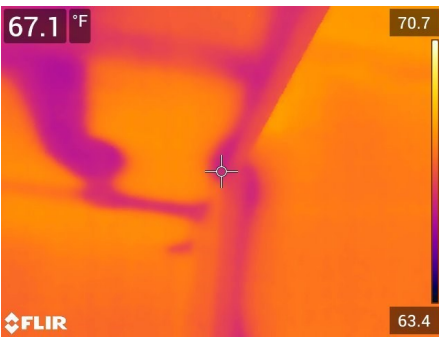
REC A water was noted that the time of the inspection. Water was dripping through the soffit in the basement. At the time of the inspection to plumbers working to locate the source of the leak and take corrective action.

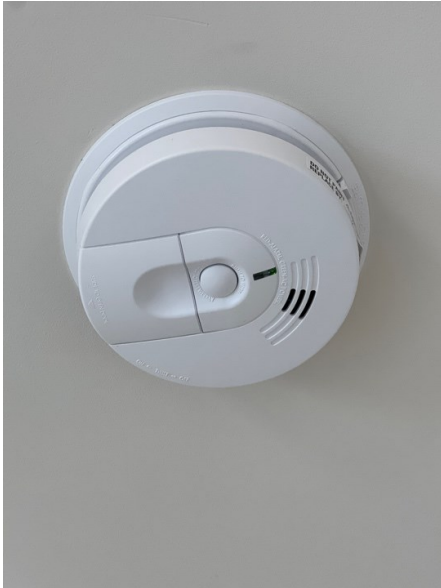
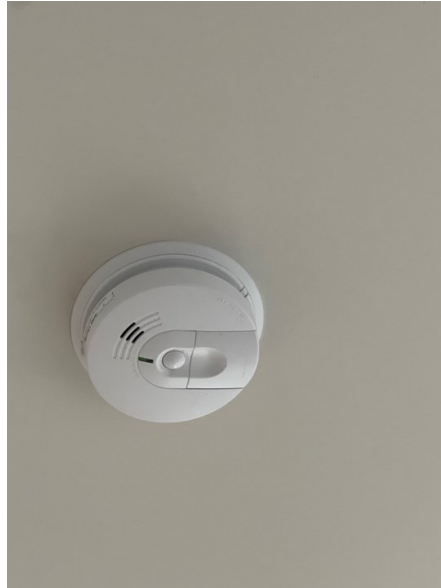
SMOKE & CARBON MONOXIDE DETECTORS

The smoke alarms in the home were Hardwired with battery back-up.

At the time of the inspection the installed smoke alarms sounded when the test button was pushed.

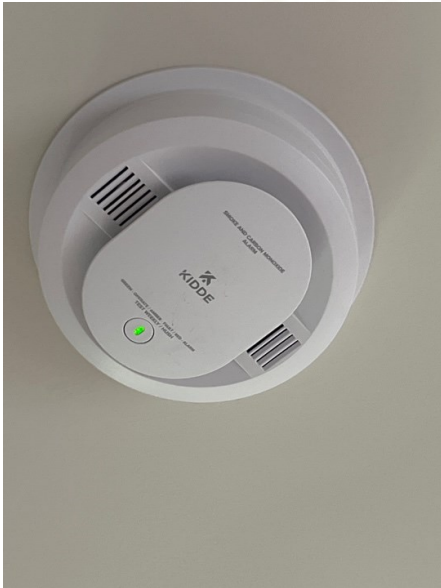
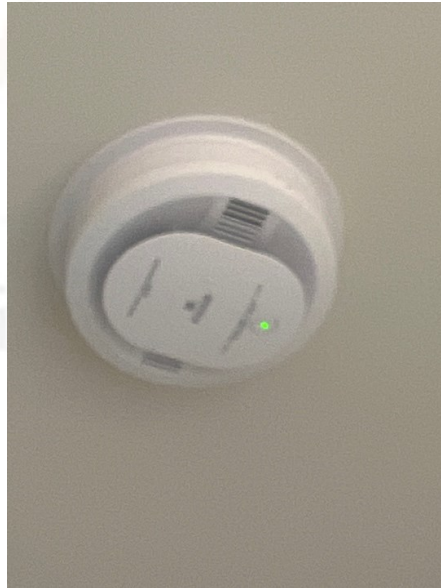
At the time of the inspection, the carbon monoxide alarms all sounded when the test button was pushed.

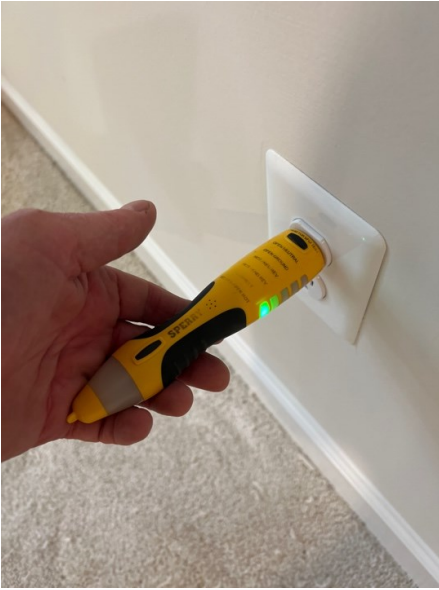
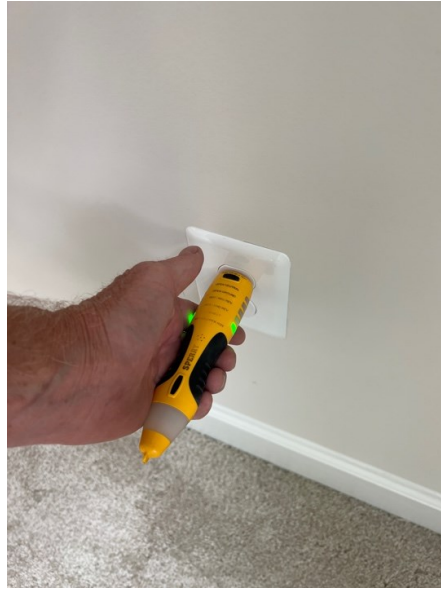
RECEPTACLES

The receptacles that were inspected are properly wired.

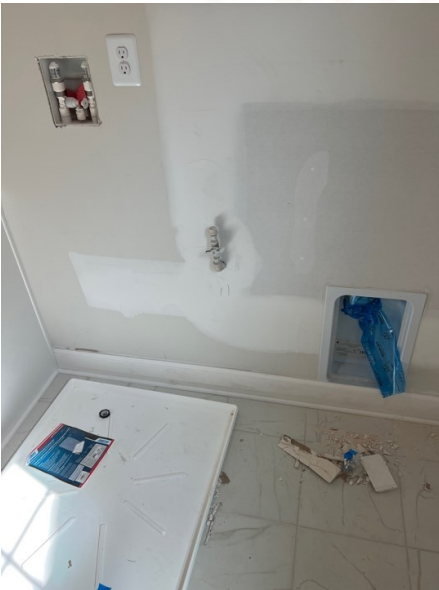
LAUNDRY

The dryer is hook up is gas. The dryer duct should be cleaned and inspected once or twice a year.

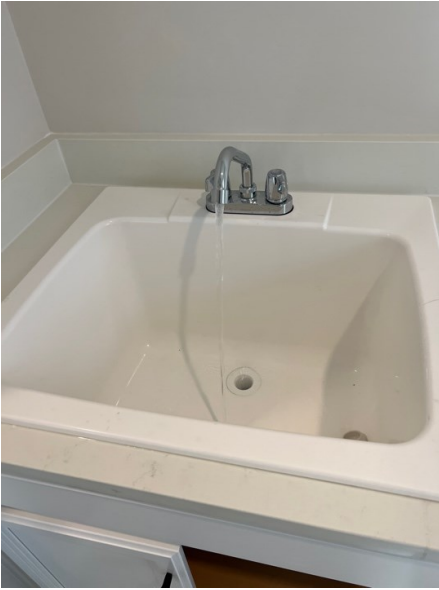
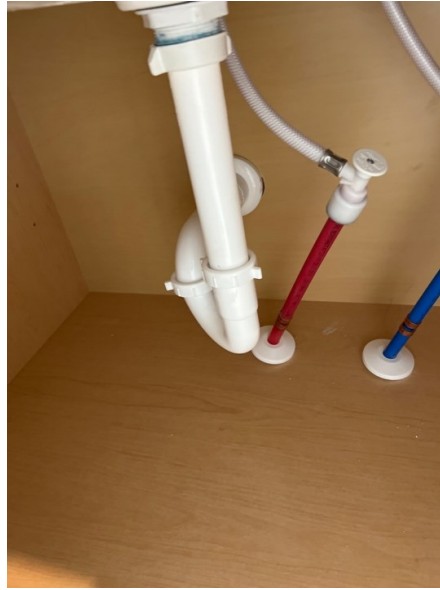
Hot and cold water ran at the utility tub. There were no leaks seen in the drainpipe for the tub, or the hot and cold water supply pipes.

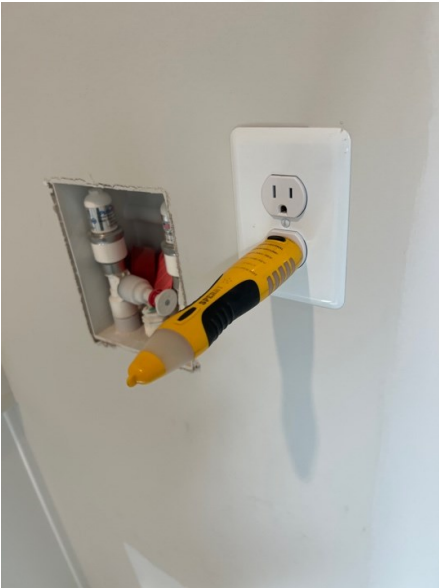
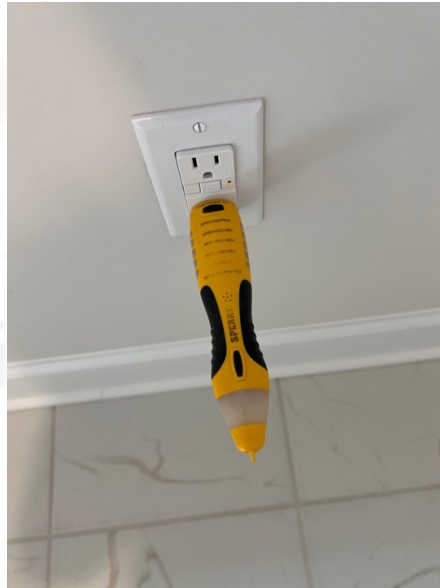
The laundry area receptacles are GFCI protected.

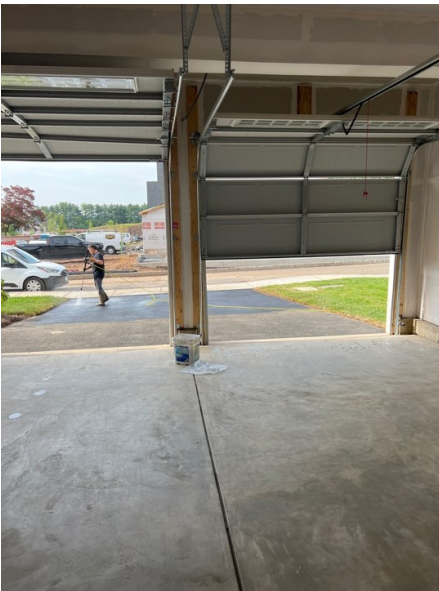
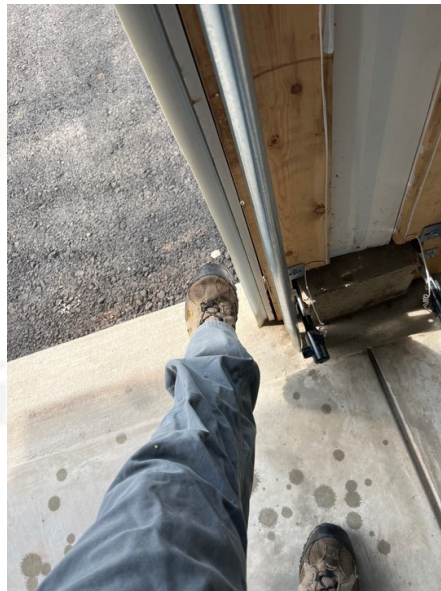
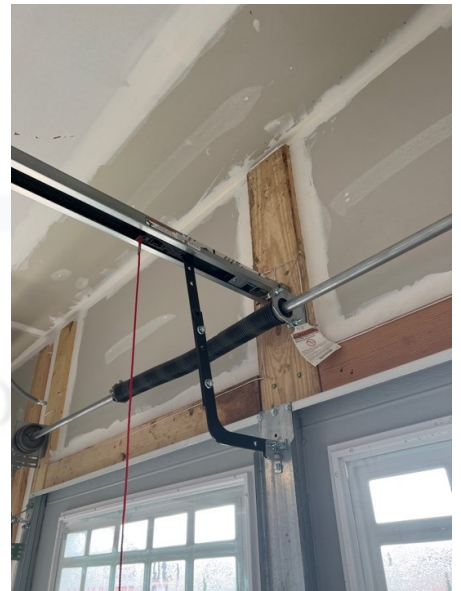
Photoelectric eyes were installed. The doors reversed and returned to the fully open position when I waved my foot in the path of the eye beam as the door was closing, Good. To prevent damaging the doors or the door openers, I did not test the contact resistance automatic reverse feature.

I recommend asking the seller if there are any remote controls for the garage door opener.
