SUNLIGHT INSPECTION SERVICE

123 Sunny Street Nice Town, PA 19460
REPORT# 230600000D

Wednesday, June 14, 2023

Inspector
Daniel Keogh
InterNACHI 212167

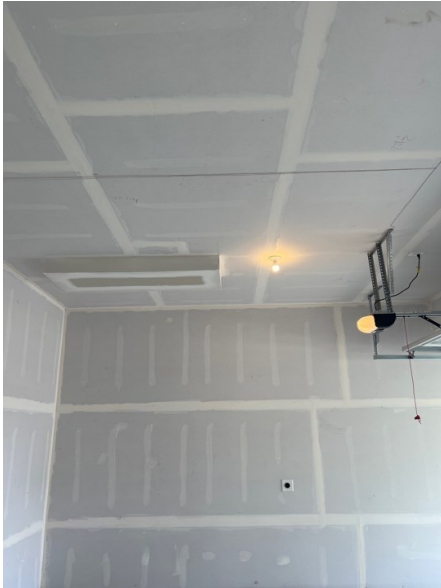
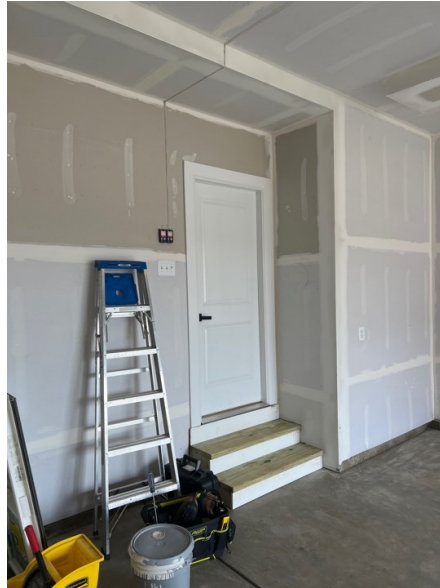
WALLS & CEILING

The walls and ceiling (which is considered the fire wall) appear to be in good condition. No significant deficiencies observed.

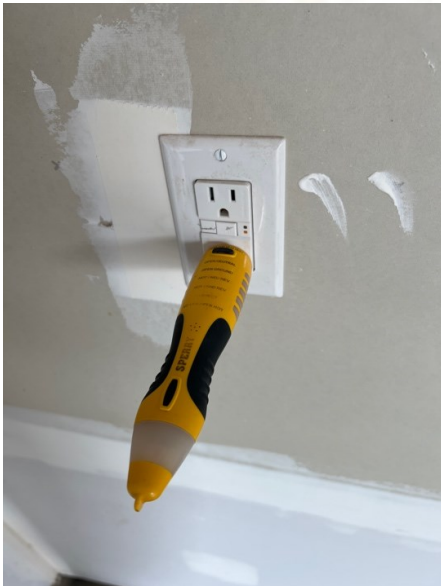
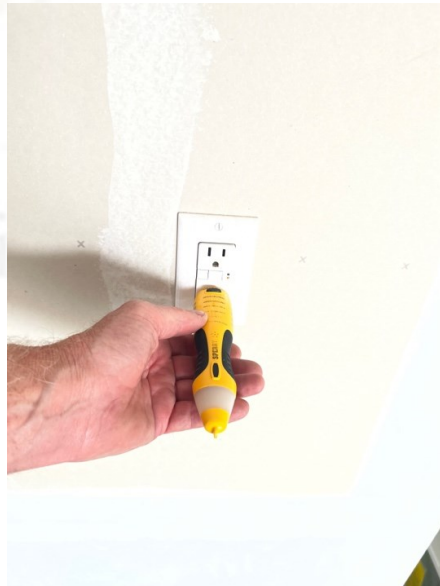
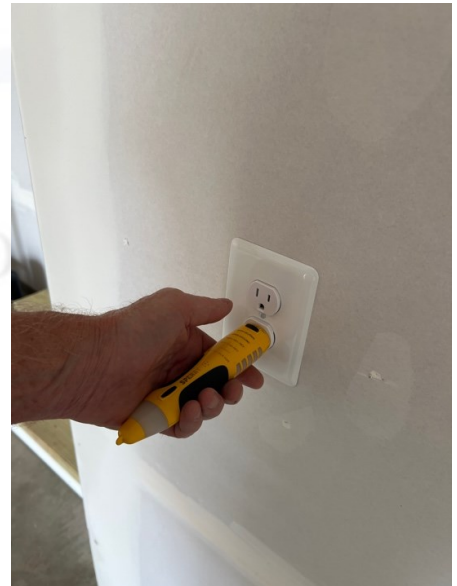
OUTLETS

The garage receptacles are live and are protected by functional GFCI protection

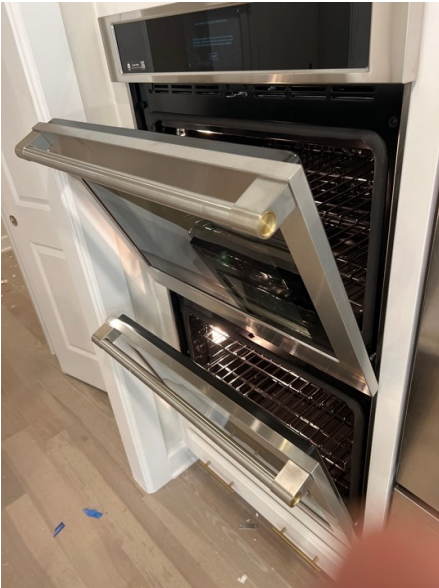
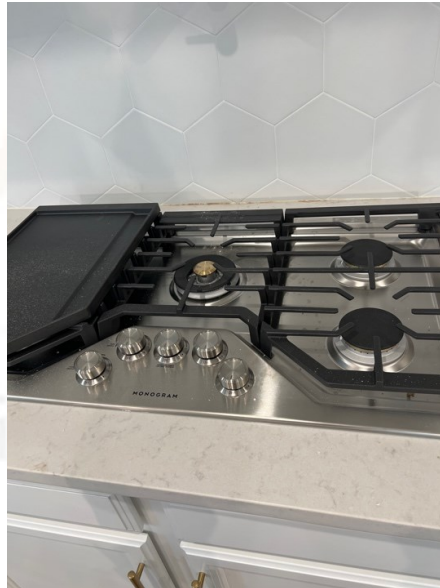
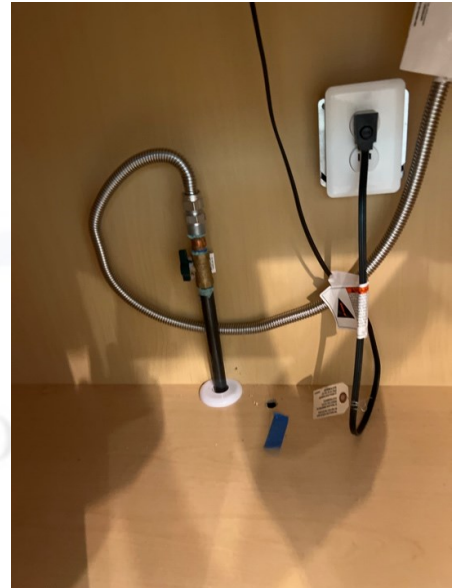
STOVE & OVEN

Stove cook top and oven turned on with normal controls.

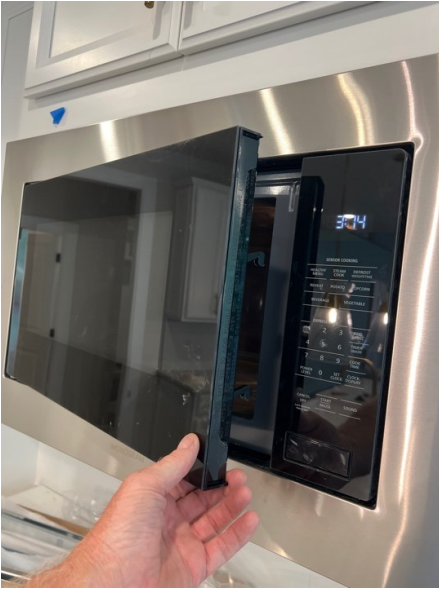
MICROWAVE

The microwave turned on with normal controls.

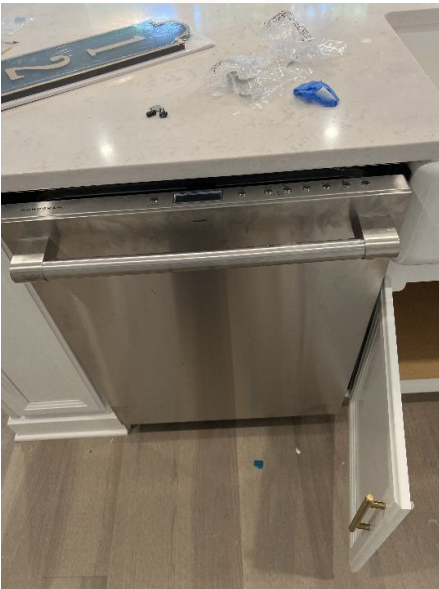
DISHWASHER

The dishwasher appeared to be in serviceable condition at the time of the inspection. The dishwasher was securely mounted. The dishwasher ran through a short cycle. The dishwasher filled and drained. There were no visible leaks coming from the dishwasher.

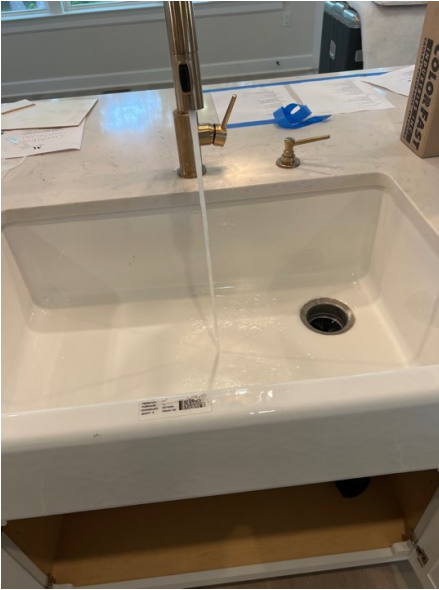
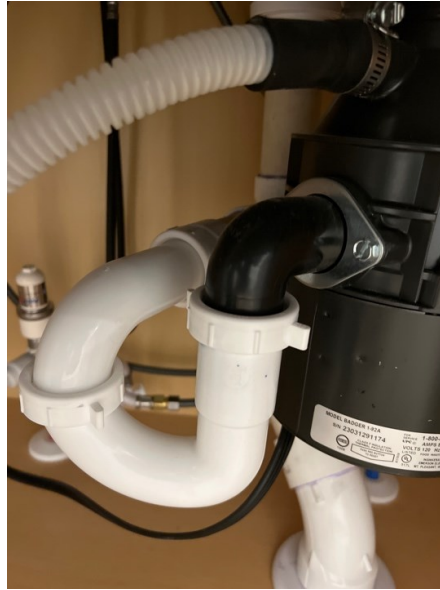
KITCHEN SINK

Hot and cold water ran at the kitchen sink.

There were no leaks under the sink at the water supply lines or the drain pipe.

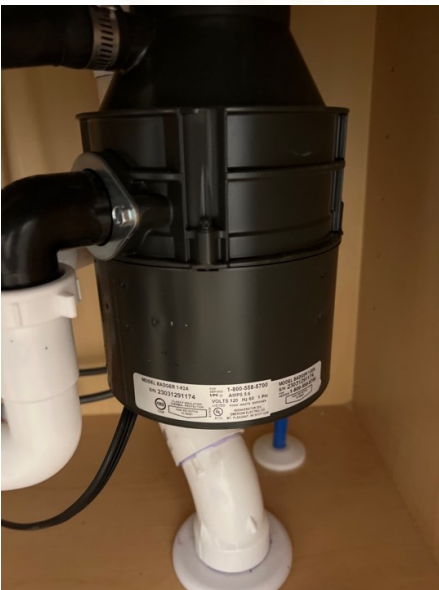
GARBAGE DISPOSAL

The garbage disposal turned on and appeared to function normally.

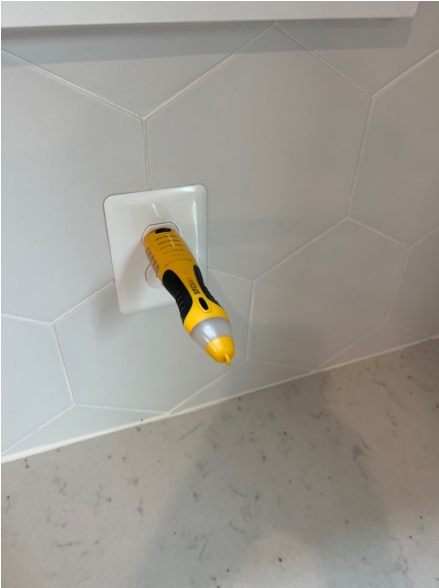
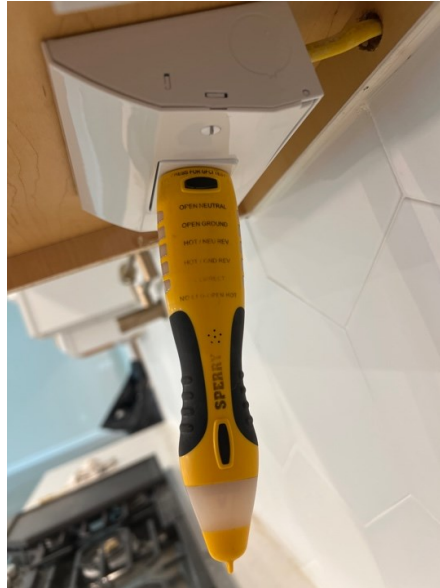
OUTLETS

All the receptacles that serve a kitchen countertop are protected by functional GFCI protection. (Ground Fault Circuit Interrupter).
