SUNLIGHT INSPECTION SERVICE

111 Happy Ave Great Town, PA 19468
REPORT# 23062002D

Friday, June 23, 2023

Report Prepared For
John & Jill Home Buyer

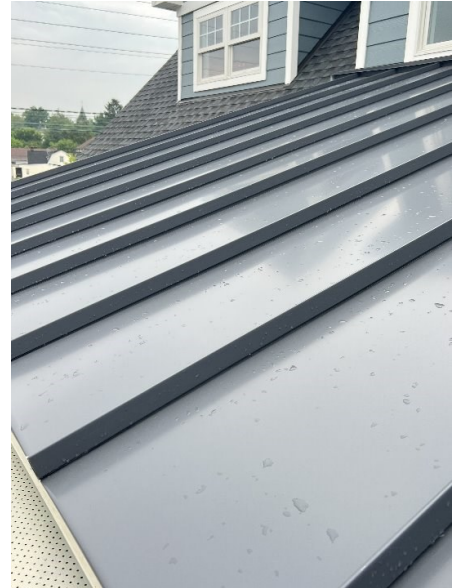
METAL ROOF

I inspected the metal roof. The standing seam metal roof appeared to be in good condition. The surface of the metal was in good condition. The seams are all tight.

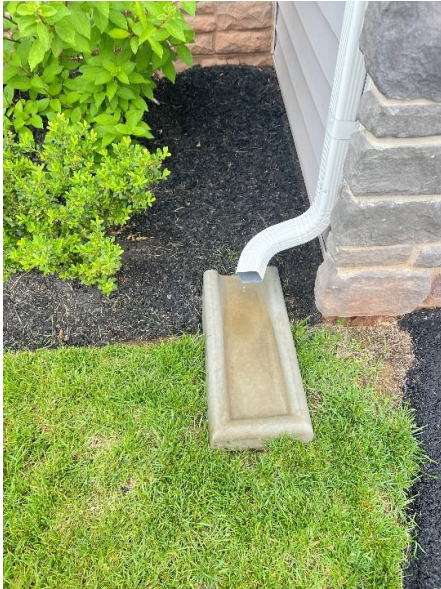
DOWNSPOUTS

REC The splash block under the downspout at the front of the house near the garage needs to be extended to take water away from the house. Water should not be allowed to drain right next to the foundations.

REC 1: The splash block under the downspout at the front of the house near the garage needs to be extended to take water away from the house. Water should not be allowed to drain right next to the foundations.

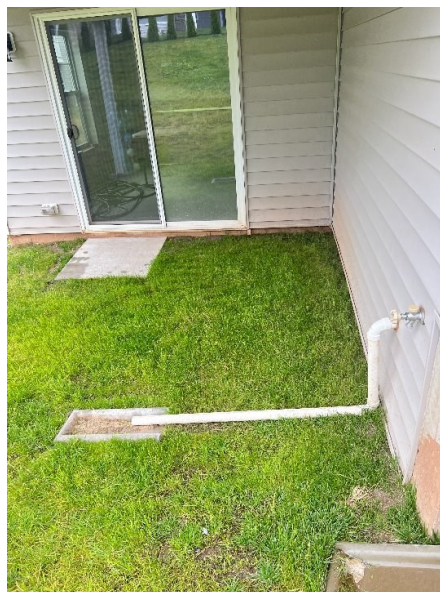
GRADING & DRAINAGE

REC Poor drainage (grading) was noted near the foundation at the rear of the house. The ground is level and not sloped away from the house.

The soil around the home should be graded to take water away from the foundation. In order for drainage to be effective, the landscaping must be configured so that the yard is sloped away from the foundation at a pitch of no less than 6 inches in the first ten feet. Failure to maintain sufficient drainage will cause rain and surface runoff to drain toward the foundation where it can seep into basements and under the basement floor.

REC 2: Poor drainage (grading) was noted near the foundation at the rear of the house. The ground is level and not sloped away from the house.

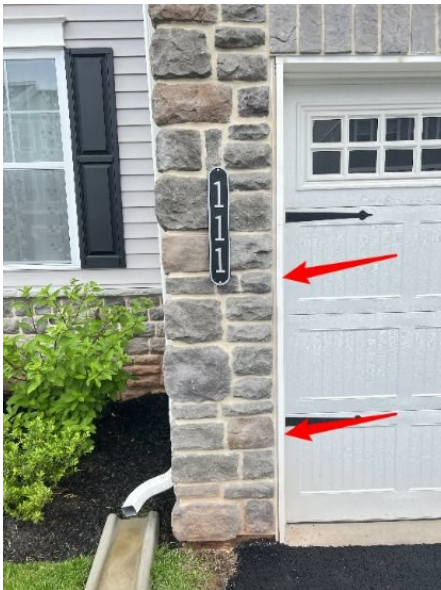
REC The casement bead (E-Z bead) has not been caulked properly. The caulk joints are shallow. The caulking should meet the edge of the caulk knife in the pictures below.

Caulking should be deep enough to meet the edge of the caulking knife.

Adhesive failure at the top left corner of the garage.

When stucco or stone veneer runs to any dissimilar material, window frames, door frames, siding, exedra, it must be separated by a soft joint (caulked joint) to allow for expansion and contraction between the dissimilar materials. A soft joint can be formed using a stop bead and caulk backer rod or as in this case, a pre-made E-Z bead can be used. E-Z bead is a stop bead and backer rod built together. After the stucco or stone veneer is installed the E-Z bead is sealed (caulked) with exterior caulking that meets ASTM standard 920. The caulking should be pushed into the E-Z bead joint and then tooled with a caulk trowel, not a finger. The built-in backer rod has a silicone release tape on it that prevents the caulking from adhering to the backer rod. This prevents the caulking from forming a three-sided bond which would cause an adhesive caulk failure.

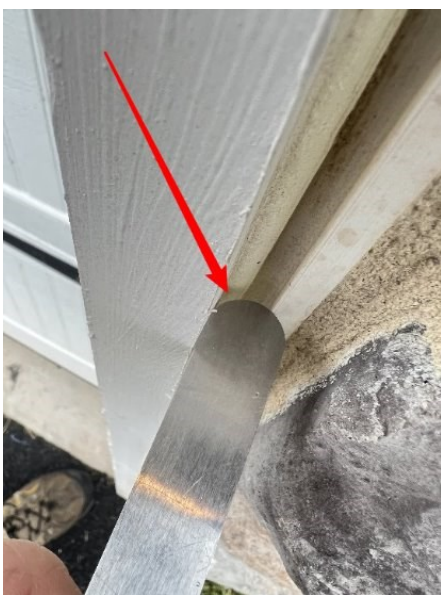
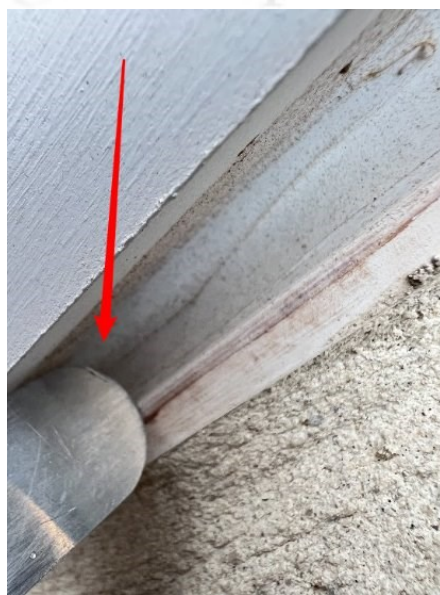
Caulk should meet the edge of the caulking knife.

R The picture shows what a mechanical caulk joint should look like. The depth of the caulk should be 1/2 the width of the joint. The back of the joint should have a release tape or film to avoid a three-sided bond. A three-sided bond will cause an adhesive failure on one side of the joint.

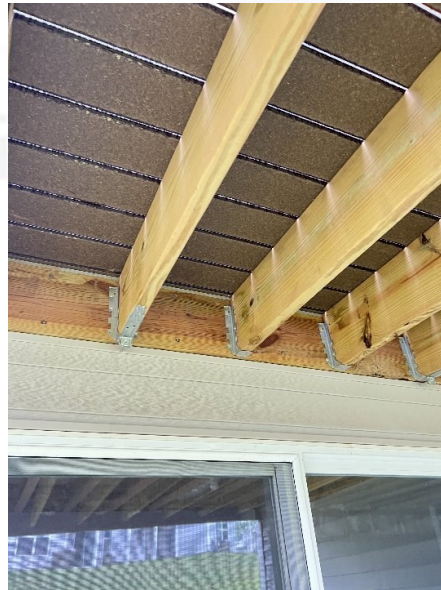
DECK/PORCH STRUCTURE

At the time of this inspection the deck structure appeared to be in good condition. There were metal joist hangers installed. The ledger board was attached to the house with visible bolts. The deck structure should be checked annually (May is deck safety month) and improved or repaired as necessary.

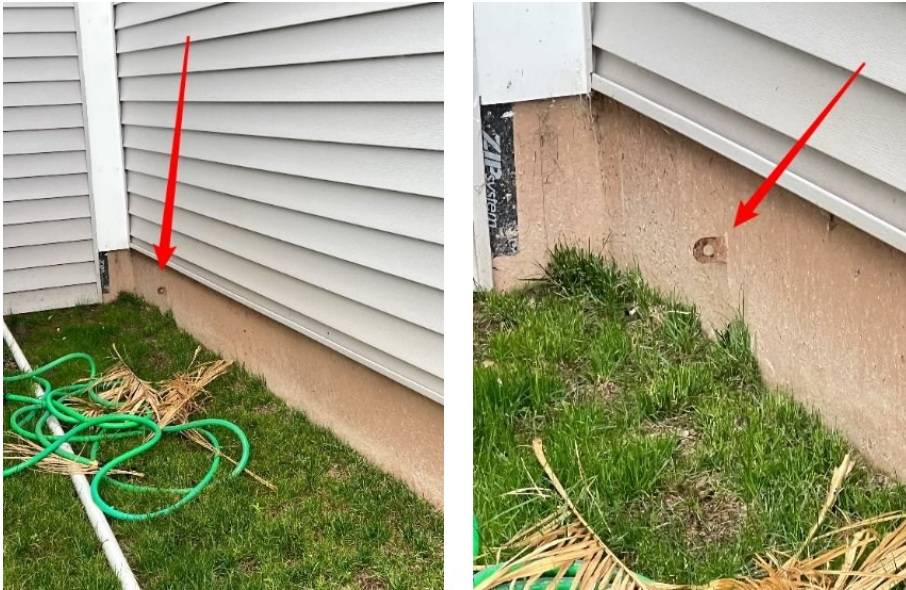
OTHER EXTERIOR COMPONENTS

REC On the backside of the house a steel foundation form tie was left in place. These should be knocked off after the concrete foundation has been poured and the steel forms removed.

REC 5: On the backside of the house a steel foundation form tie was left in place. These should be knocked off after the concrete foundation has been poured and the steel forms removed.

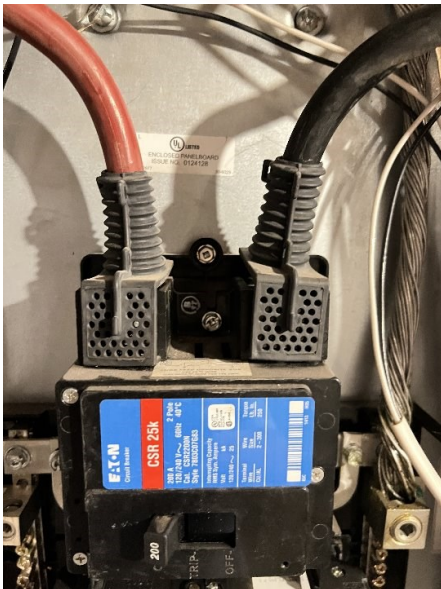
Damaged electrical panel

REC Damage was noted in the electrical panel. Scorching was noted on the buss bars. Four tabs on the buss bars are warped or deformed. It appears that something hit the buss bars while the panel was energized.

Breakers can not be safely installed on the damaged tabs. Breakers that are installed in damaged tabs may not seat properly. Installing breakers on the damaged tabs could cause overheating, a fire hazard. The electrical panel should be replaced.

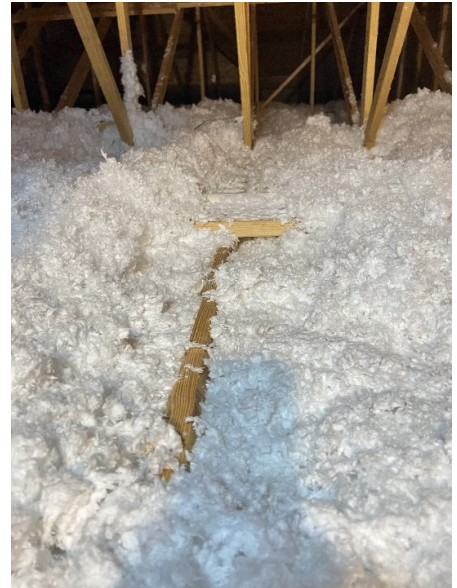
INSULATION

REC There were low levels of insulation on the attic floor where people have moved it to work. Workmen often move the loose fill insulation out of the way while they are working in the attic and then fail to replace it once the work is done. I recommend adding/re-disrupting the insulation to maintain the R value of the attic insulation and reduce energy loss.

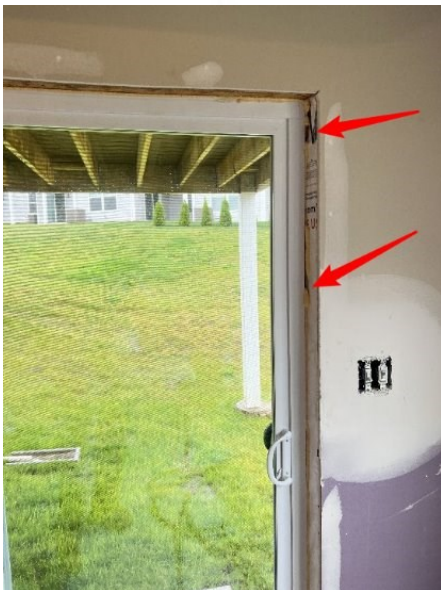
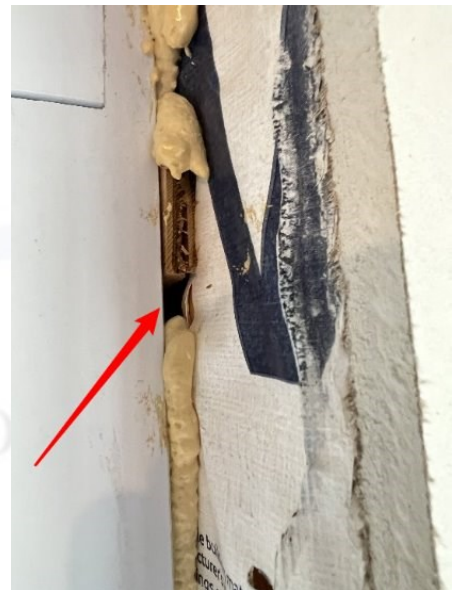
DOORS

REC Incomplete air sealing was noted around the basement sliding door. There are gaps around the door that should have been sealed.

R Code Reference

N1102.4 Air leakage.

The building thermal envelope shall be durably sealed to limit infiltration. The sealing methods between dissimilar materials shall allow for differential expansion and contraction. The following shall be caulked, gasketed, weatherstripped or otherwise sealed with an air barrier material, suitable film or solid material.

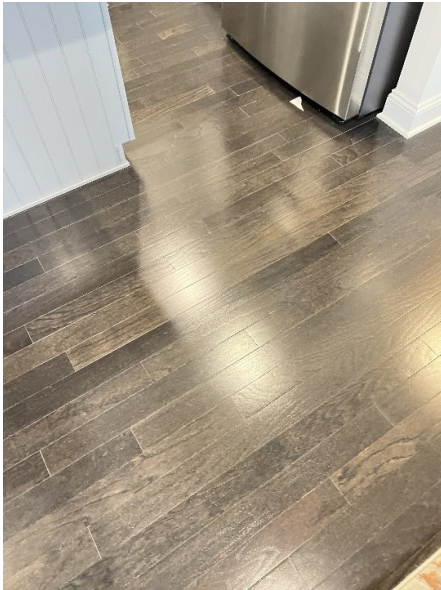
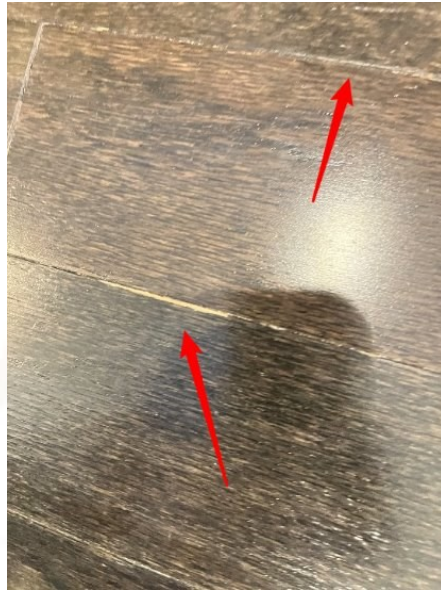
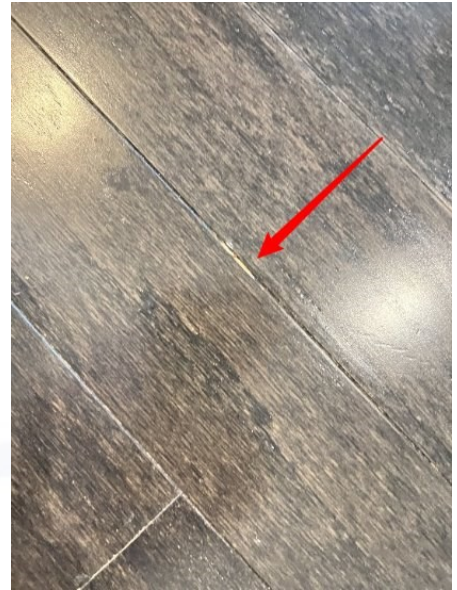
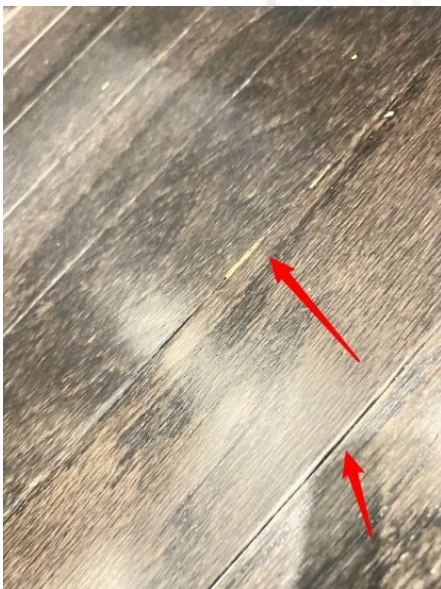
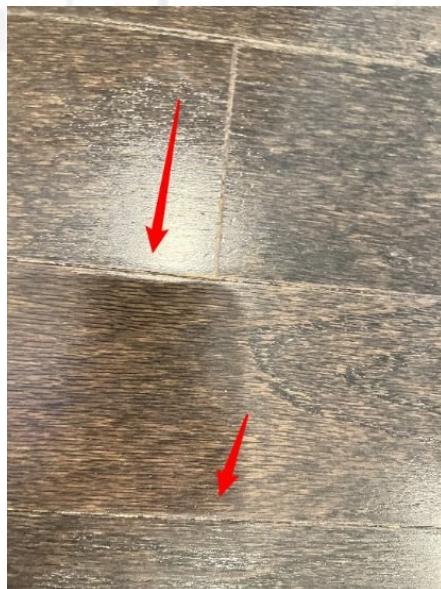
FLOORS

REC Excessive splintering was noted on the first floor hardwood floor. Excessive splintering was noted along the joints where the floor boards meet. The splintering is visible throughout the floor and not limited to a single area.

Splintering of this nature is often caused by excessive lippage at the joints. It can also be due to a manufacture defect. Below are two guidelines found in the National Association of Home Builders "Residential Construction Performance Guidelines for Professional Builders & Remodelers, Sixth Edition"

I recommend consulting with the builder to determine if this is an installation issue or a manufacture warranty issue.

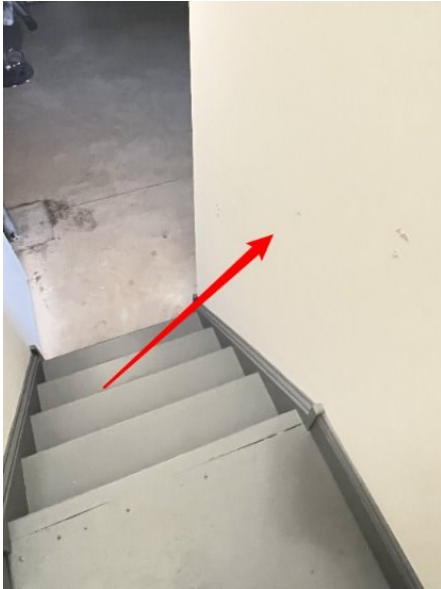
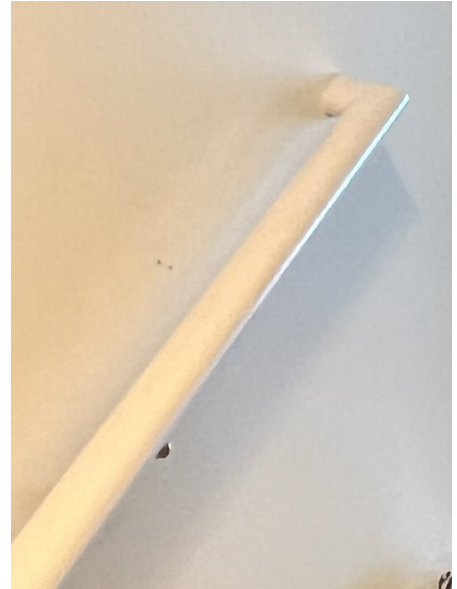
REC The lower stairs to the basement were noted without a hand railing. The owner reports that the railing pulled out of the wall when it was used. The top of the upper basement railing is loose. An addition support should be added near the top of this railing section.

No support near the top of the railing.

R Code Reference **R311.7.8 Handrails.**
