SUNLIGHT INSPECTION SERVICE

125 New Home Rd Lot 34 Phoenixville, PA 19460

REPORT# 23021204D

The following numbered and attached pages are your pre-drywall inspection report. The report includes photographs, comments, and the Standards of Practice. This inspection was performed in accordance with the current Standards of Practice for Residential Pre-drywall Inspections of the American Society of Home Inspectors. The Standards contain certain and very important limitations, exceptions, and exclusions to the inspection. A copy is available prior to, during, and after the inspection, and it is part of the report. All components designated in the ASHI standards of practices, except for limitations that may be noted in the report, will be inspected. The inspection is for the most part a limited visual inspection only. A representative sampling of the building components is viewed in areas that are accessible at the time of the inspection. No destructive testing or dismantling of components is performed. Be sure to keep your signed copy of the home inspection agreement along with the report for future reference.

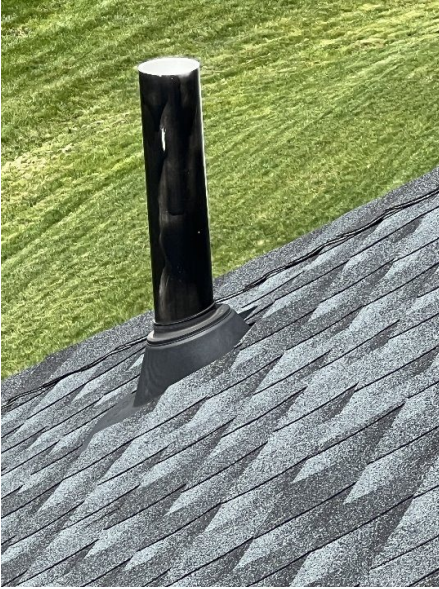
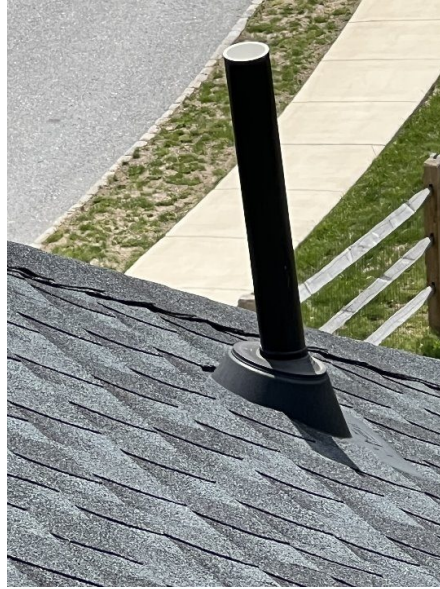
The asphalt fiberglass shingles on the main roof structure appear to be in good condition.

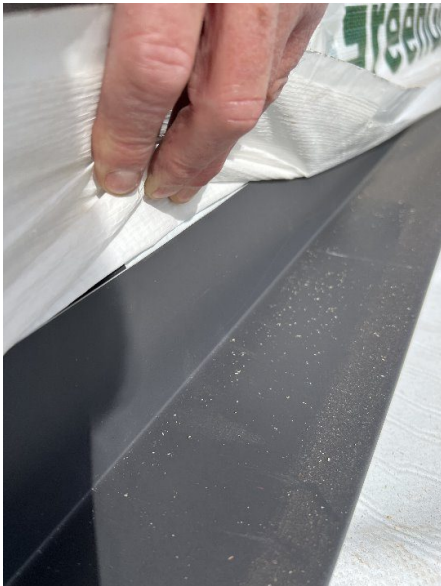
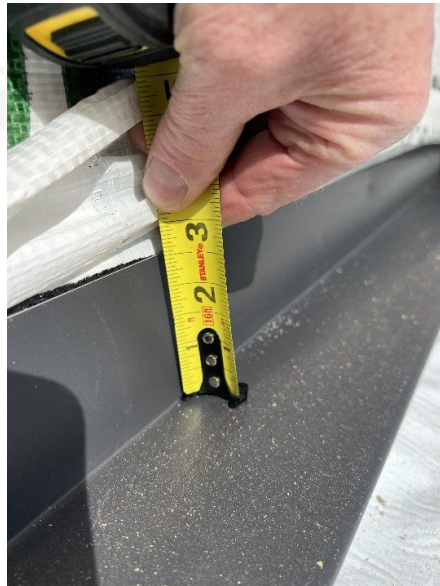
The side wall flashing for the metal roof does not extend far enough up the wall. Sidewall flashing should extend up the exterior wall a minimum of 4 inches.

The sidewall flashing is less than 3 inches high. This will be an issue when installing the Hardi plank siding. Hardi plank siding requires 2 inches of clearance from the bottom of the siding to the roofing material. This will leave less than an inch of coverage over the top edge of the flashing.

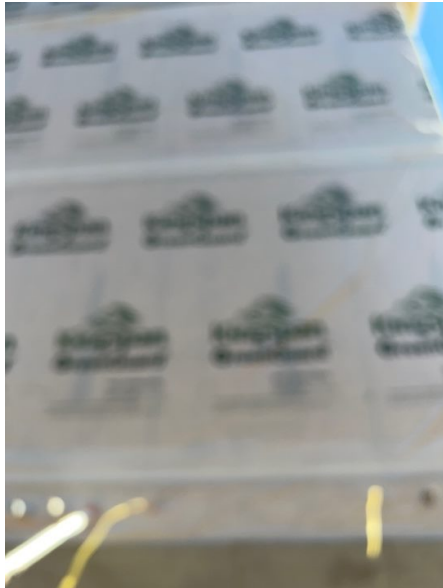
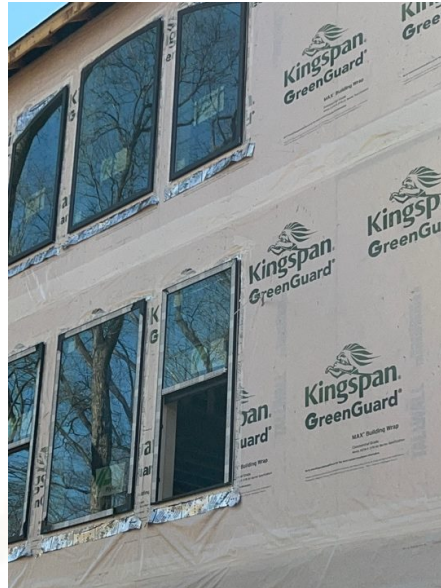
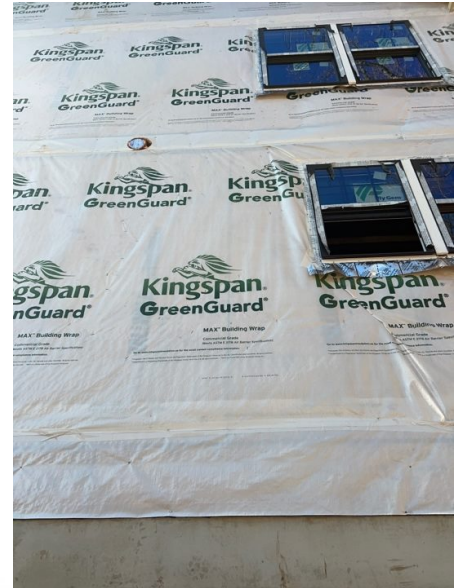
WATER RESISTANT BARRIER

The house wrap has been installed. The upper layers are overlapped over the lower at least 2 inches. The joints are overlapped at least 6 inches.

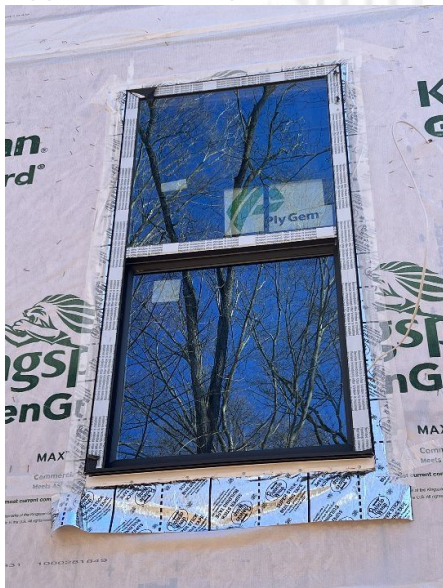
WINDOW FLASHING

The windows have been flashed and integrated with the house wrap to form a continuous drainage plain down the wall using the builder's specifications. The bottom corners near the sill flashing need to be tapped. This is a possible water intrusion area.

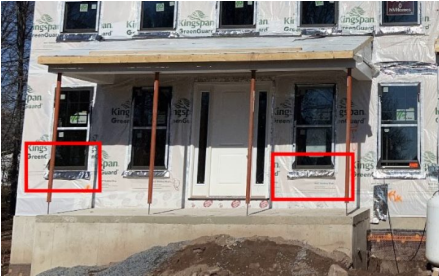
C A poor taping detail was noted on two of the windows at the front of the house. The flashing tape and house wrap should be better integrated to prevent water intrusion.

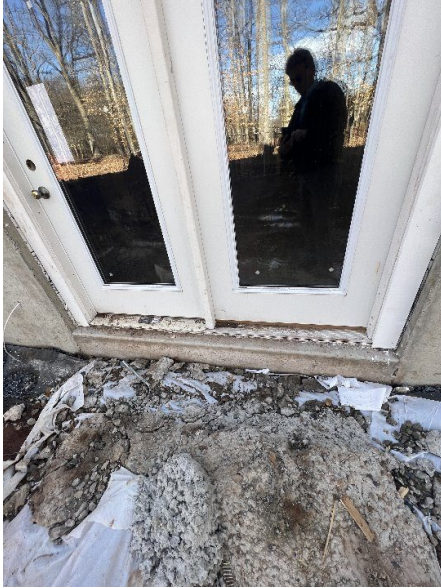
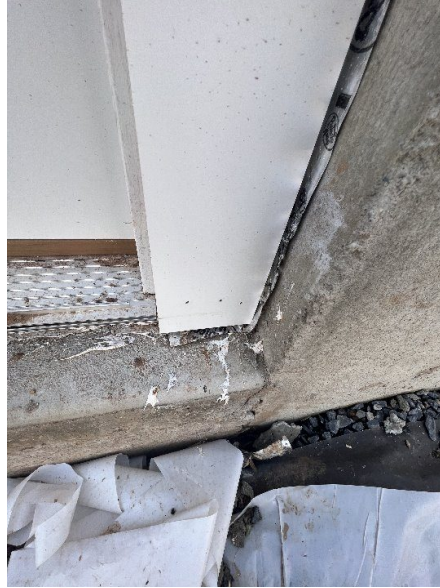
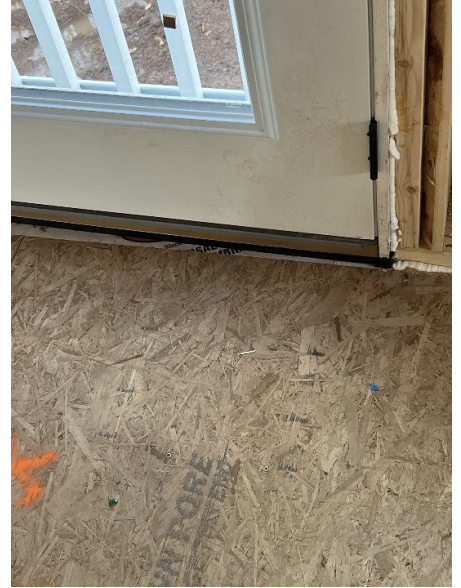
DOOR FLASHING

The doors have been well flashing and the flashings have been properly integrated with the building paper to form a continuous drainage plain down the wall and around the door.

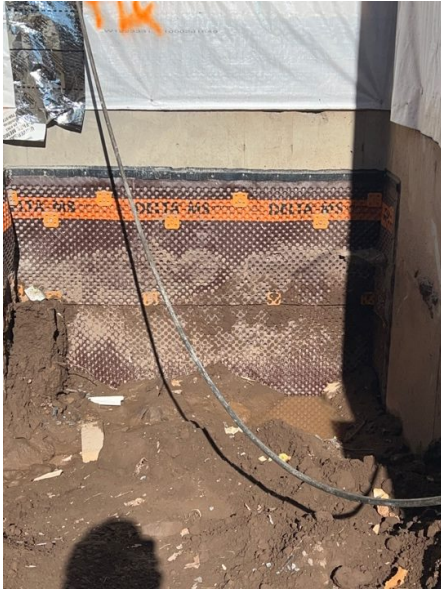
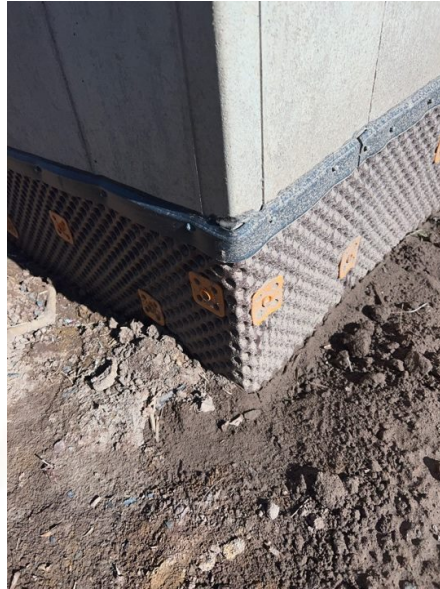
WATERPROOFING OR DAMPPROOFING

Water proofing has been installed on the exterior of the foundation walls. A drainage membrane can be seen on the foundation.

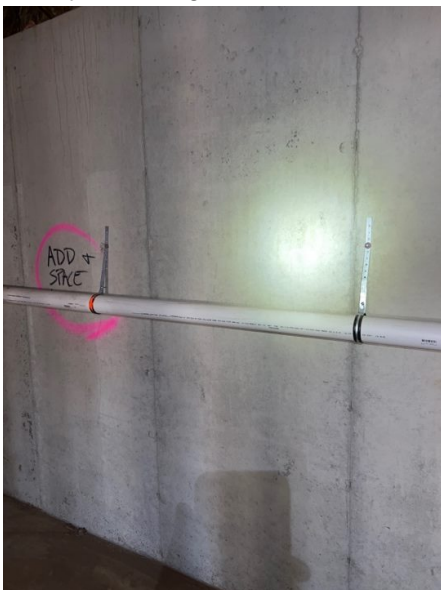
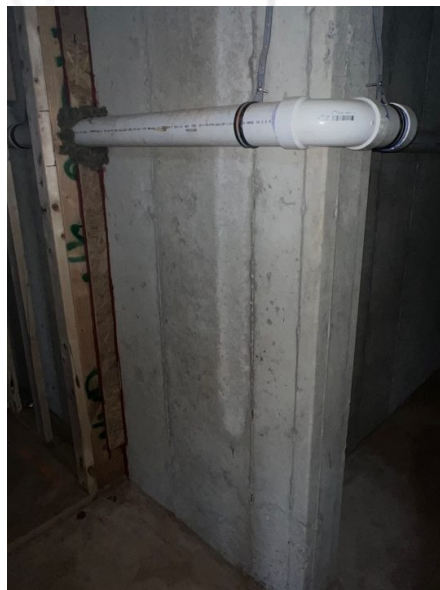
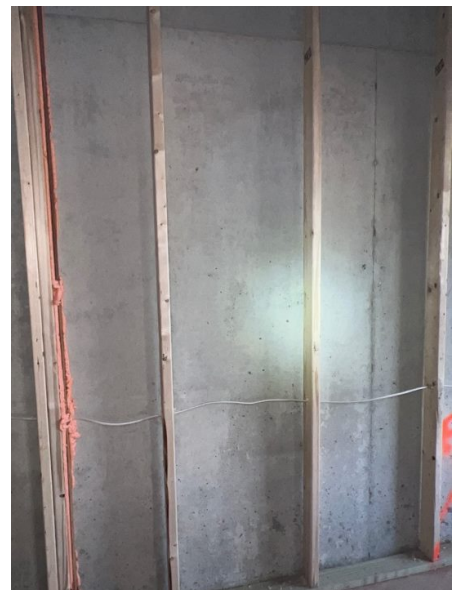
FOUNDATION WALLS

The foundation walls appeared to be free of defects. The walls were vertical with no abnormal cracking or honey combing observed.

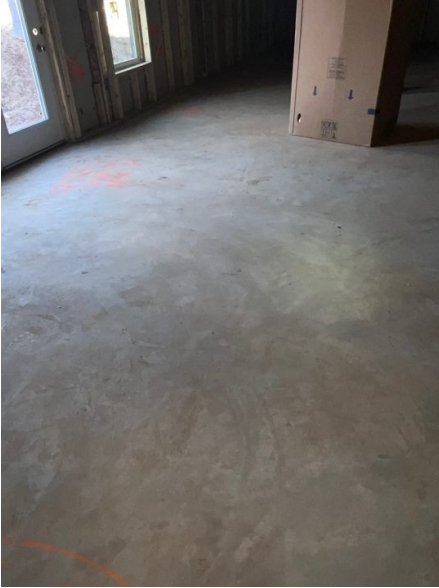
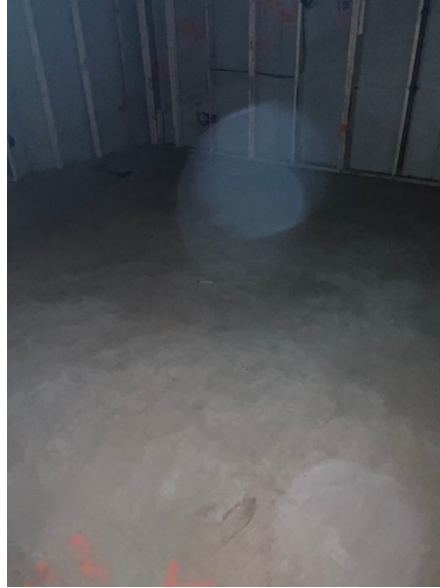
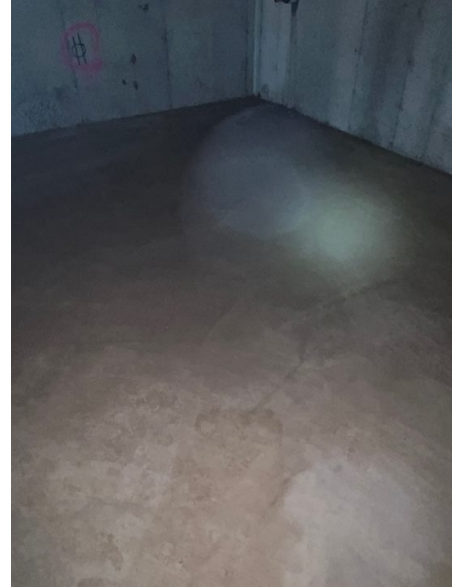
CONCRETE FOUNDATION SLABS

The concrete slab appears to be free of defects at this time. The builder installed control joints in the floor to control cracking should it accrue.

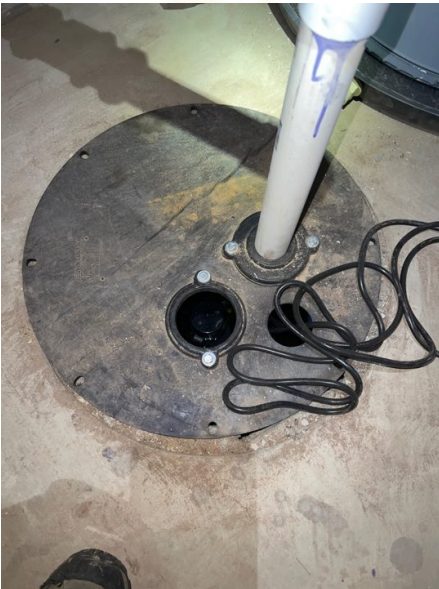
FOUNDATION DRAINS

The interior foundation drains terminate in the sump. Two ends of the foundation drain tile are visible at the sump.

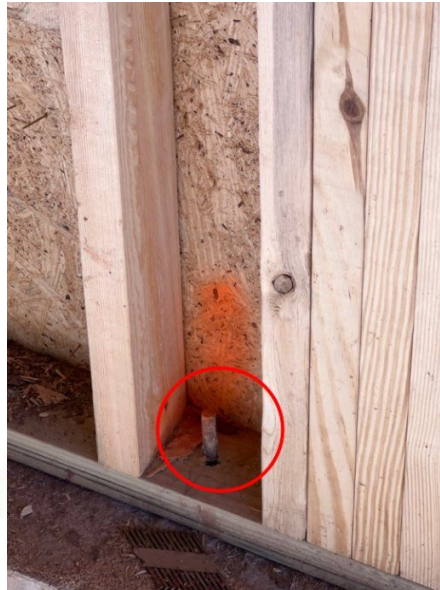
Garage

C Missing foundation bolts were noted. Foundation bolts without nuts and washers on them were noted. Bent and damaged foundation bolts were noted.

Five foundation bolts in the garage were noted without washers and nuts on them. In the basement above the left foundation wall, four foundation bolts are missing and three foundation bolts are damaged.

The bottom sill plate of each exterior wall should be anchored to the top of the foundation wall with 1/2 inch bolts. There should be a bolt within 6 inches of the end of each sill plate and the bolts are 6 ft on center. Each bolt should have a washer and a nut on it.

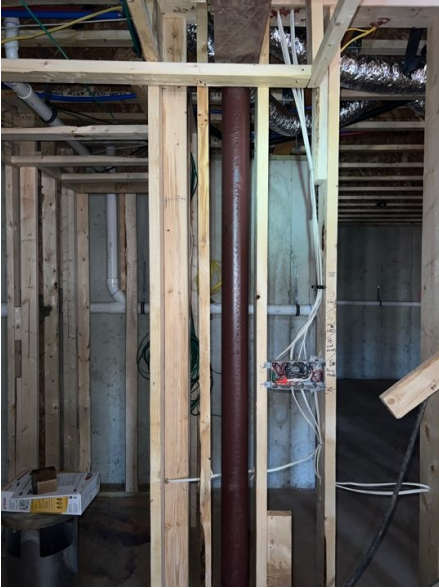
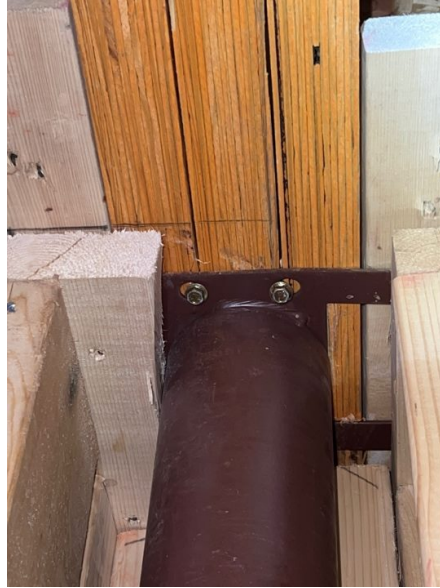
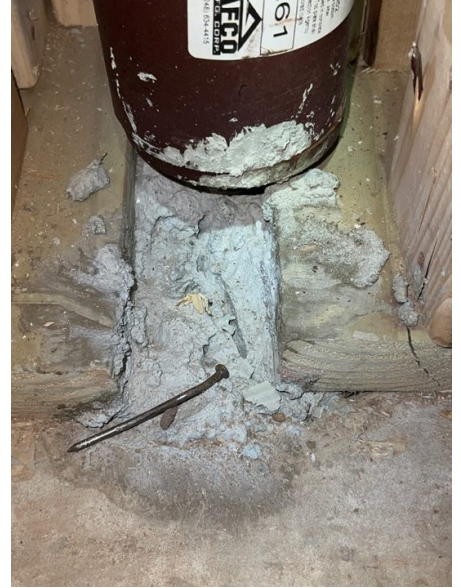
STRUCTURAL COLUMNS

The steel columns are secured (anchored) at the bottom and top to prevent lateral displacement. The columns are plumb within 3/8 of an inch in 8 feet.

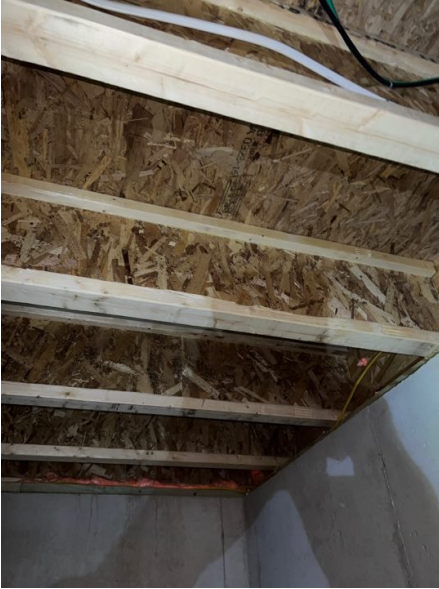
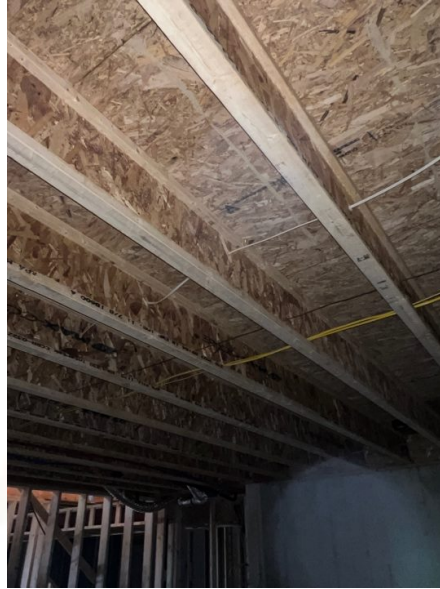
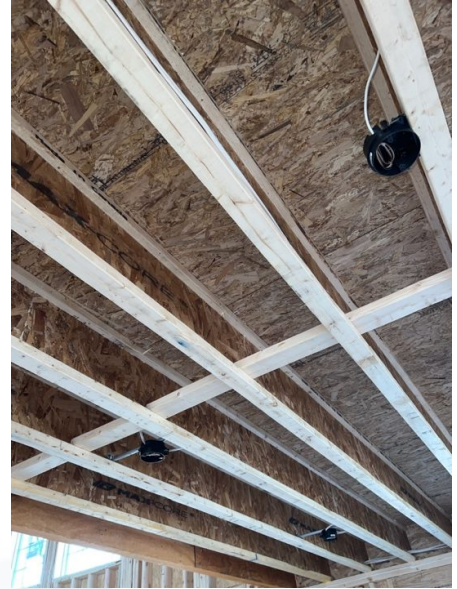
The floor joist appear to be free of defects at this time. At the time of this inspection the drilling and notching of the floor joist complied with section R502.8.

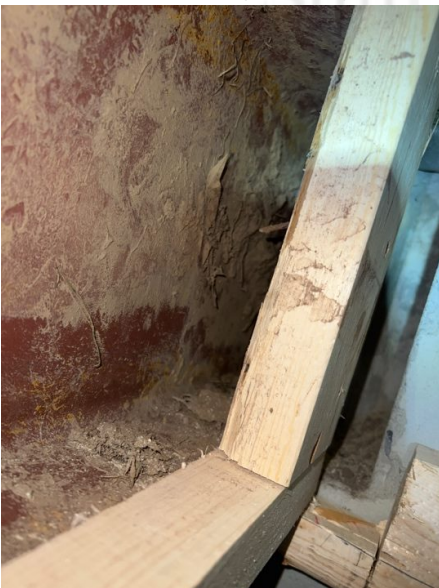
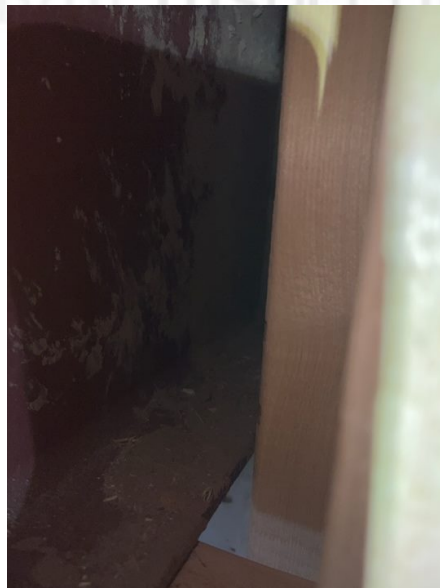
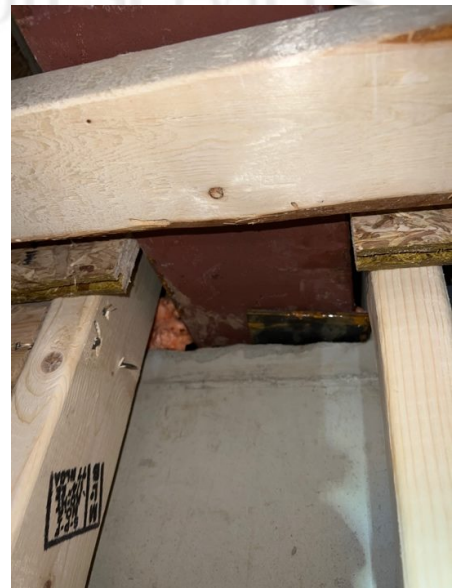
The steel beams are secure in the foundation beam pockets. The beams are bearing at least 3 inches on the concrete wall. (R502.6)

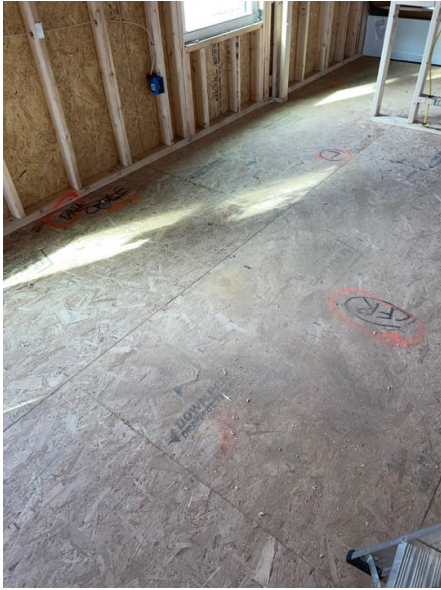
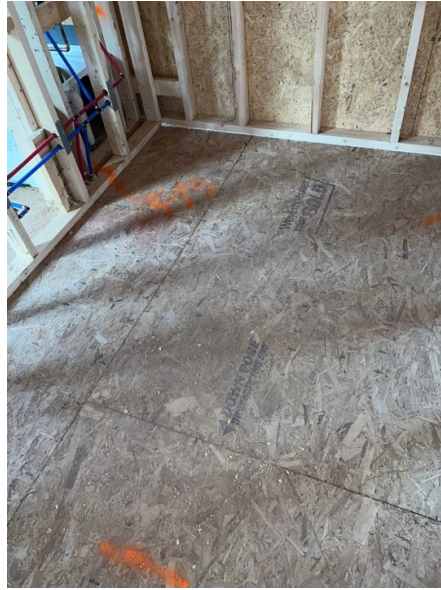
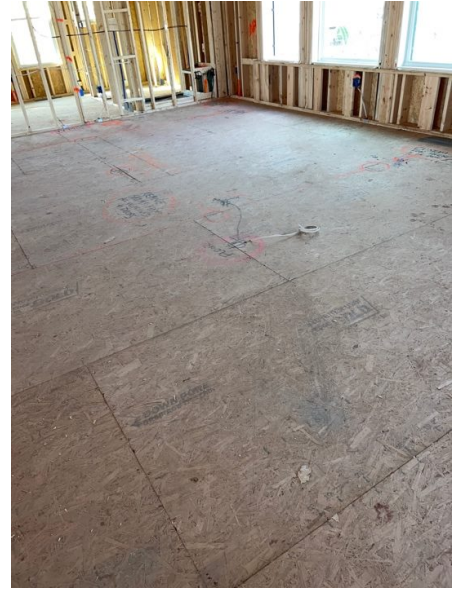
The floor sheathing was free of defects. The sheathing is within allowable spans.

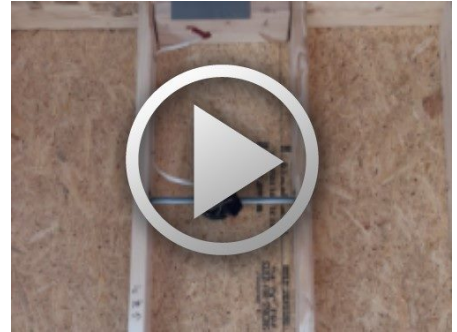
C A top plate that has been cut all the way through was noted in the back left first-floor bathroom wall. When the top plate of a loadbearing wall has been cut more than 50% to allow access for pipes, wires or ducts a metal tie must be installed to add structural support to the wall. The strap must extend 6 inches past the opening on both sides and have eight 10d nails installed on each side.

metal plate in wooden block are not
inadequate repair

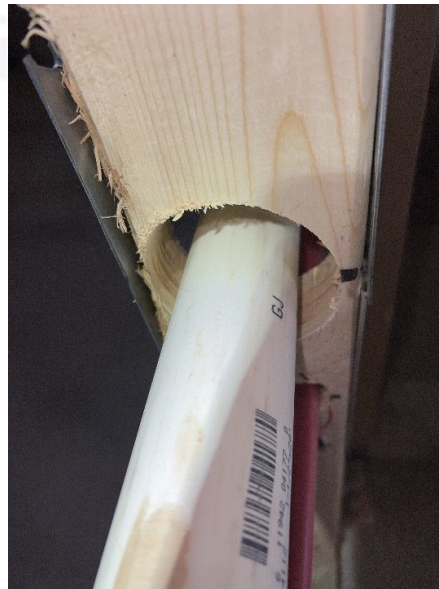
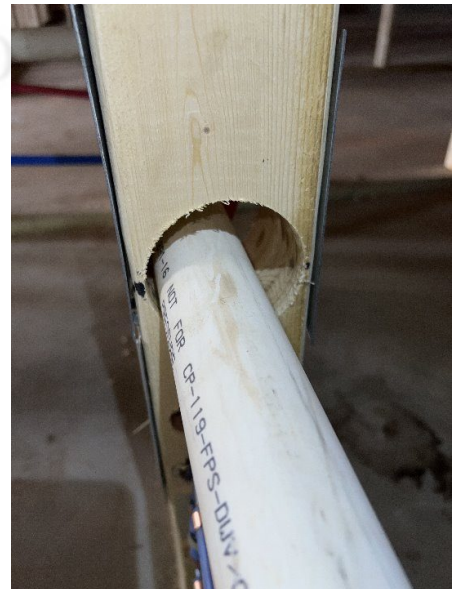
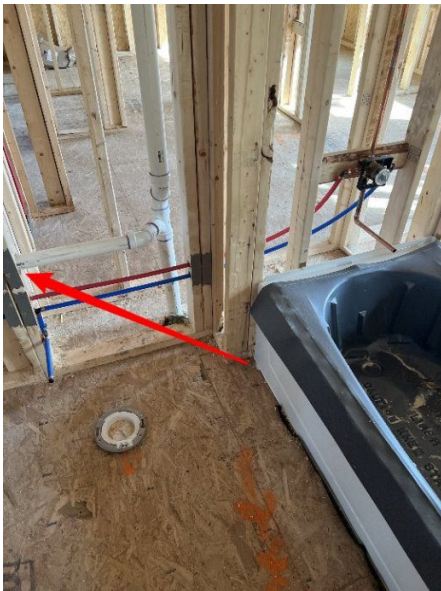
second floor center bathroom

C Improper bored holes were noted in the basement bathroom and second-floor center bathroom. The holes exceed 60% of the stud width that are closer than 5/8 of an inch to the edge of the stud. Bored holes in studs of interior nonbearing walls may not exceed 60% of the stud depth and may not be within 5/8 of the stud edge. The hole may not be located in the same section as a cut or notch.

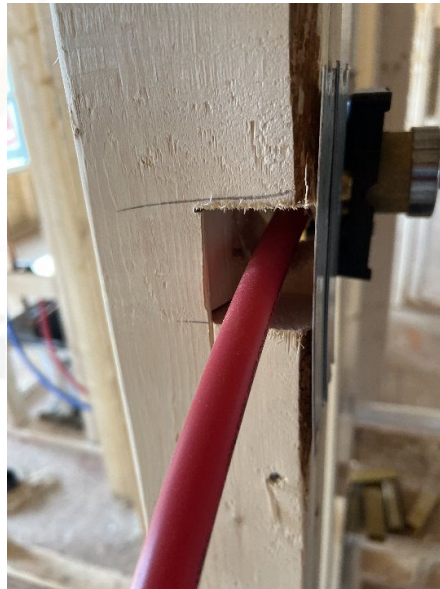
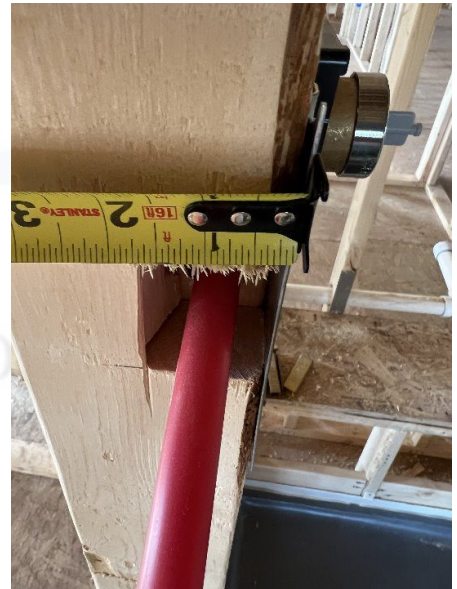
second floor right bathroom

C Over notched stud was noted near the shower in the second-floor right bathroom wall. Studs in nonbearing interior walls may not be cut or notched more than 40% of their width.

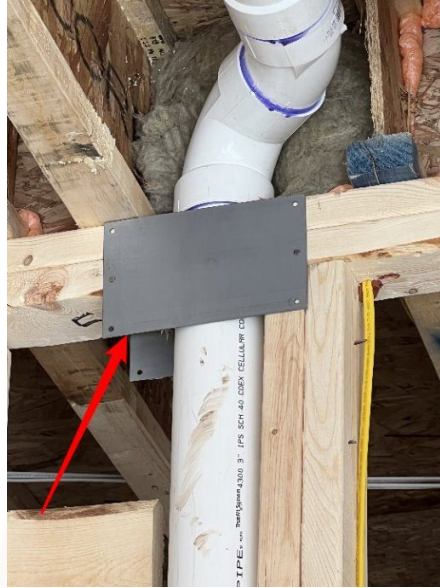
Rear wall of the garage

C missing metal ties were noted in the top plates of the two rear interior walls that separate the garage from the living space. Both these walls are loadbearing walls. When the top plate of a loadbearing wall has been cut more than 50% to allow access for pipes, wires or ducts a metal tie must be installed to add structural support to the wall. The strap must extend 6 inches past the opening on both sides and have eight 10d nails installed on each side. The metal shields that are in place are not adequate.

Steel plate not adequate

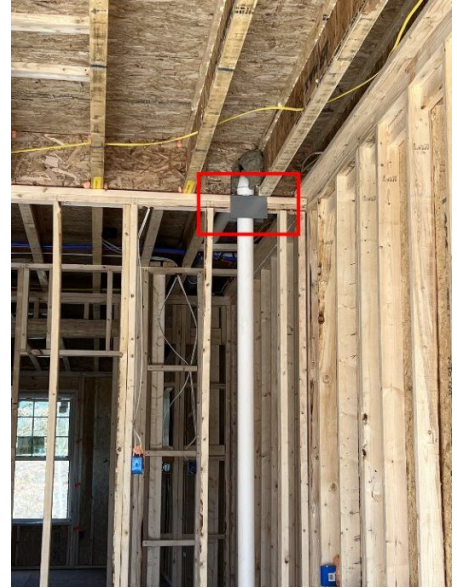
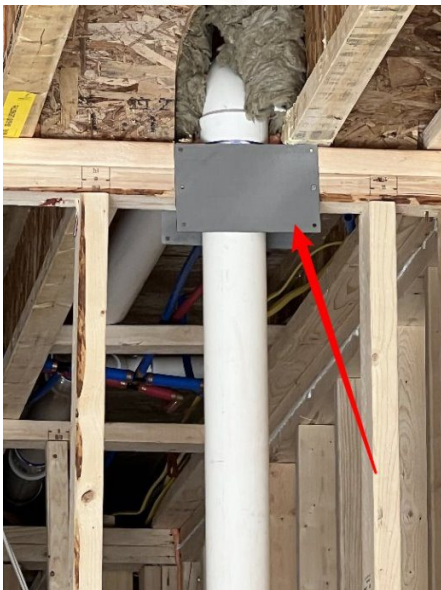
Rear wall of the garage

Steel plate not adequate

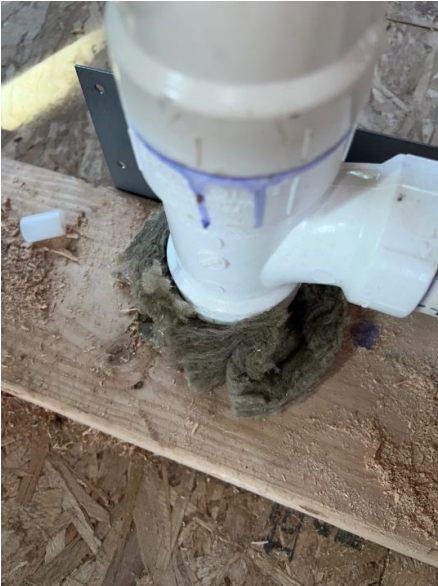
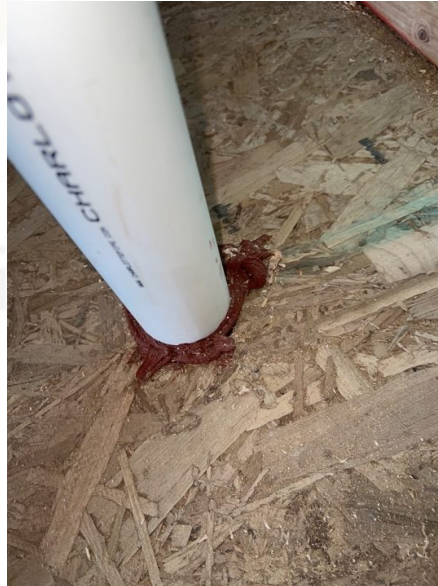
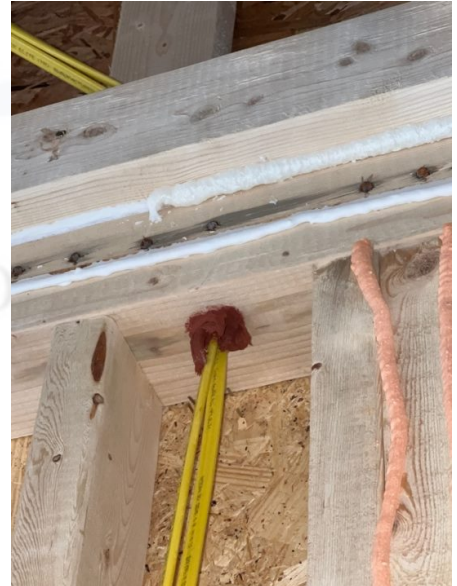
and ducts should be sealed where they pass through wall plates and floors. The sealing off of wall cavities and floors helps prevent the spread of fire. (R302.11)

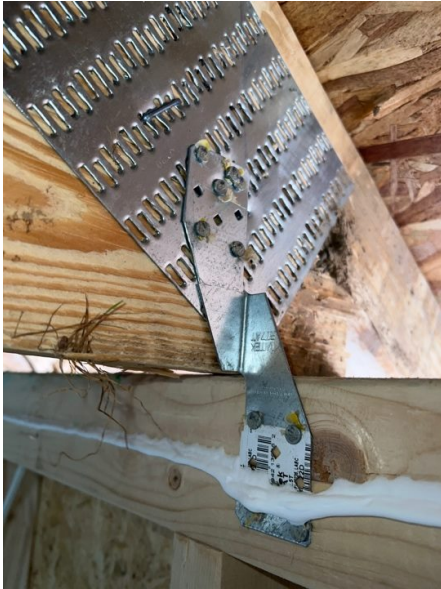
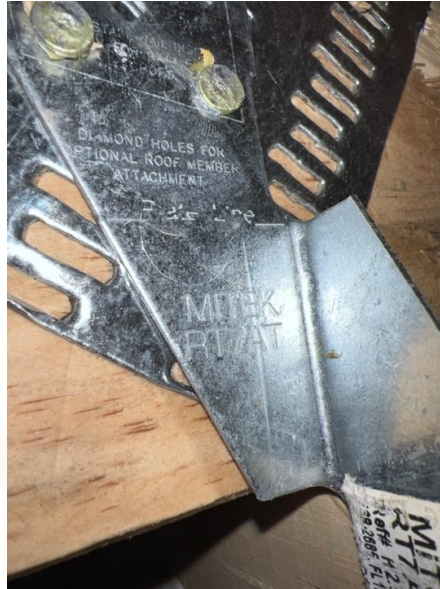
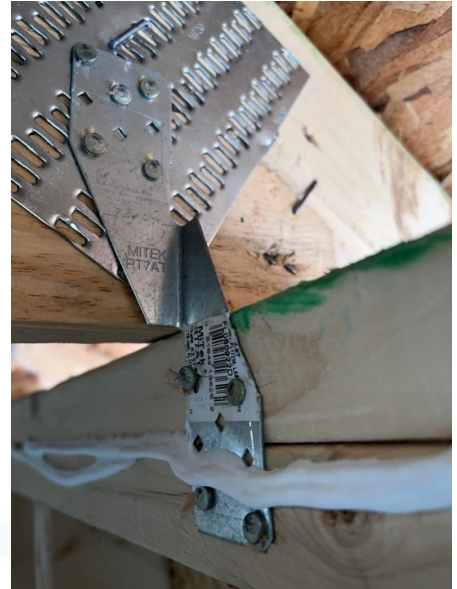
The roof trusses are strapped to the exterior walls to prevent up lift. .

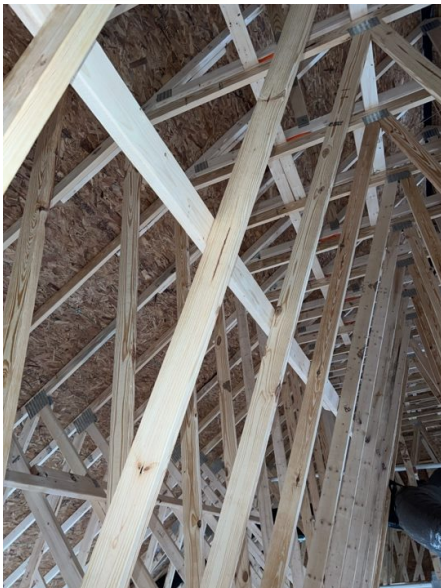
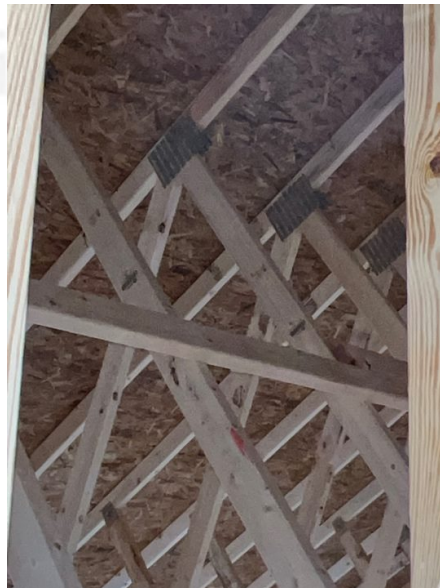
The roof trusses have been laterally braced to prevent rotation.

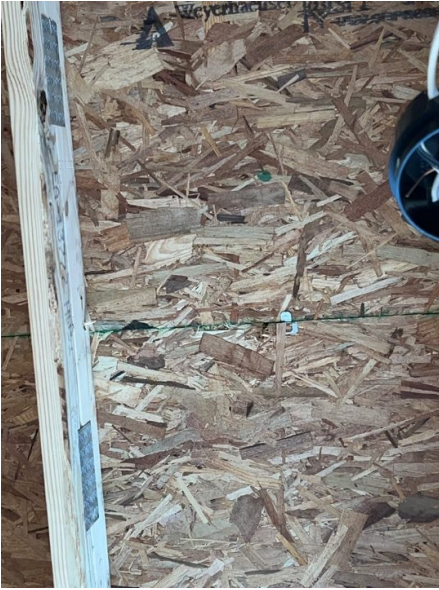
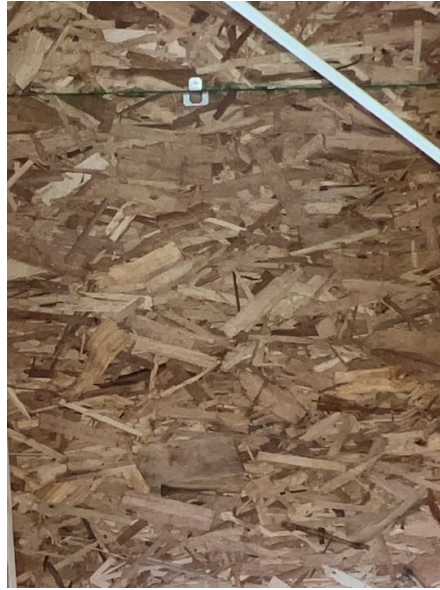
The roof sheathing is spaced to allowable in table R503.2.1(1). The sheathing was free of visible defects.

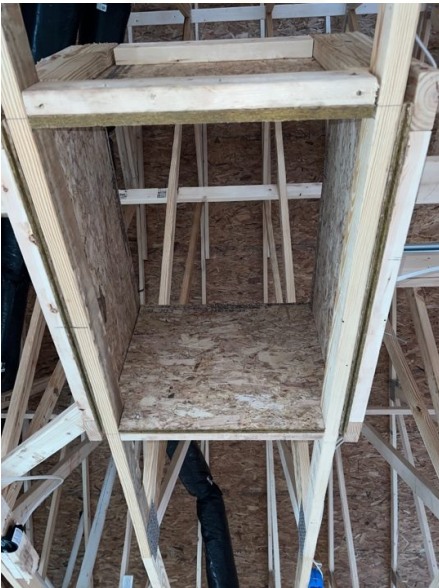
Back left bedroom

The attic access is in the back left second bedroom and meets the required minimum size, 22 inches by 30 inches. (R807.1)

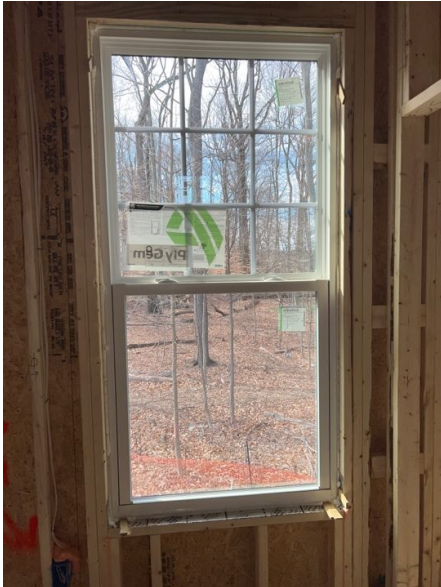
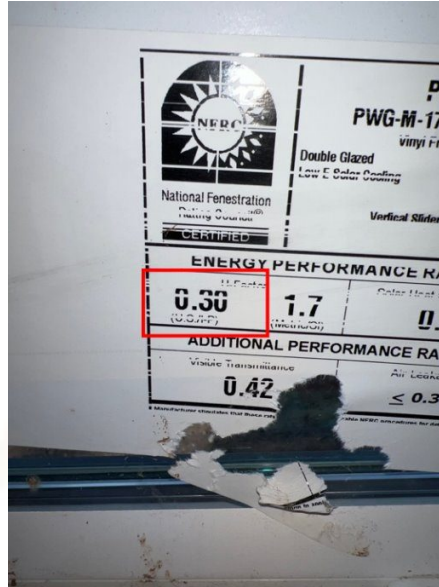
All the windows meet the required U factor rating. There is tempered glass in all the required locations.

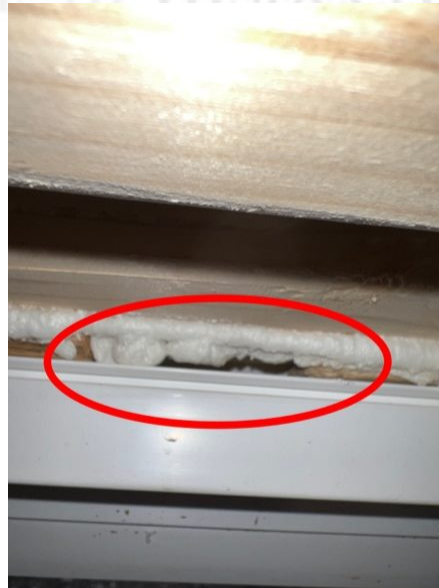
basement window

C Missing and poorly applied foam insulation was noted around many of the windows. Large gaps can be seen between the windows and the framing. These gaps should be filled with foam to prevent air leakage.

C 8: Missing and poorly applied foam insulation was noted around many of the windows. Large gaps can be seen between the windows and the framing. These gaps should be filled with foam to prevent air leakage.

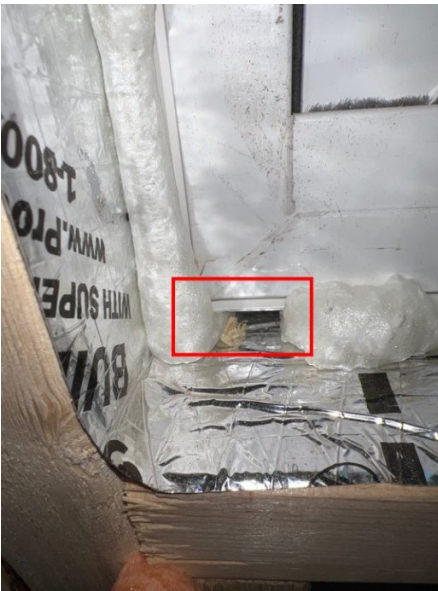
first floor rear bedroom

The building thermal envelope shall be durably sealed to limit infiltration. The sealing methods between dissimilar materials shall allow for differential expansion and contraction. The following shall be caulked, gasketed, weatherstripped or otherwise sealed with an air barrier material, suitable film or solid material.

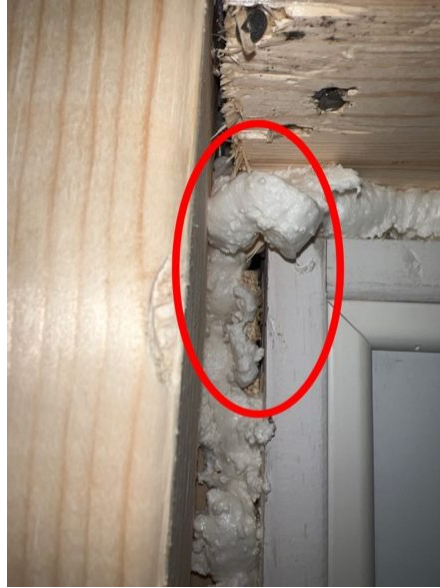
basement door

C Missing and poorly applied foam insulation was noted around the basement door. Large gaps can be seen between the door and the framing. These gaps should be filled with foam to prevent air leakage.

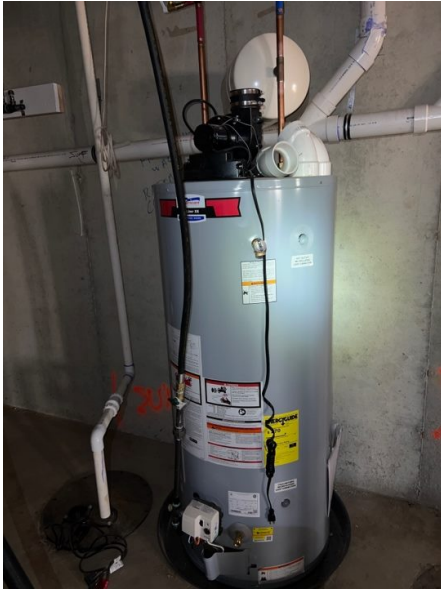
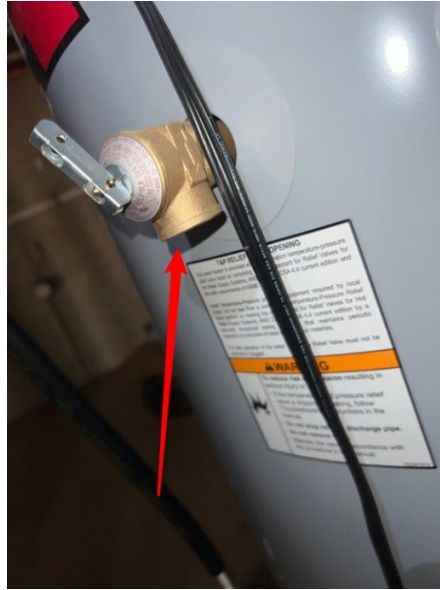
The water heater is in place. The flue pipe, T&P valve extension, and overflow pan drain line still need to be installed.

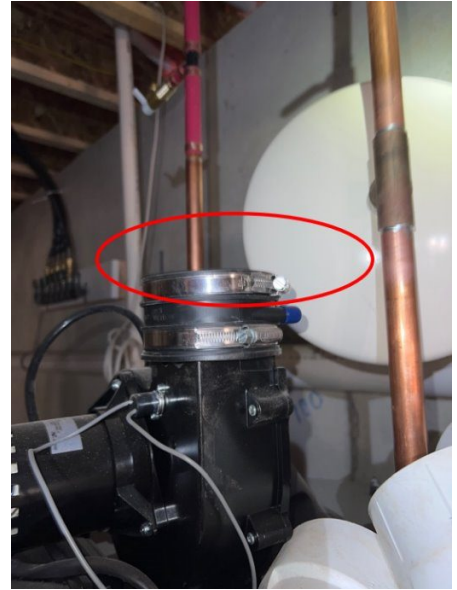
extension pipe needed

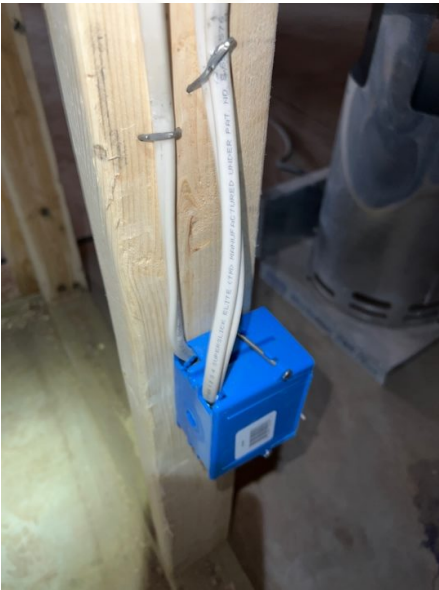
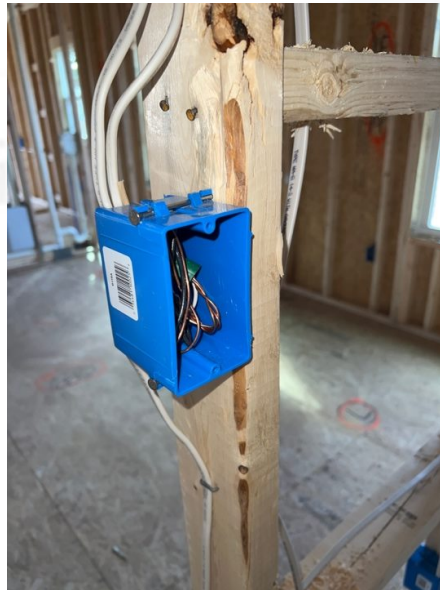
Receptacle box and switch depths are correct.

The electrical cables were supported within 8 inches of the boxes.

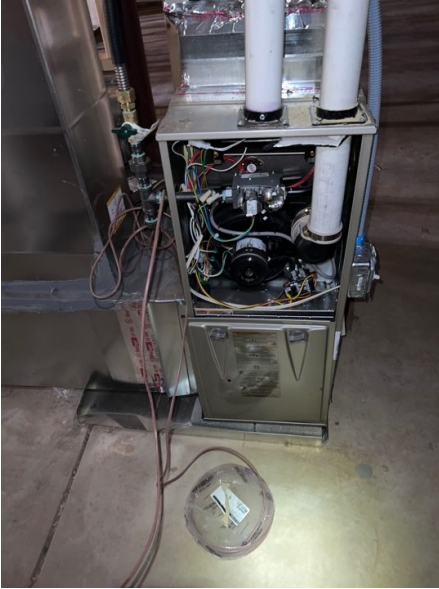
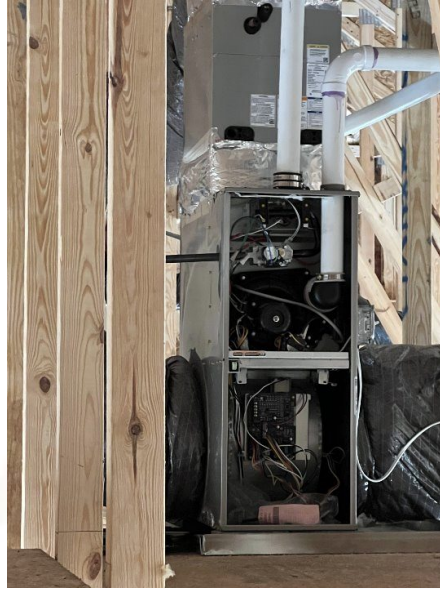
The gas furnaces and air conditioning evaporator coils were in place. There is an overflow pan under each HVAC system.

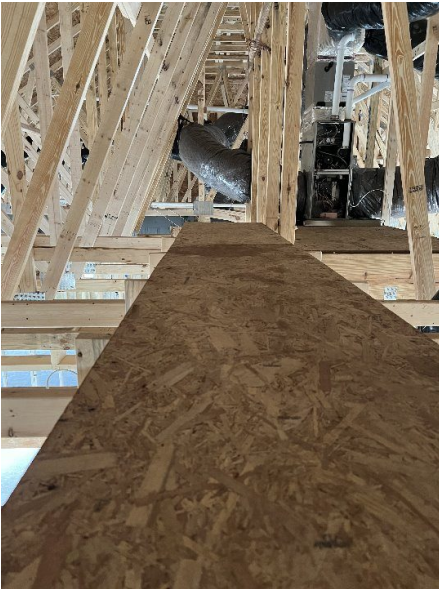
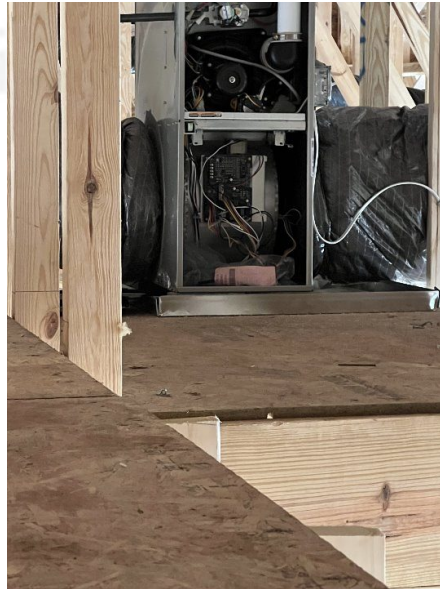
The HVAC system for the second floor has been installed in the attic. There is a walking surface to the HVAC system. There is a working surface in front of the equipment.

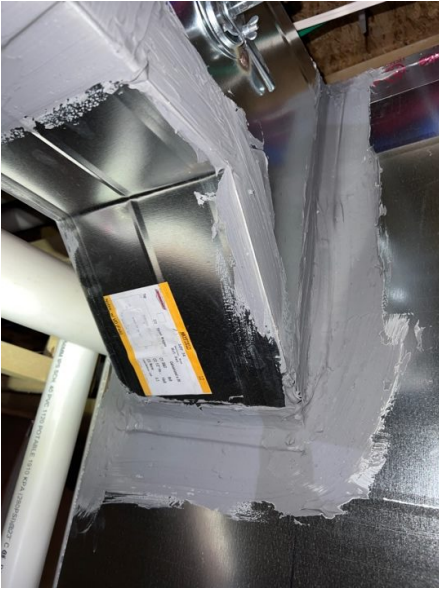
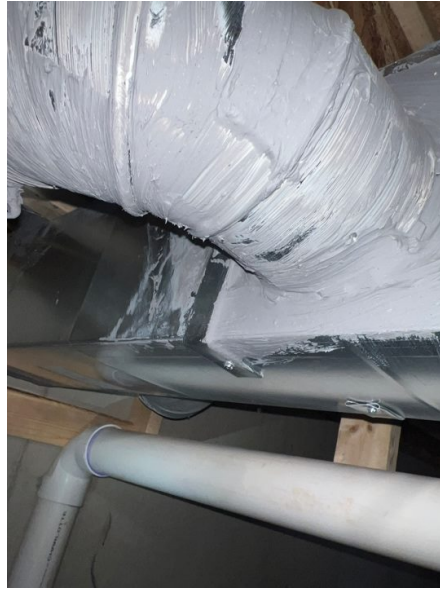
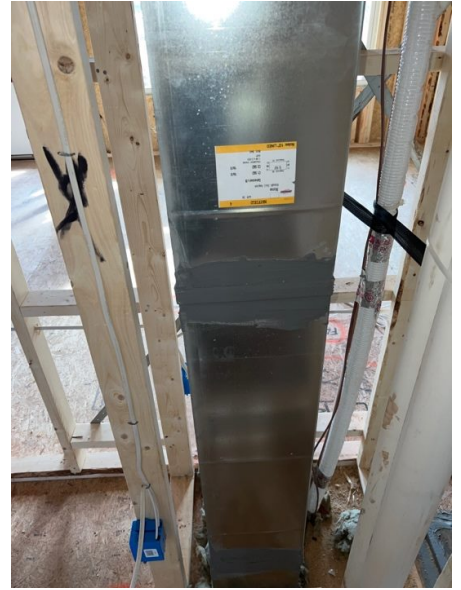
The seams on the HVAC duct work have been well sealed, good. (M1601.4.1)
