100 Nice Street Phoenixville, PA 19460  
**MOLD & MOISTURE Report**

**Thursday, August 31, 2023**

100 Nice Street  
Phoenixville, PA 19460

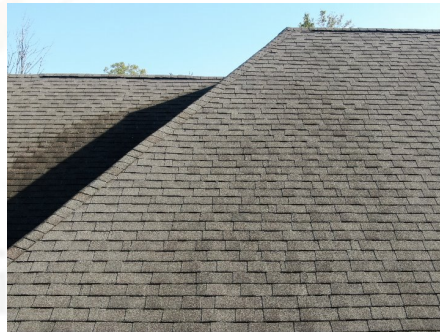
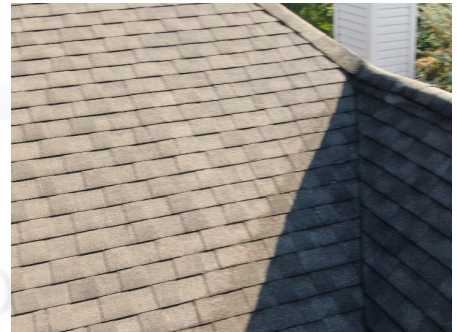
**IMP** A small hole was noted at the ridge cap at the front of the house. A qualified roof should repair the damaged ridge cap to prevent the possibility of water intrusion.

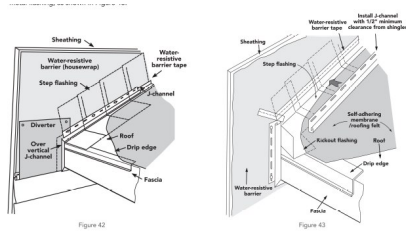
Option 1 & 2 for kick out or diverter flashing

**IMP** Missing kick-out or diverter flashings were noted at the front of the house in two locations. The flashing detail called a kick-out is needed at locations where a roof ends on an exterior wall. The kick-out prevents water from running behind the siding and from streaking down the front of the siding by diverting it from the roof surface into the gutter. Proper flashings reduce the chances of water intrusion. A qualified siding contractor should install the kick-out flashings.

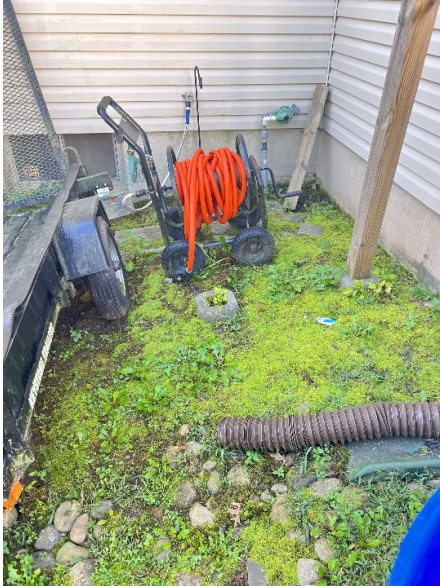
Left side of house

**IMP** Poor drainage (grading) was noted near the foundation on the left side. The ground slopes towards the house.

The soil around the home should be graded to take water away from the foundation. In order for drainage to be effective, the landscaping must be configured so that the yard is sloped away from the foundation at a pitch of no less than 6 inches in the first ten feet. Failure to maintain sufficient drainage will cause rain and surface runoff to drain toward the foundation where it can seep into basements and crawlspaces.

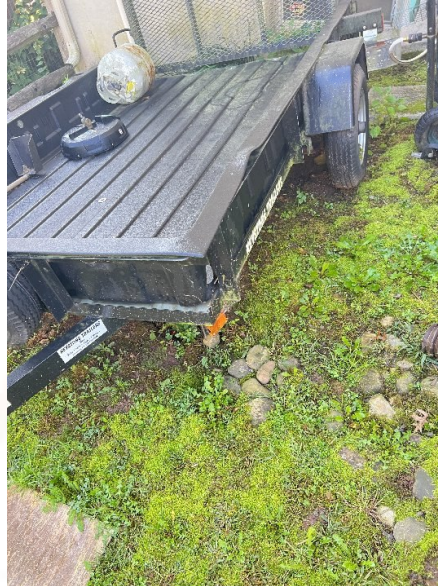
Hard to see with trailer here but the ground slopes towards the house

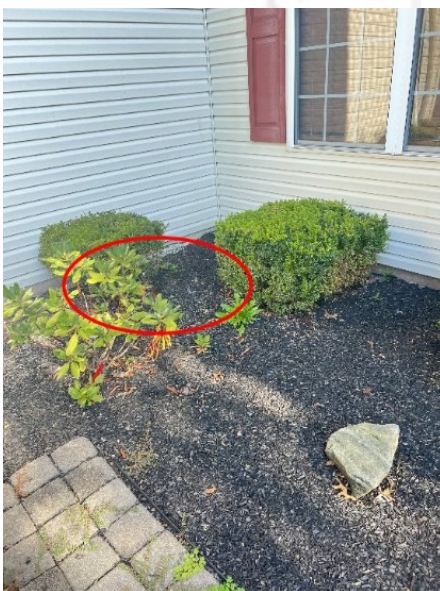
Front of house

Poor drainage (grading) was noted near the foundation at the front of the house. There is a slump (low area).

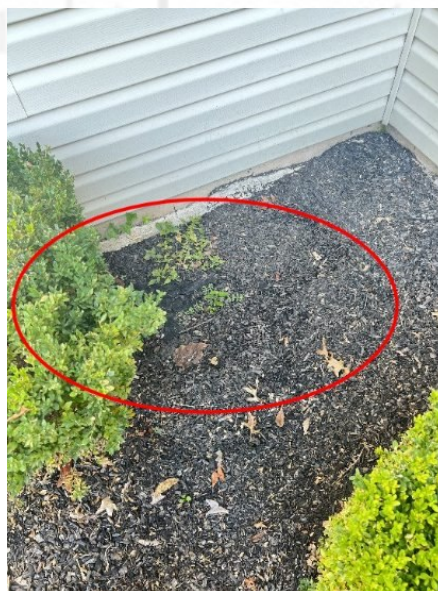
Low/slumped area

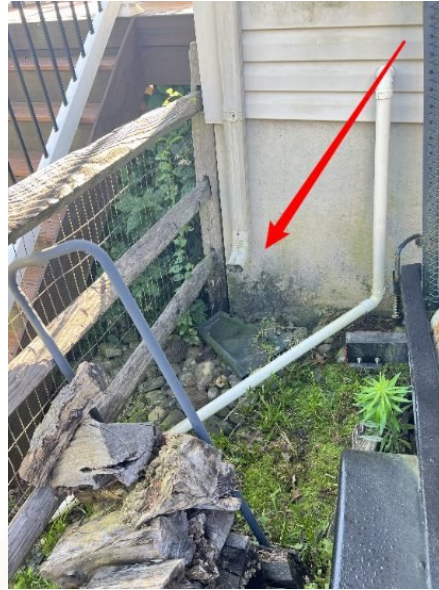
Back left corner

**IMP** Downspouts were noted draining too close to the house at the front of the house to the left of the front entrance, at the back left corner, and at the right front corner where there is a broken drain pipe. The downspout should be extended to take water further away from the house. Water should not be allowed to drain right next to the foundations. Ideally, the downspout should extend 4 to 6 feet away from the house. A qualified person should extend the spout.

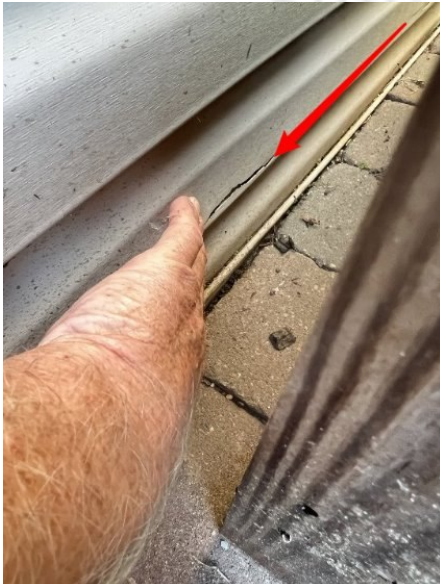
**IMP** Damaged siding was noted to the right of the basement exterior door. Damaged siding can allow water intrusion into the exterior walls. A qualified siding contractor should repair as needed.

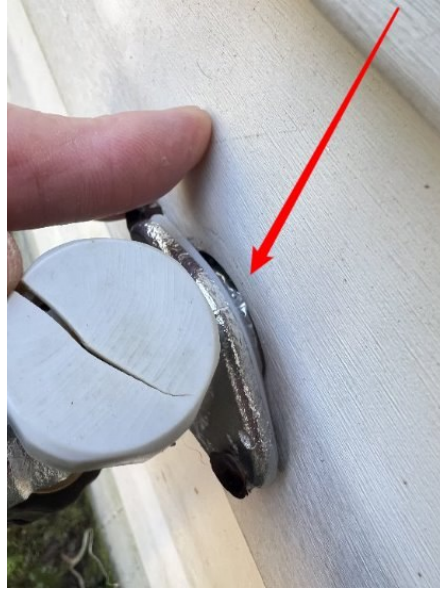
Exterior spigot left side of house

**IMP** Unsealed exterior wall penetrations were noted.

All pipes, vents, cables, and other wall penetrations should be sealed with exterior-grade caulking to prevent water intrusion and energy loss.

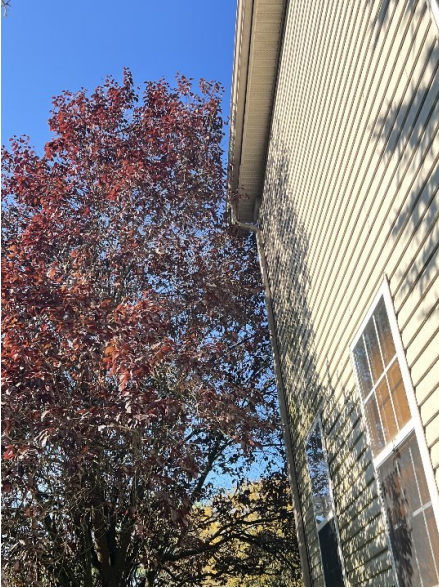
**IMP** Shrubs and trees were noted growing on the side of the house. Shrubs and tree limbs should not be leaning on or touching the house. Plants on the side of a house can hold moisture against the house for extended periods of time. This can contribute to decay and water intrusion. Pruning of the shrubs and trees around the house is recommended.

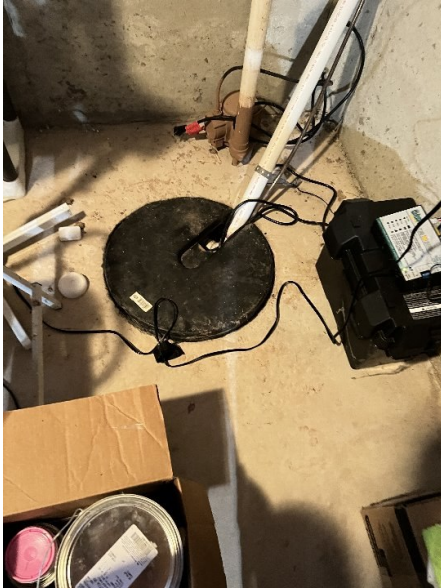
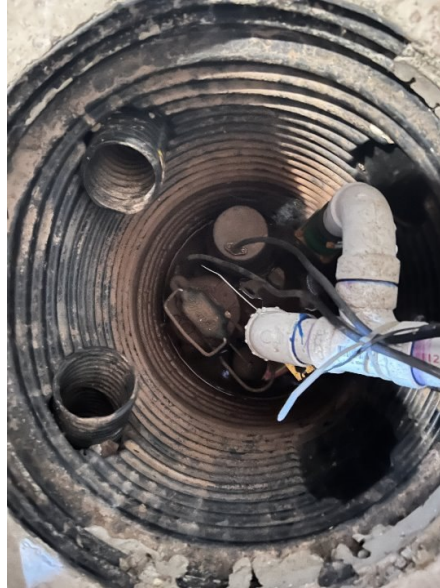
There is a sump pump in the basement.  
There was no water in the sump pump well at the time of the inspection.  
The sump pump functioned when tested.

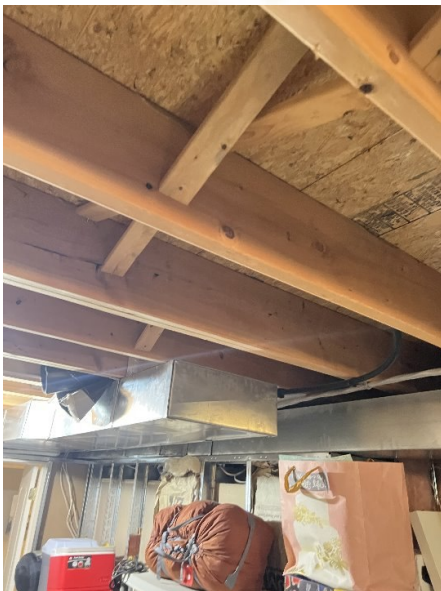
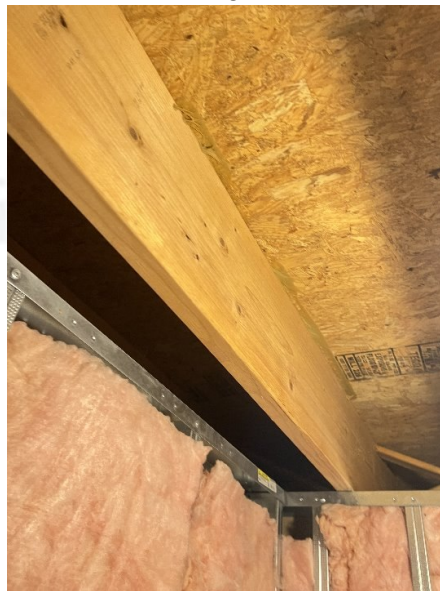
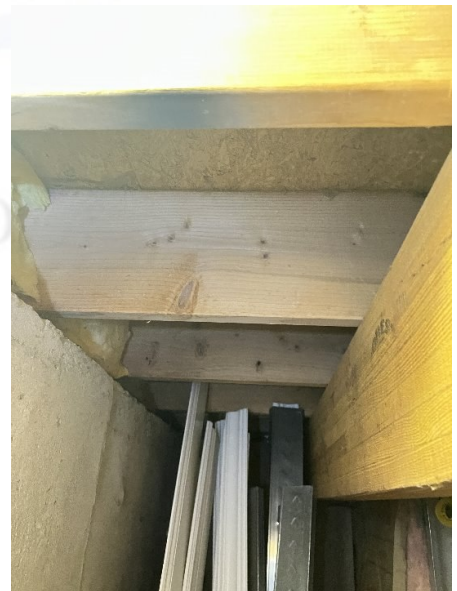
There were no water stains visible on the floor framing in the accessible area.

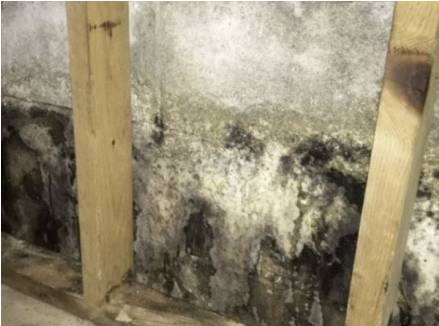
**MR** Mold or mold-like growth was noted on the backside of the finished wall in the basement office. Mold or mold-like growth was noted on the back side of the sheetrock. The owner reported that the discolored area of sheetrock is going to be removed. A sample of the discolored sheetrock was not taken.

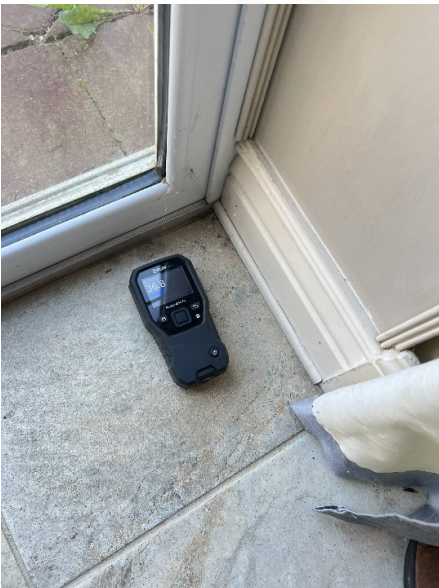
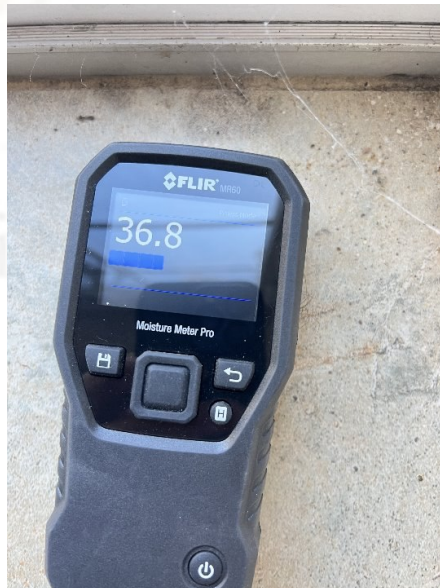
The flooring near the exterior door was probed with a moisture meter. The meter did not detect elevated levels of moisture.

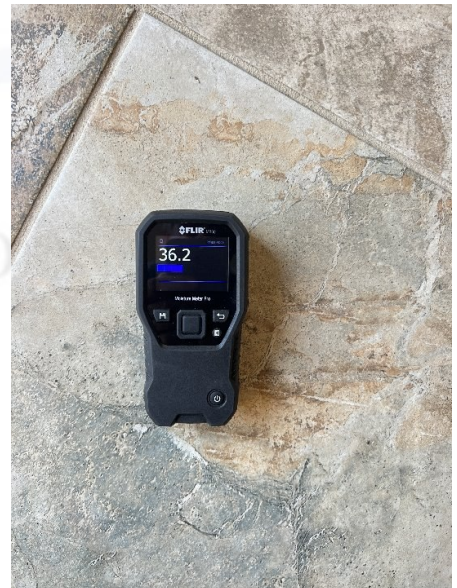
Center of floor reading

The readings near the door match the readings at the center of the floor.

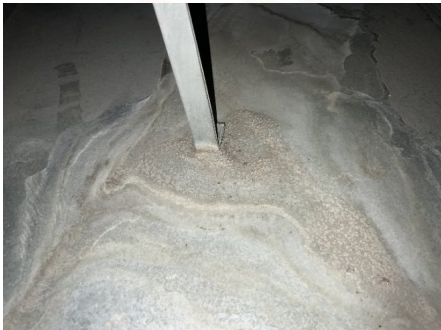
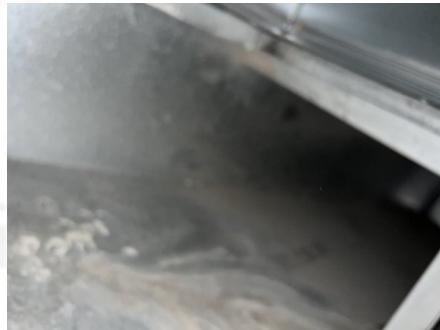
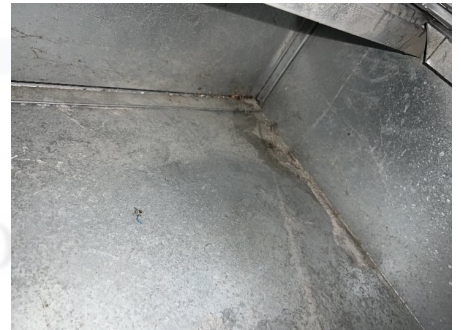
**IMP** Water stains were noted on the ductwork directly under the HVAC system. Condensation leaks or a leak from the humidifier could contribute to mold growth in the HVAC system.

I recommend cleaning the ductwork under the HVAC system to remove the water stains. The system should be monitored during use to confirm that there are no active leaks.

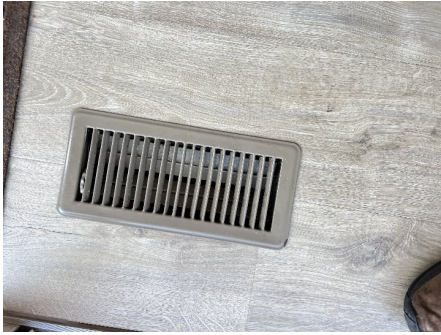
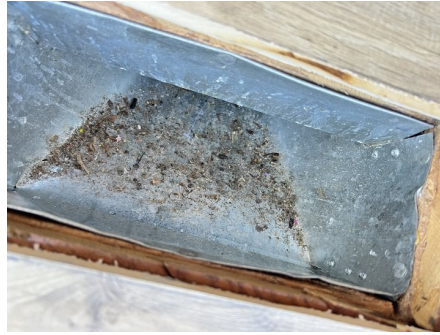
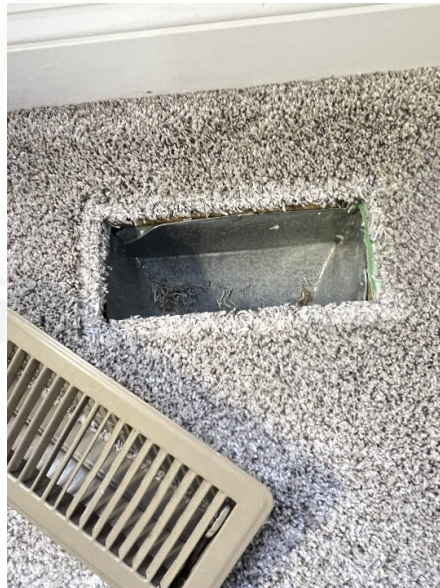
**IMP** A representative number of register covers were removed for inspection. Debris was just inside the ductwork. Dust, dirt, sawdust, and other debris can be a food source for mold. I recommend removing and cleaning under the HVAC registers.

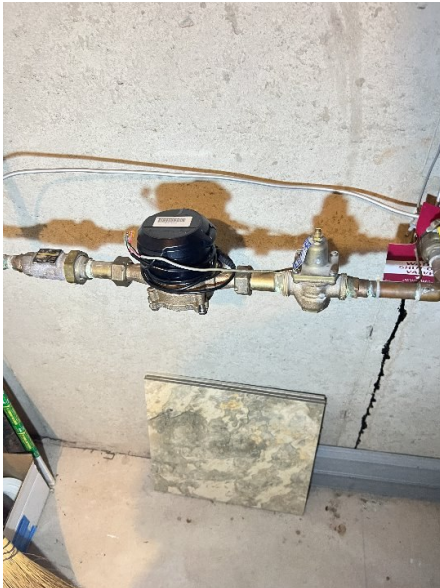
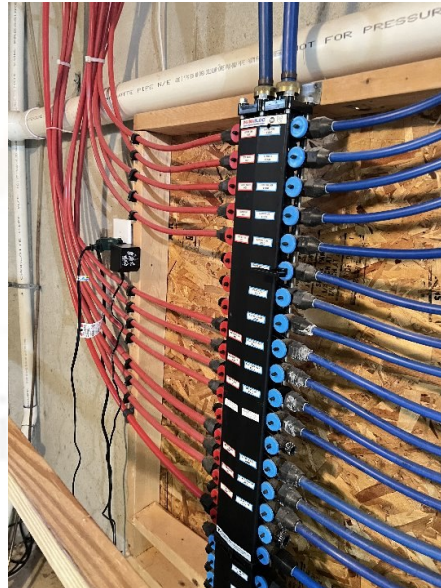
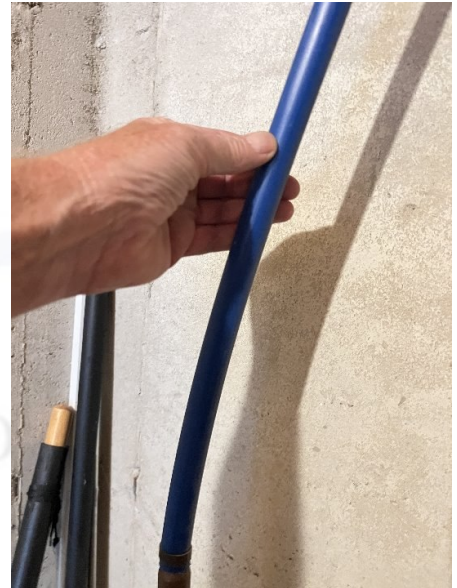
No visible water line leaks were noted at the time of the inspection.

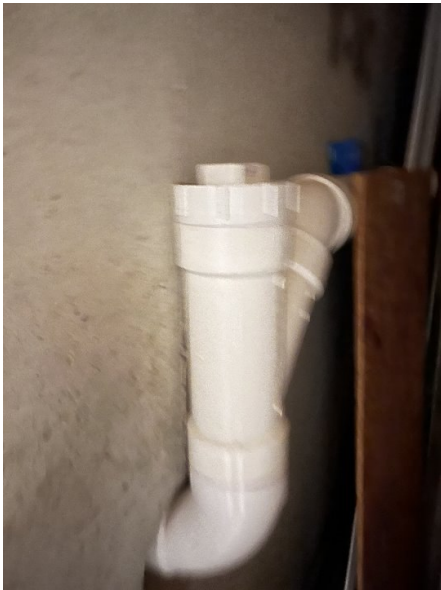
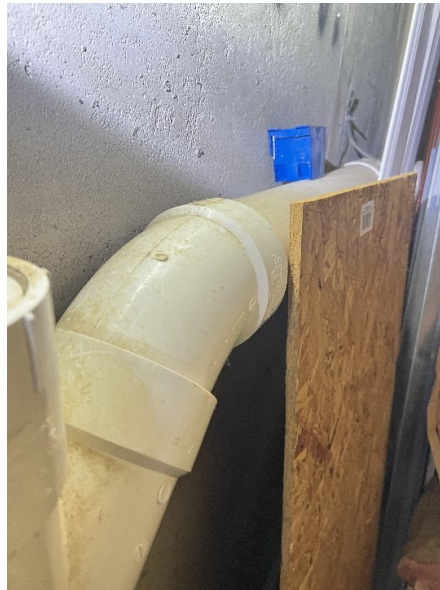
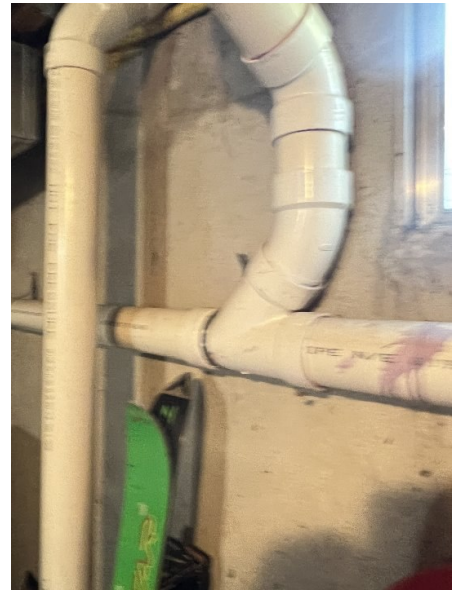
No visible waistline leaks were noted at the time of the inspection.

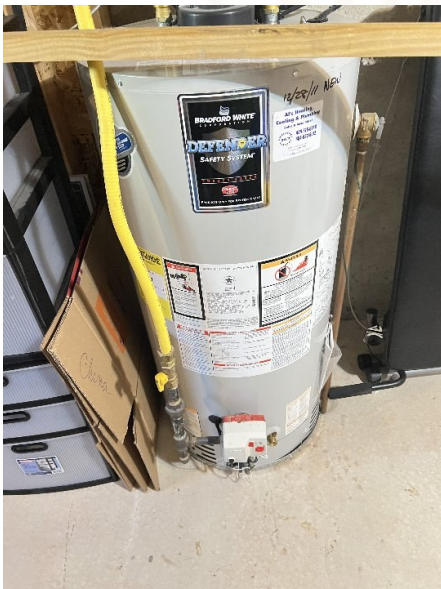
No leaks were noted at the water heater at the time of the inspection.

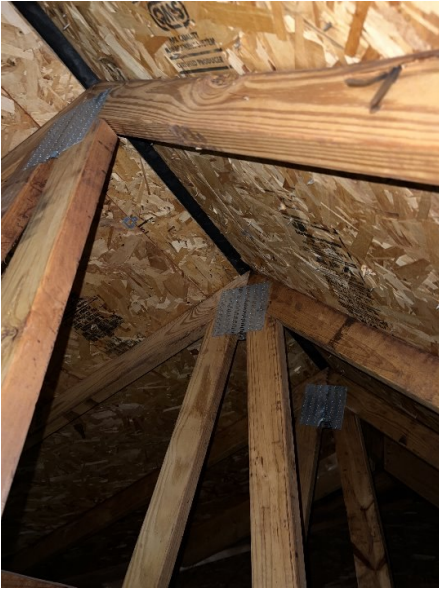
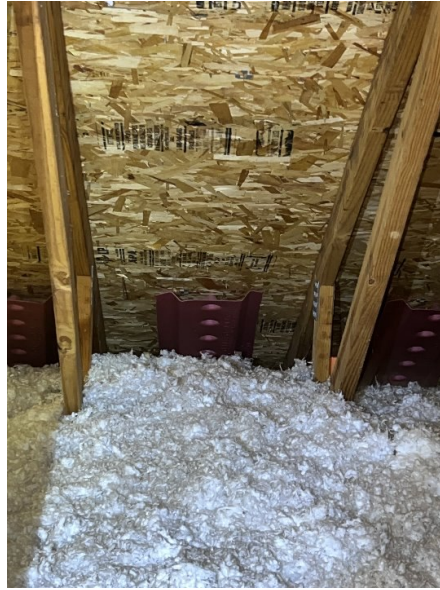
The roof is well-vented with both ridge and soffit vents.

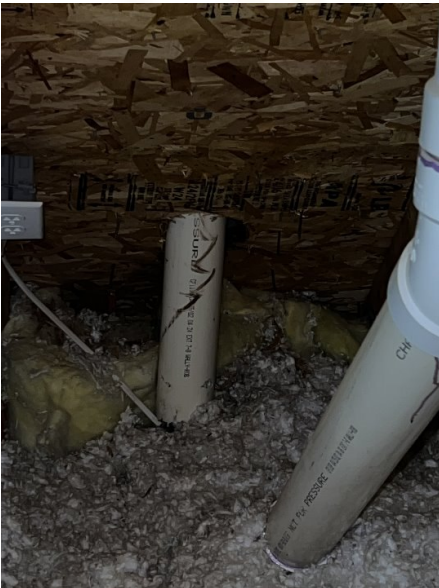
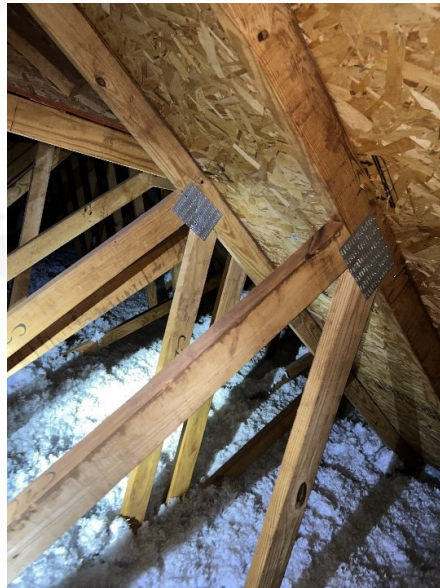
The attic floor area was insulated with approximately 10 to 12 inches of insulation. Providing an approximate R-value of R30, good.

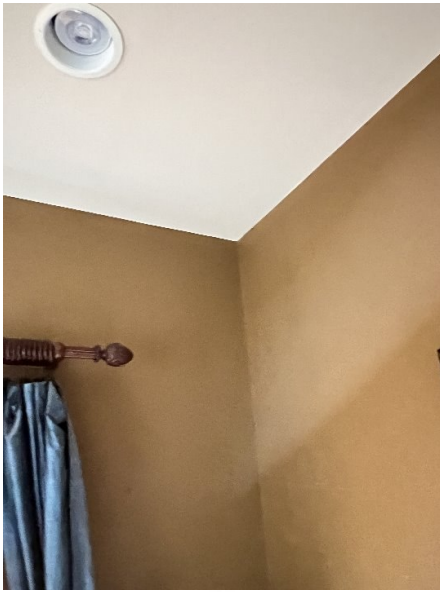
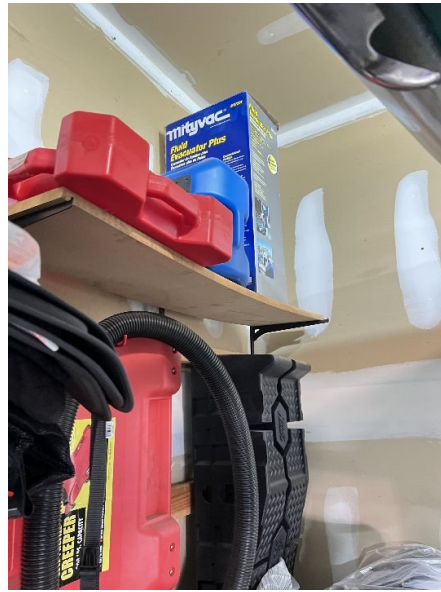
No visible evidence of water stains or mold in the accessible areas.

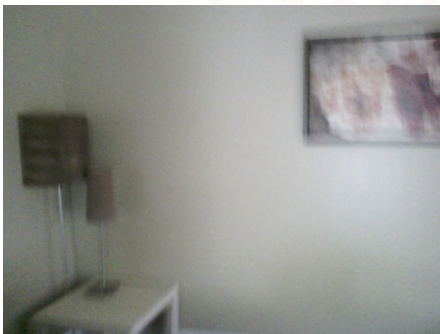
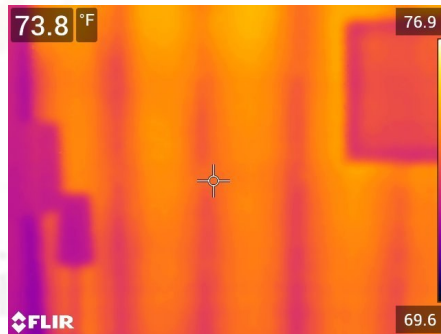
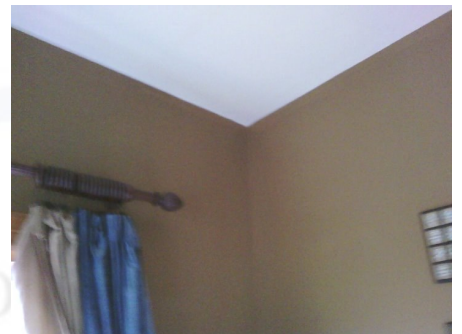
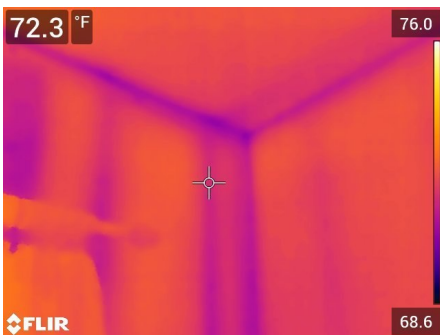
The walls were scanned with an infrared camera to check for temperature differences on walls that could indicate water intrusion.

No anomalies were noted.

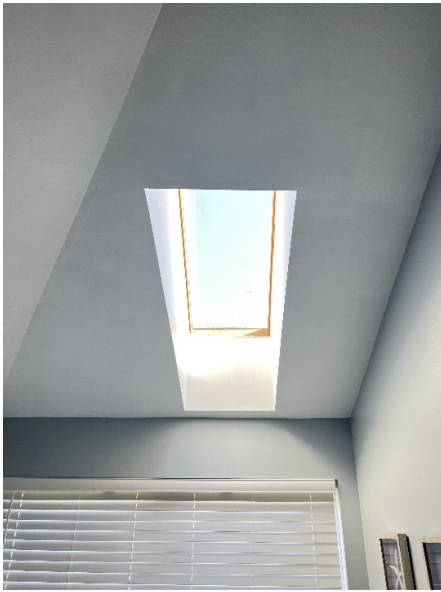
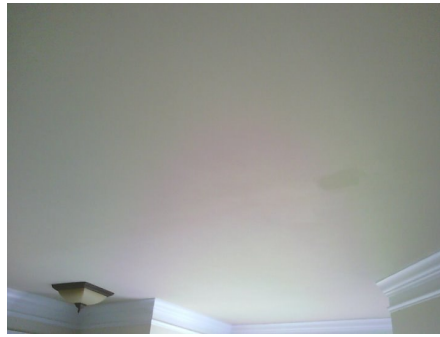
No visible evidence of water stains or mold in the accessible areas.

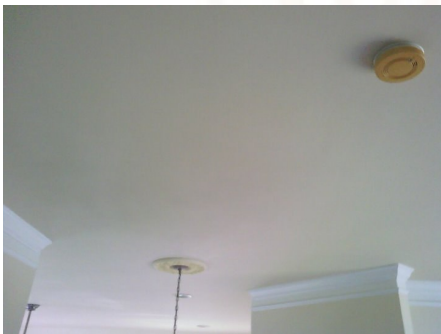
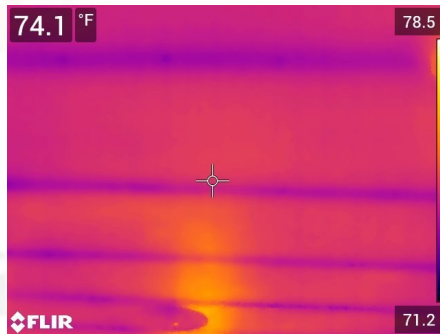
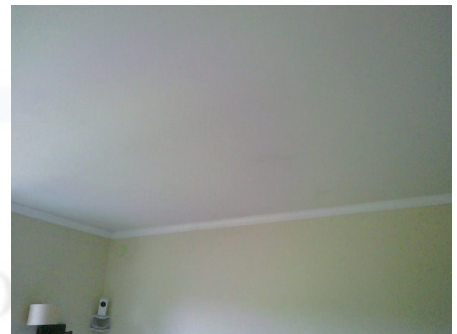
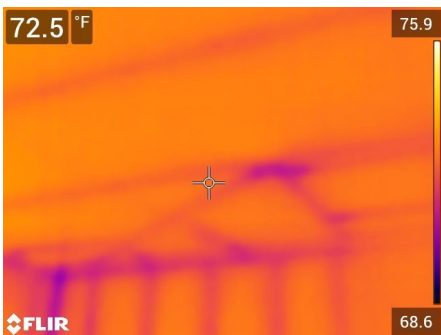
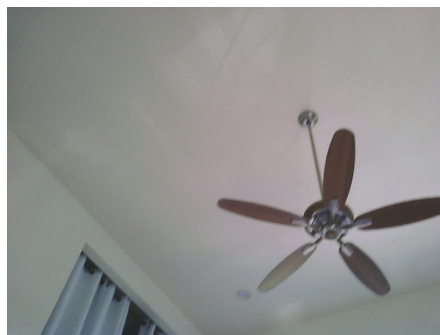
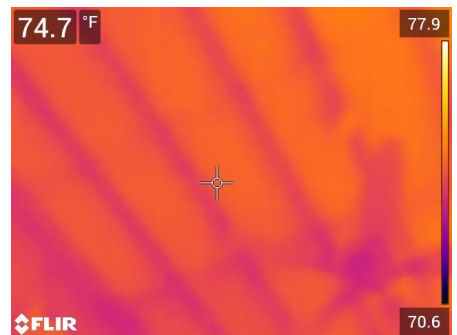
The ceilings were scanned with an infrared camera to check for temperature differences on ceilings that could indicate water intrusion. No anomalies were noted.

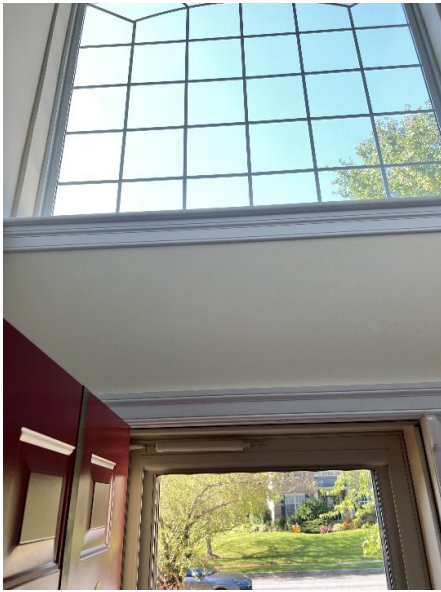
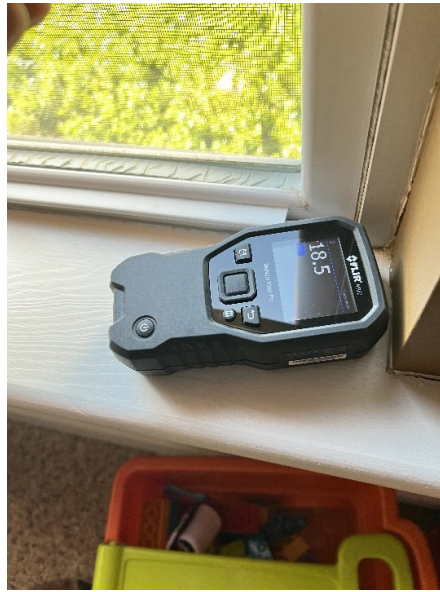
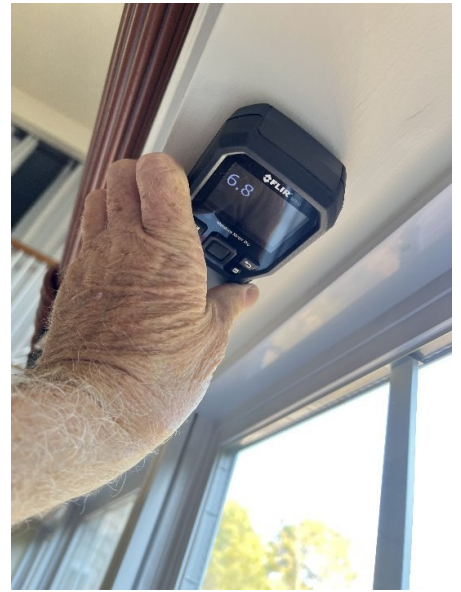
No visible evidence of water intrusion or mold growth was noted at the window.

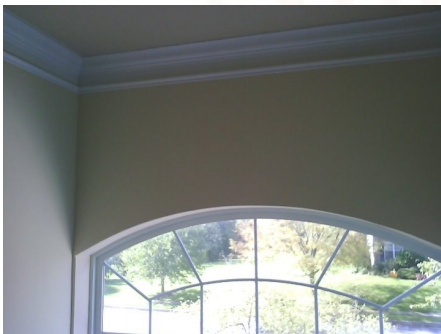
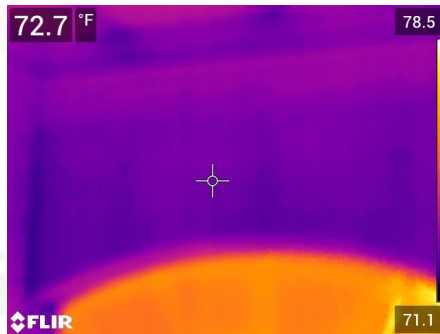
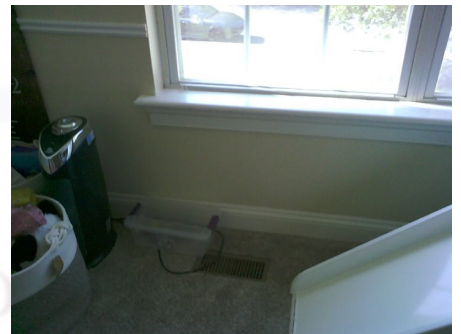
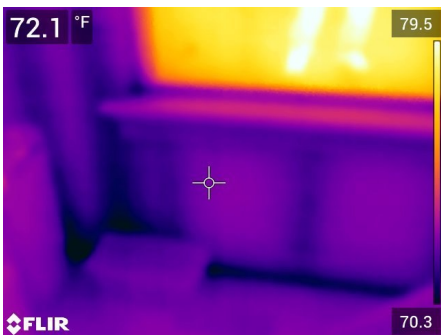
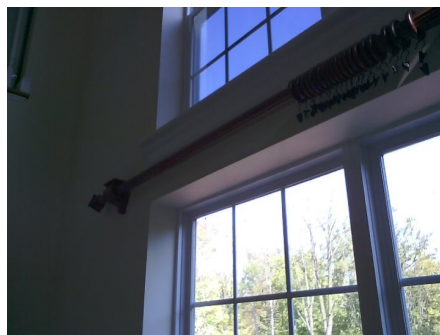
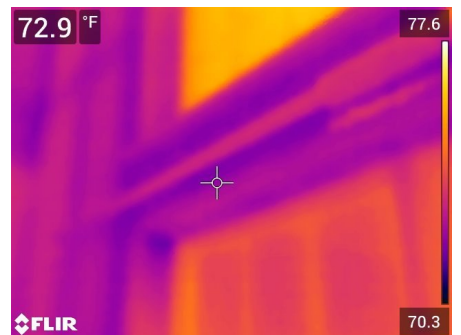
The walls around the windows were scanned with an infrared camera to check for temperature differences near the windows that could indicate water intrusion. No anomalies were noted.

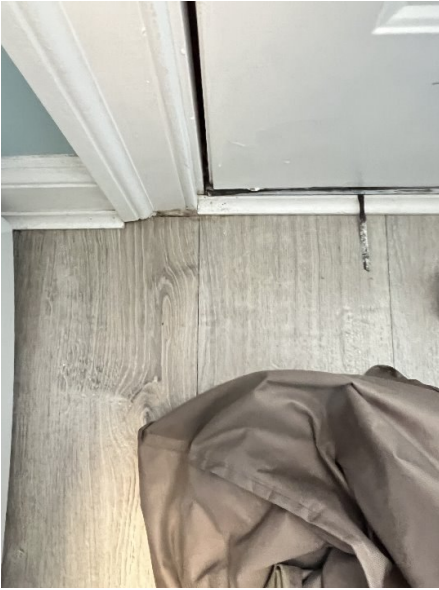
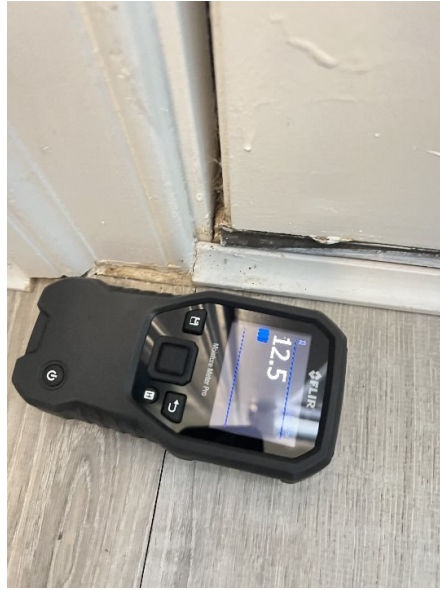
No visible evidence of water intrusion or mold growth was noted at the exterior doors.

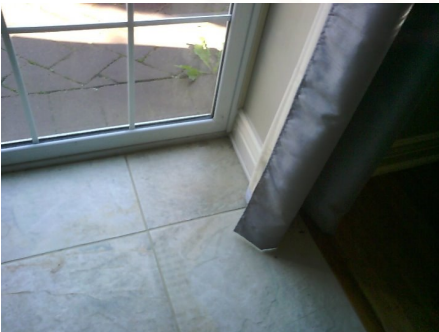
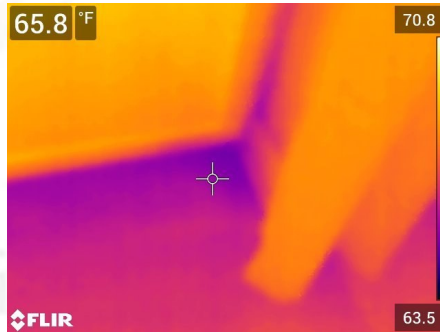
The floors near the exterior doors were scanned with an infrared camera to check for temperature differences on the floors that could indicate water intrusion. No anomalies were noted.

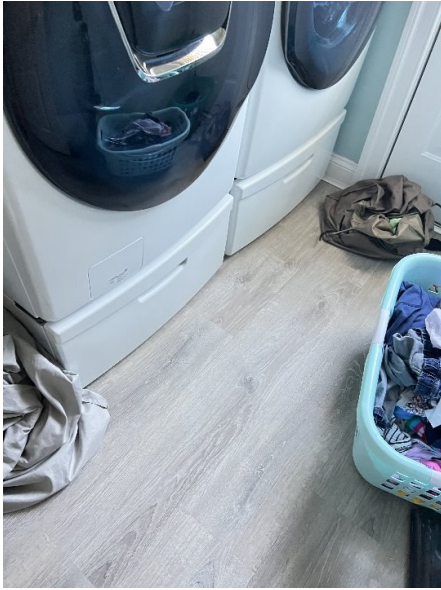
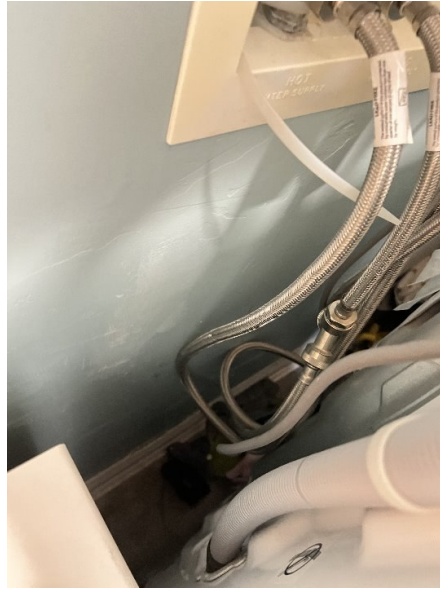
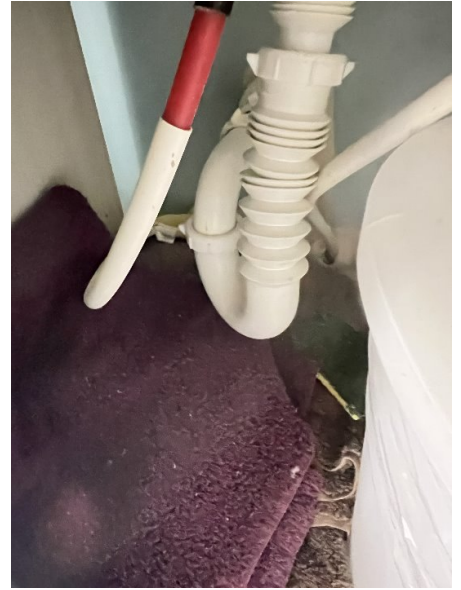
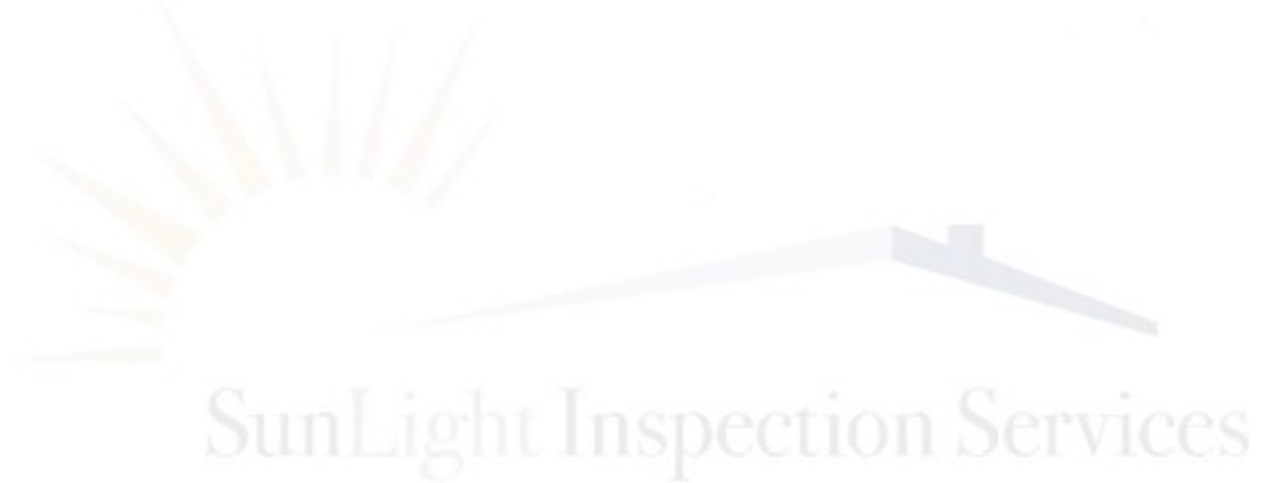
No signs of water stains or mold growth were noted in the laundry area.

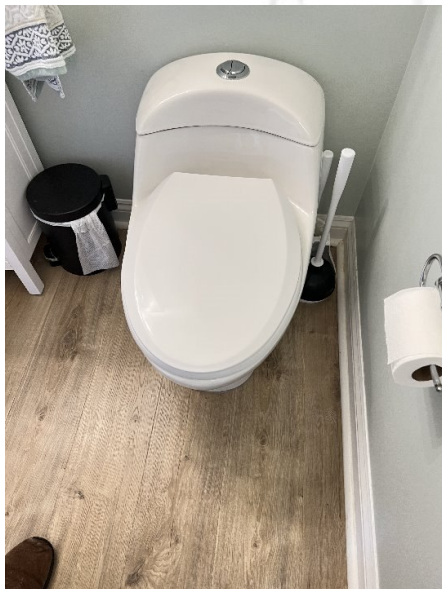
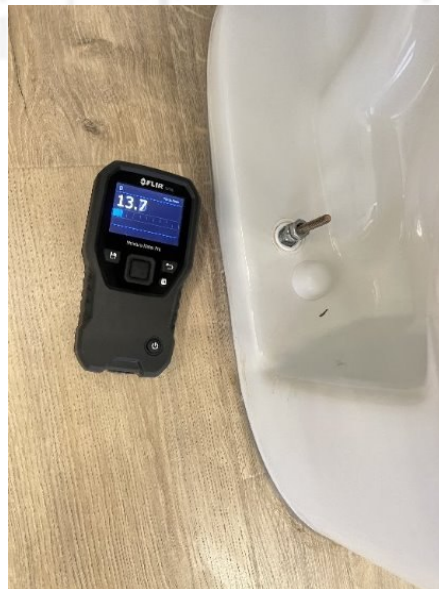
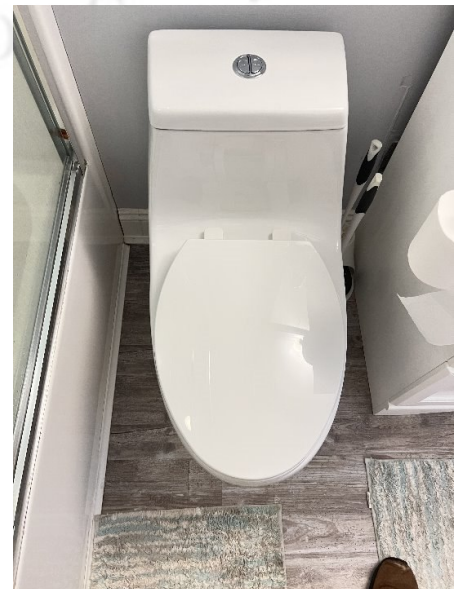
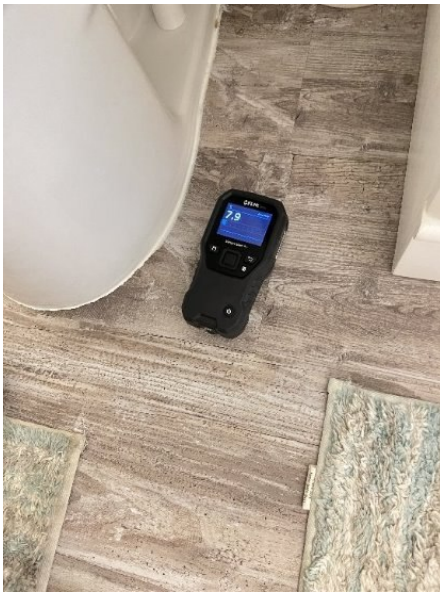
The floors around the toilets were probed with a moisture meter. The meter did not detect elevated levels of moisture near the toilets.

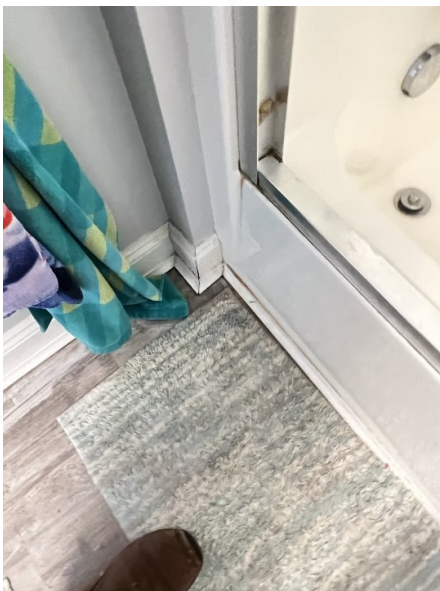
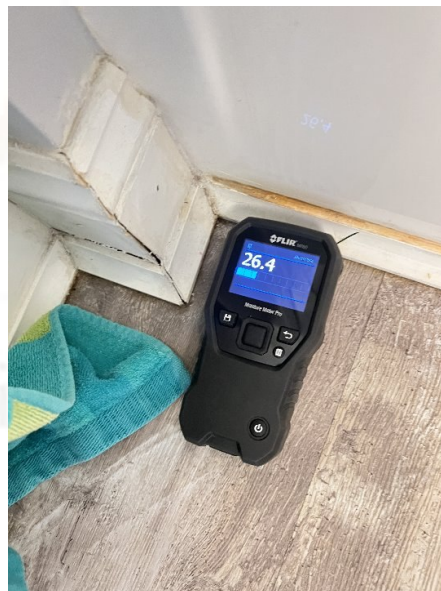
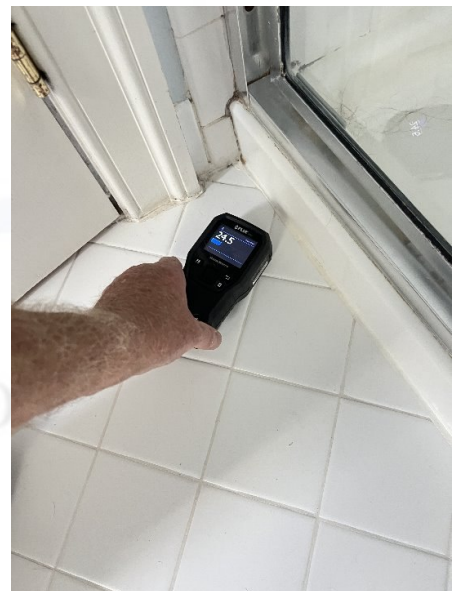
The floors around the tub/showers were probed with a moisture meter. The meter did not detect elevated levels of moisture.

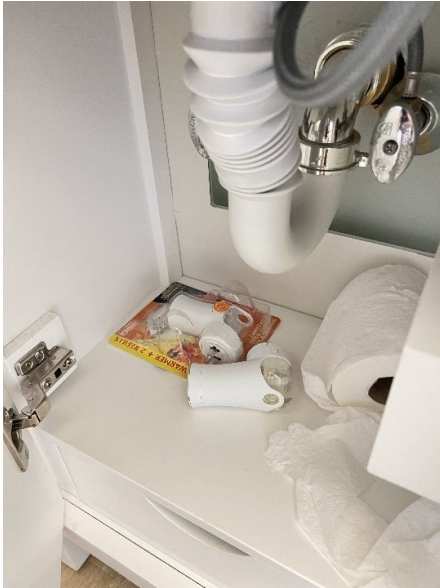
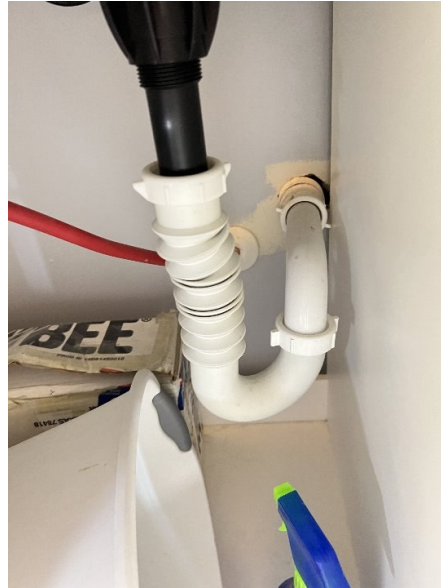
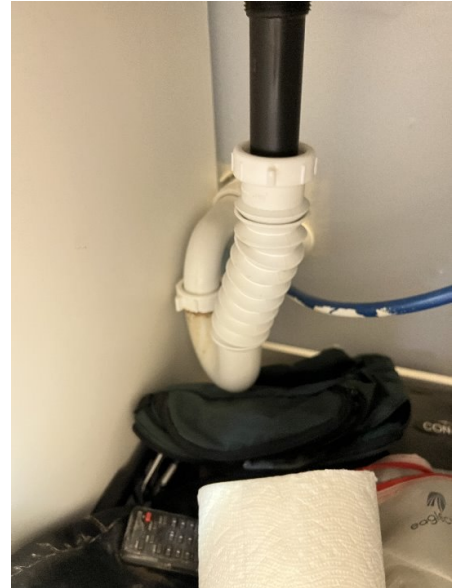
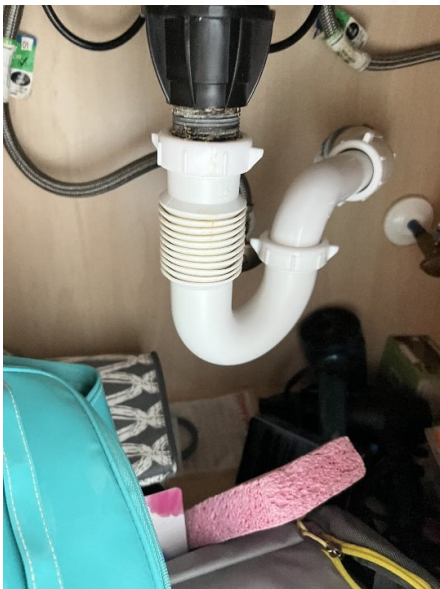
No leaks were found at the bathroom sinks. No water stains or mold growth were noted in the sink cabinets

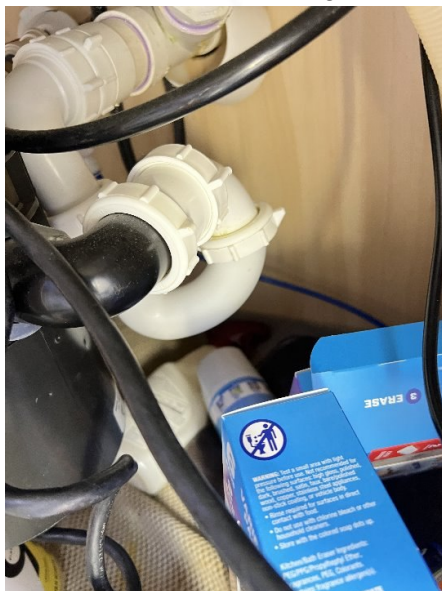
No visible leaks were noted under the kitchen sink.

No water stains or mold growth were noted in the sink cabinets

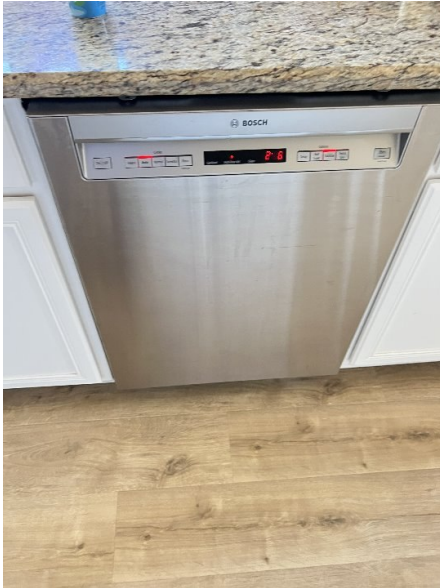
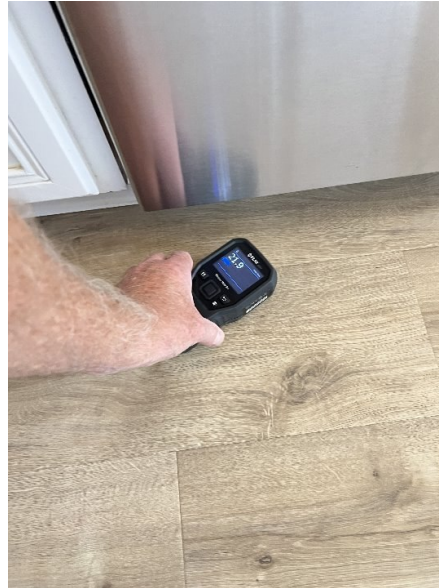
The floor near the dishwasher was proper with a moisture meter. The meter did not detect elevated levels of moisture.
