SUNLIGHT INSPECTION SERVICE

123 New Home Rd. Phoenixville, PA  
REPORT# 23032501D

**REVISED** Inspector  
Dan Keogh  
InterNACHI 13121612

The following numbered and attached pages are your pre-drywall inspection report. The report includes photographs, comments, and the Standards of Practice. This inspection was performed in accordance with the current Standards of Practice for Residential Pre-drywall Inspections of the American Society of Home Inspectors. The Standards contain certain and very important limitations, exceptions, and exclusions to the inspection. A copy is available prior to, during, and after the inspection, and it is part of the report. All components designated in the ASHI standards of practices, except for limitations that may be noted in the report, will be inspected. The inspection is for the most part a limited visual inspection only. A representative sampling of the building components is viewed in areas that are accessible at the time of the inspection. No destructive testing or dismantling of components is performed. Be sure to keep your signed copy of the home inspection agreement along with the report for future reference.

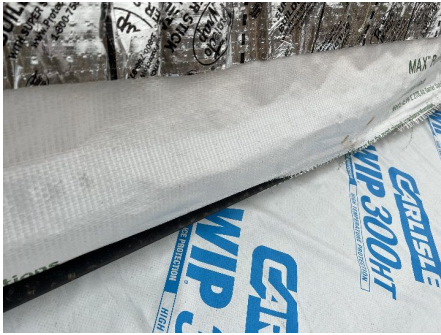
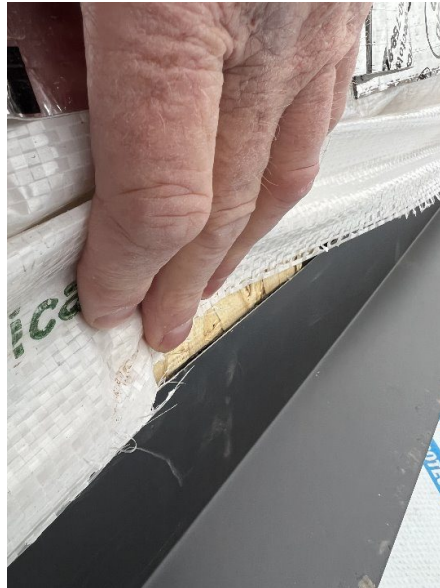
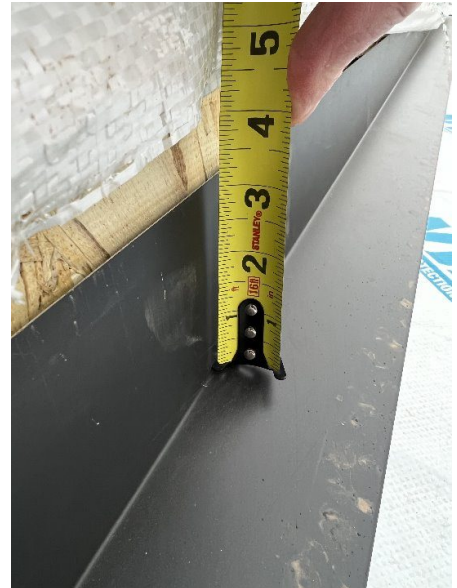
**C** The side wall flashing does not extend far enough up the wall. Sidewall flashing should extend up the exterior wall a minimum of 4 inches and be behind the house wrap.

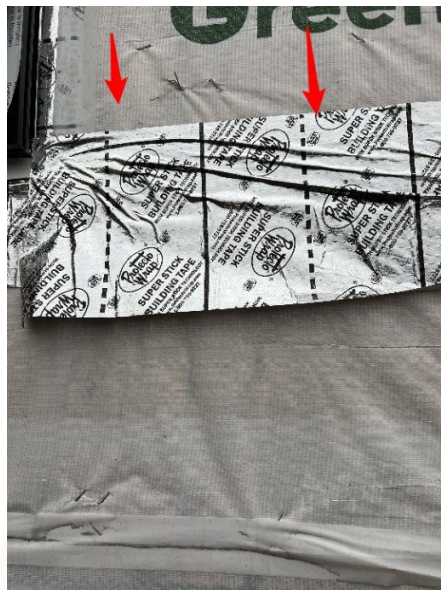
**M** It is unclear what the builder's intention is with the flashing tape installed at the approximate height of where the stone veneer will terminate on the front walls. The flashing tape has been installed in reverse lap flat fashion. Metal coping flashing will be installed over the top edge of the stone veneer. The metal coping flashing should be installed **behind the house wrap that comes down behind the vinyl siding.** I recommend discussing this with the builder to verify what his intentions are in making this transaction watertight.

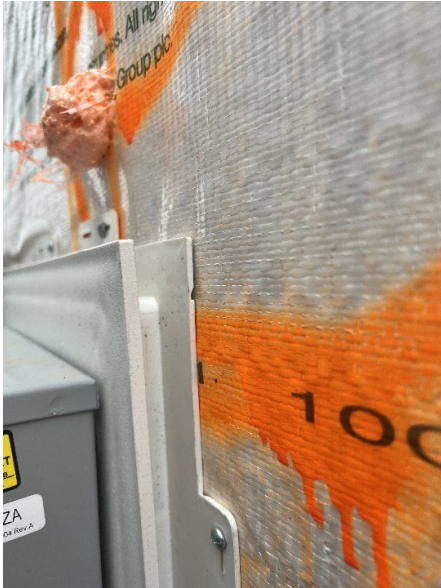
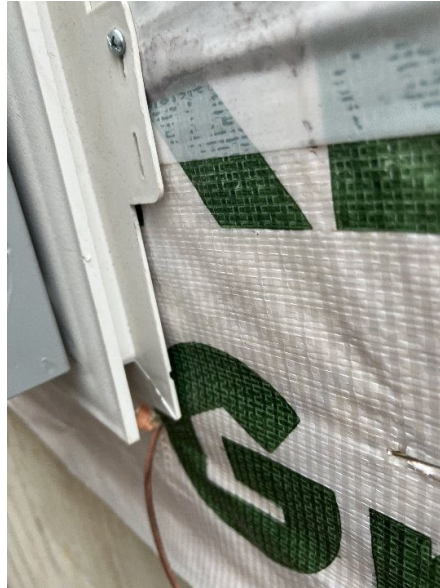
**C** The nailing phalange around the mounting block for the electric meter needs to be taped and integrated with the house wrap to form an effective drainage plane.

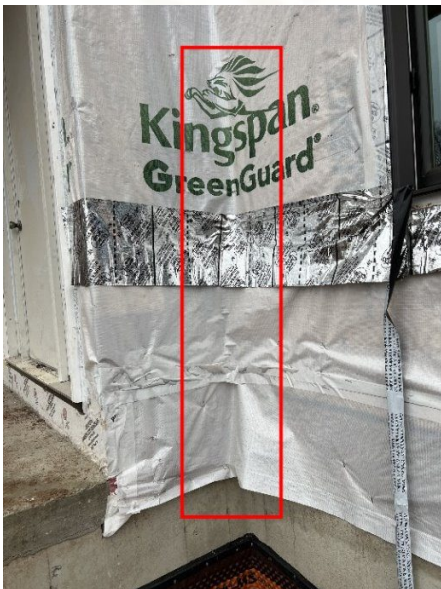
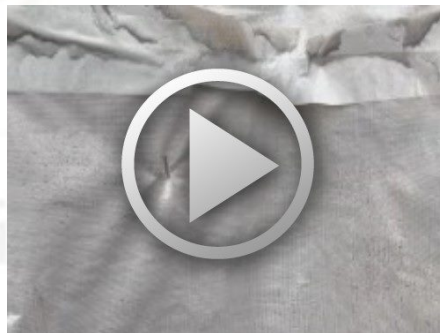
**C** At the front of the house, the house wrap is not been installed tight to the inside of the corner. The house wrap will need to be cut and fitted in tightly to the corner. An additional piece of house wrap will need to be installed over the corner to achieve the proper overlaps.

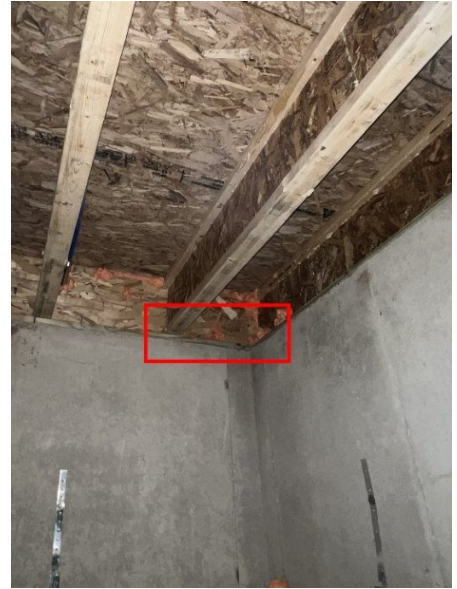
**C** A missing foundation bolt was noted on the short wall section at the front center of the basement and another at the front right corner. A minimum of two bolts is required in each sill plate. A bolt is required within 12 inches of the end of each sill plate.

only one bolt on this section

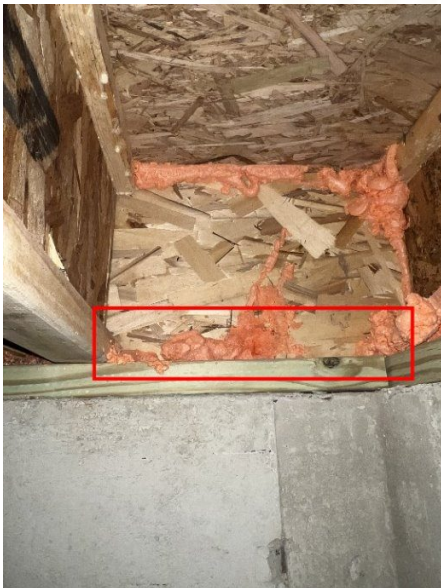
front right corner no bolt

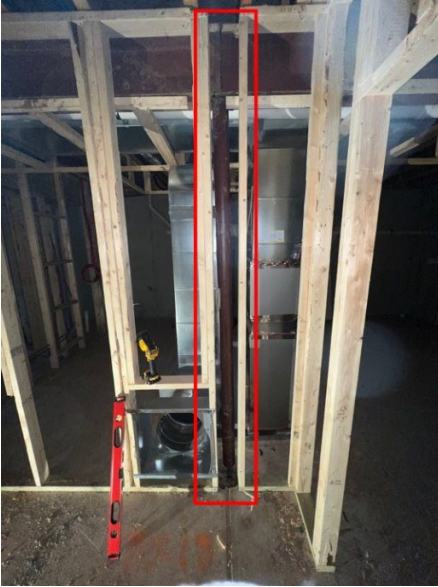
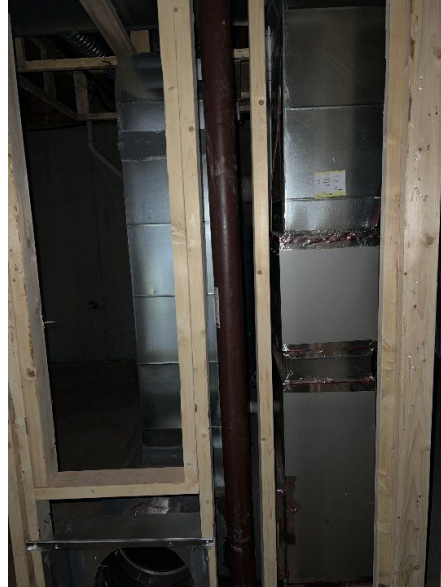
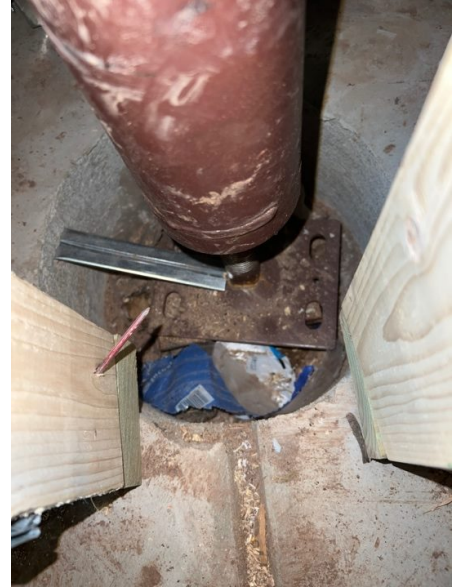
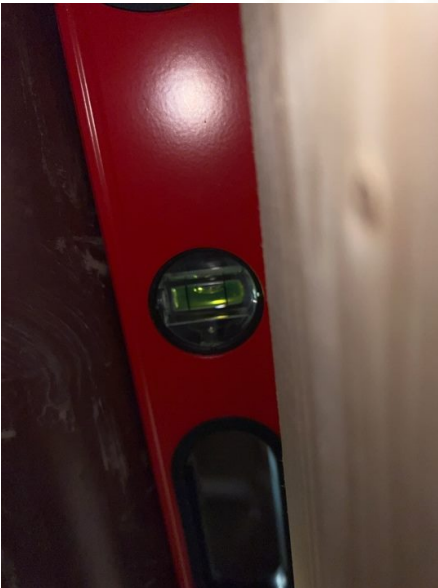
**C** The steel column near the basement HVAC system is out of plumb. The steel columns should not be out of plumb in excess of 3/8 of an inch and 8 feet. The bottom of this column is not been set yet. The builder should plumb the column before the concrete is poured.

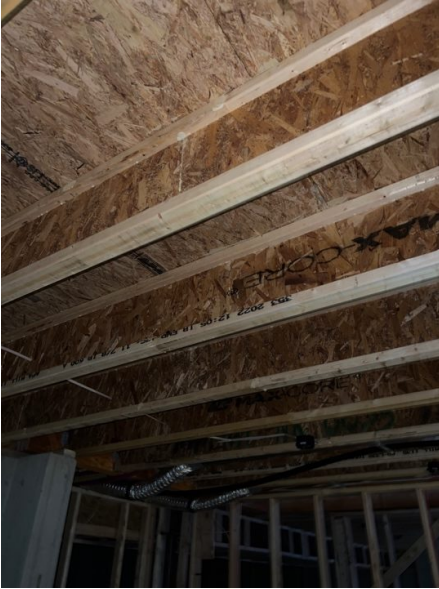
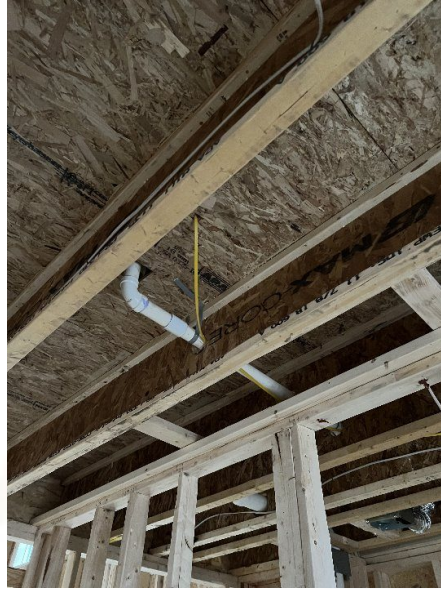
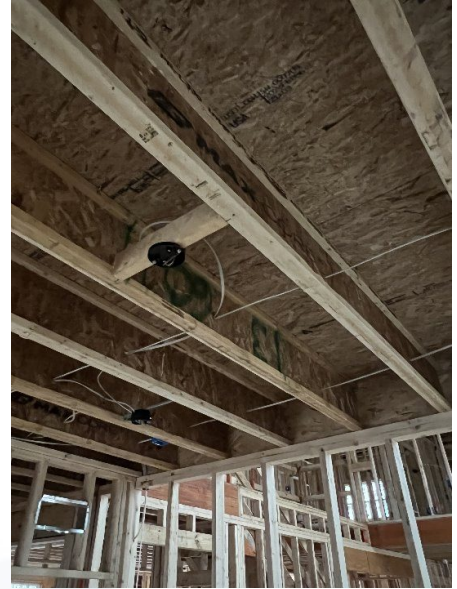
The floor joist appear to be free of defects at this time. At the time of this inspection the drilling and notching of the floor joist complied with section R502.8.

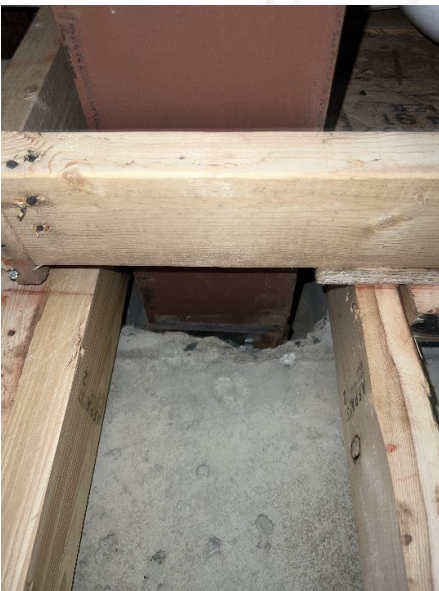
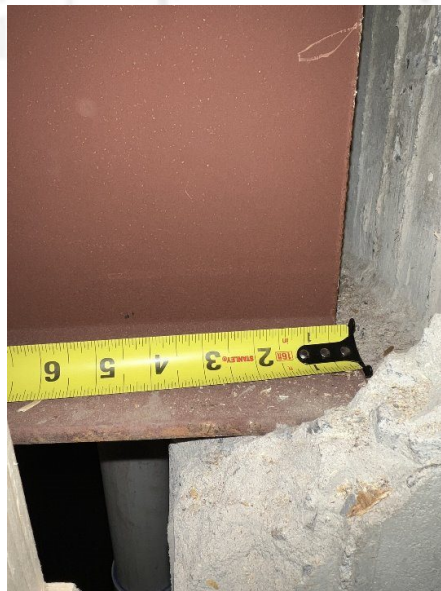
The beams are bearing on at least 3 inches on the concrete wall. (R502.6)

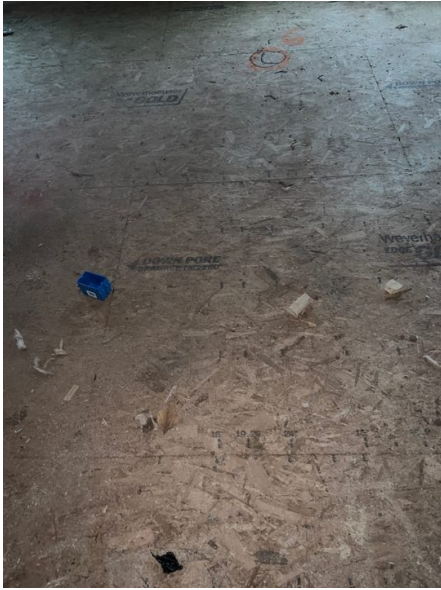
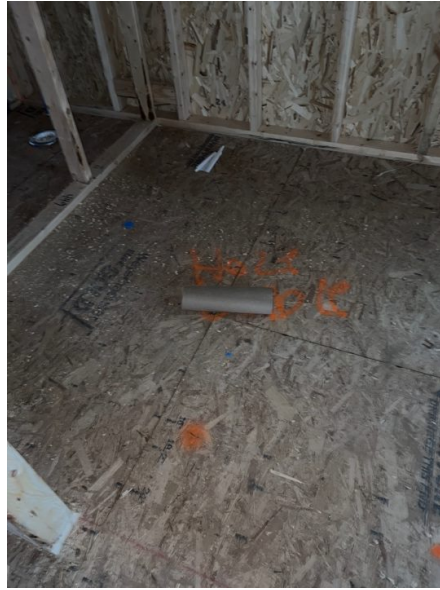
The floor sheathing was free of defects. The sheathing is within allowable spans.

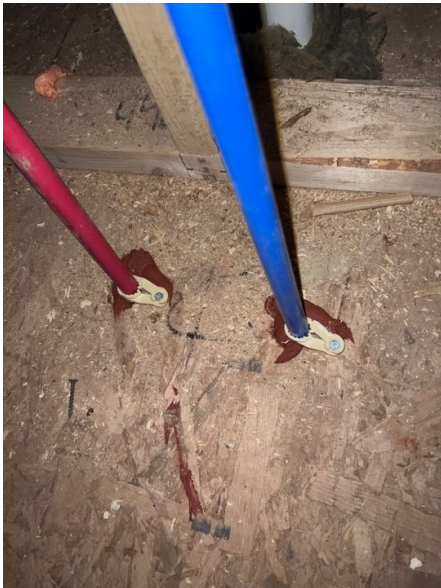
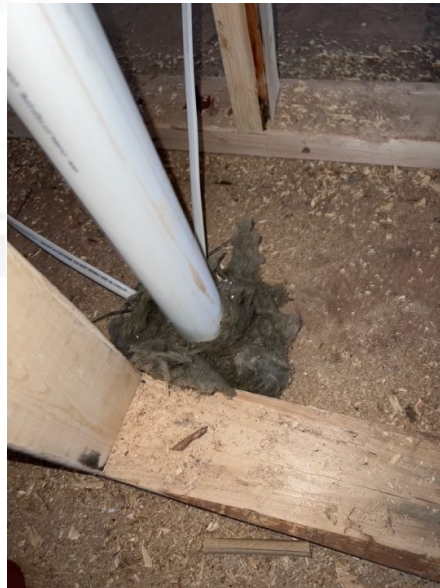
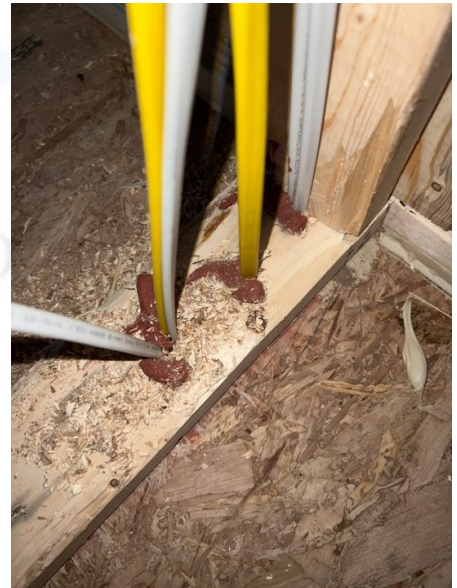
The pipes, electrical wires, and HVAC ducts are sealed where they pass through wall plates and floors, good.

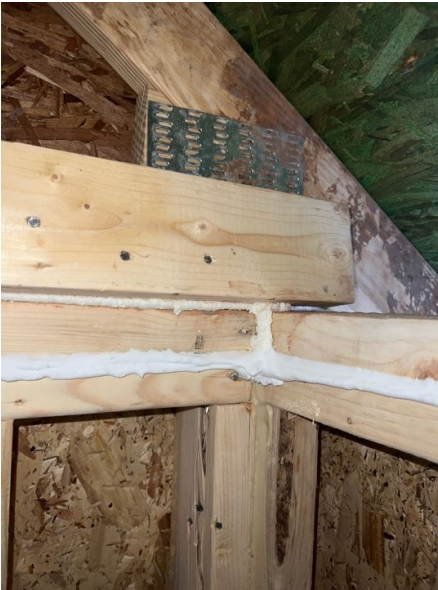
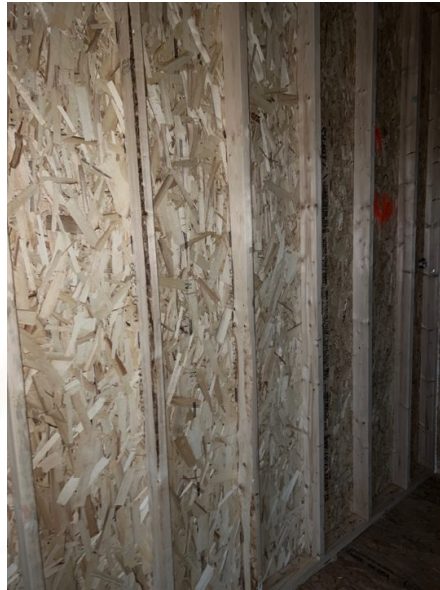
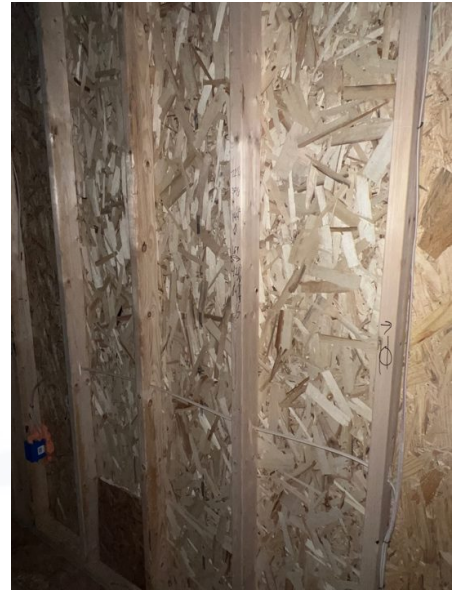
At the time of this inspection the drilling and notching in the studs complied with R602.6.

At the time of this inspection the notches in the top plate complied with R602.6.1.

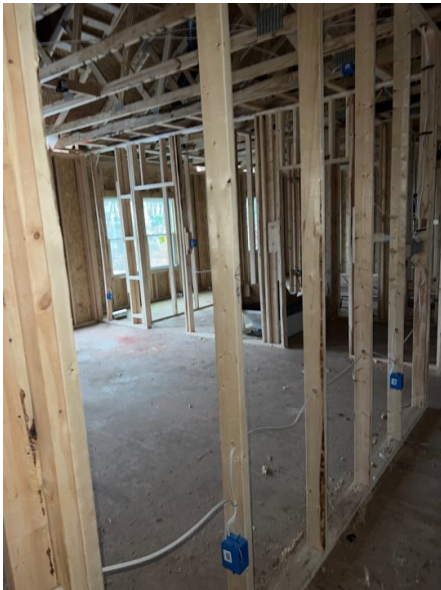
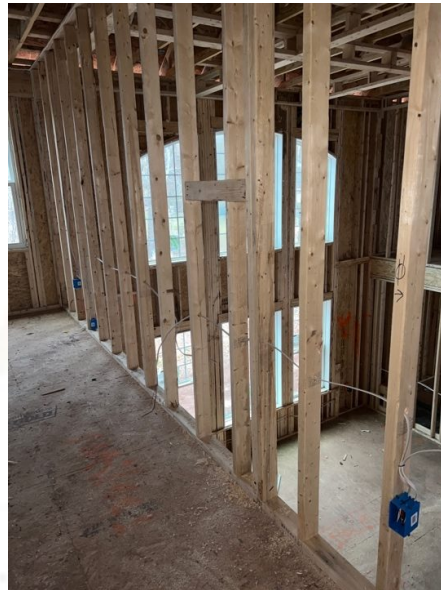
At the time of this inspection, the drilling and notching in the studs complied with R602.6.

At the time of this inspection the notches in the top plate comply with R602.6.1.

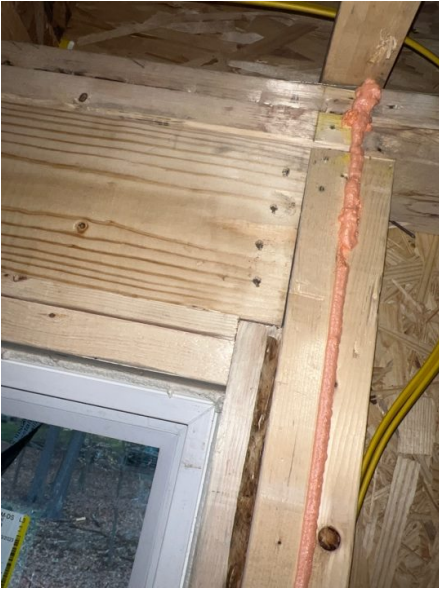
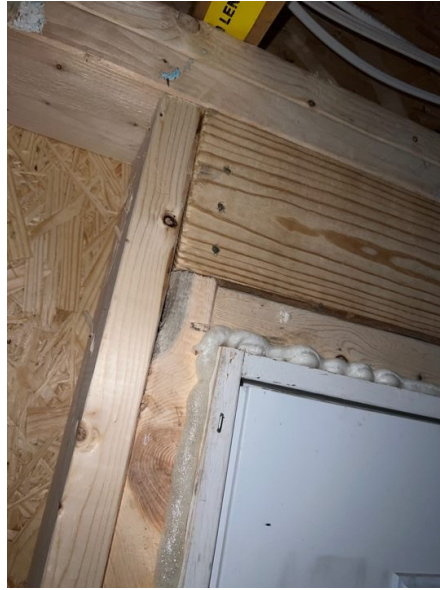
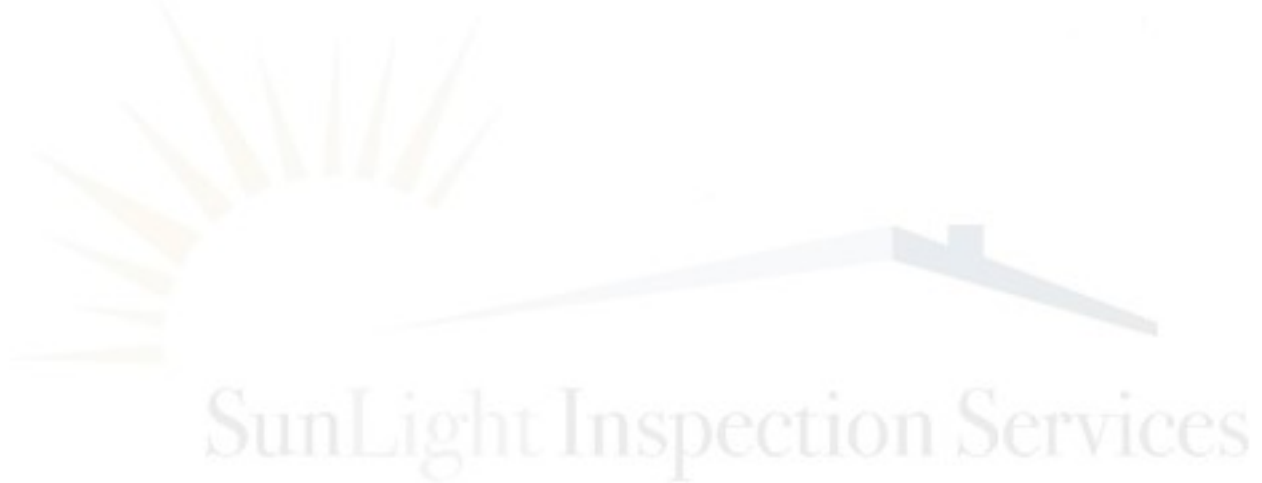
All framing studs to the headers above doors and window are tight, no gaps, good.

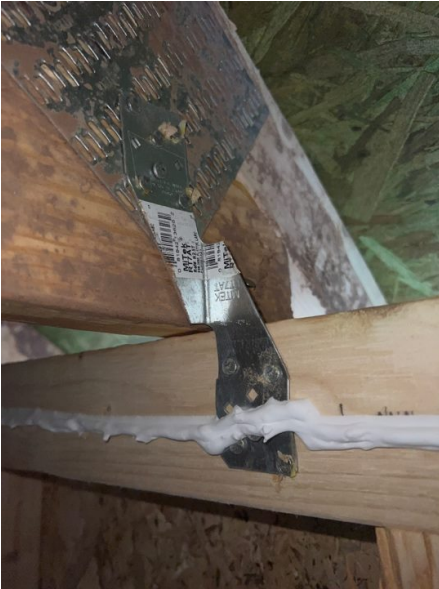
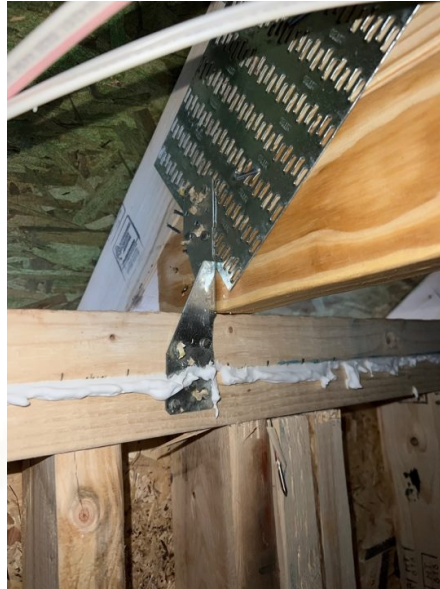
The roof trusses are strapped to the exterior walls to prevent up lift. .

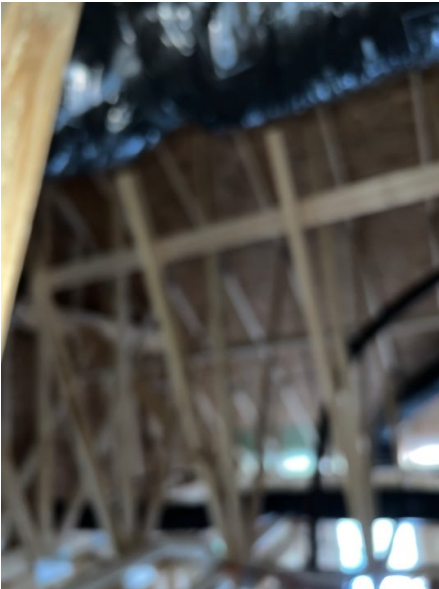
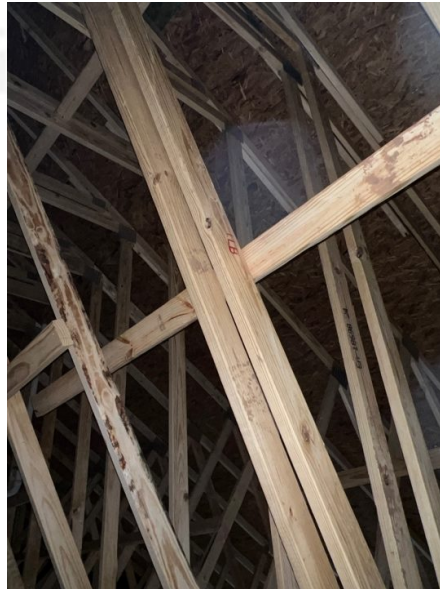
The roof trusses have been laterally braced to prevent rotation.

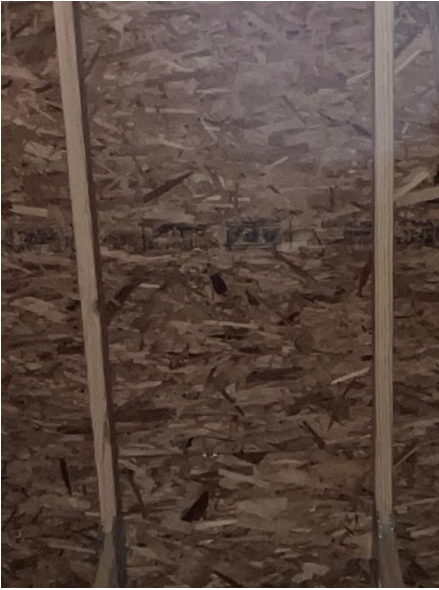
The roof sheathing is spaced to allowable in table R503.2.1(1). The sheathing was free of visible defects.

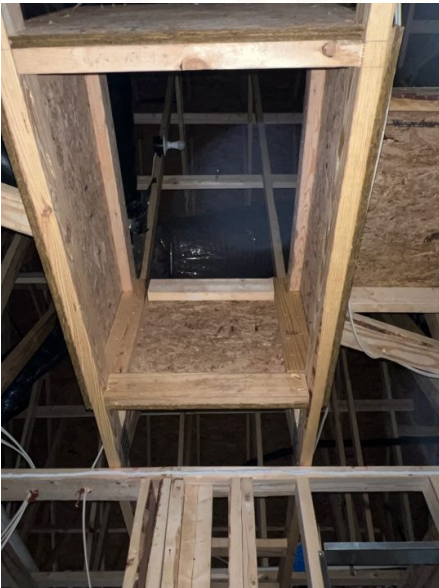
The attic access is in the back right bedroom and meets the required minimum size, 22 inches by 30 inches. (R807.1)

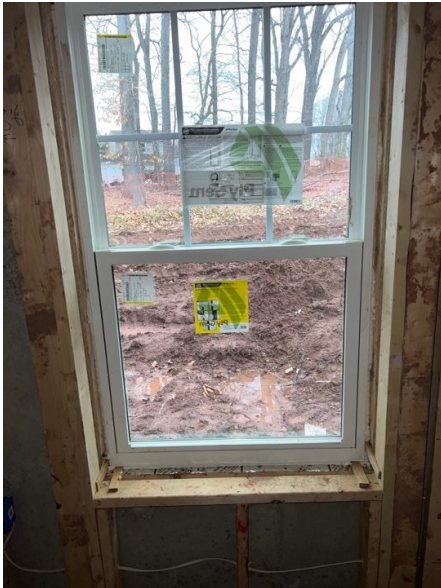
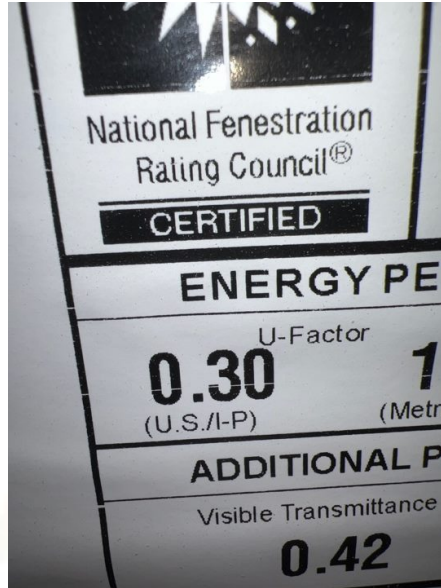
All the windows meet the required U factor rating. There is tempered glass in all the required locations.

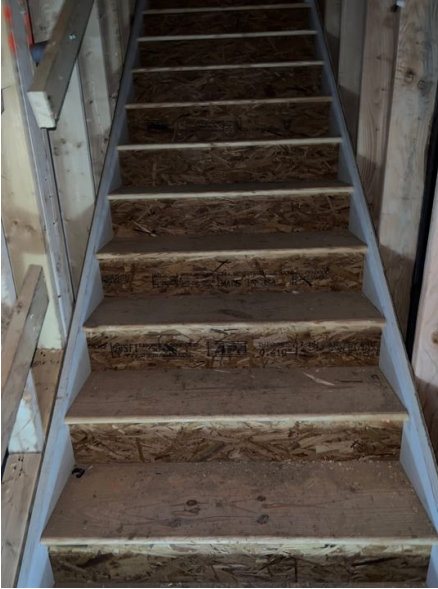
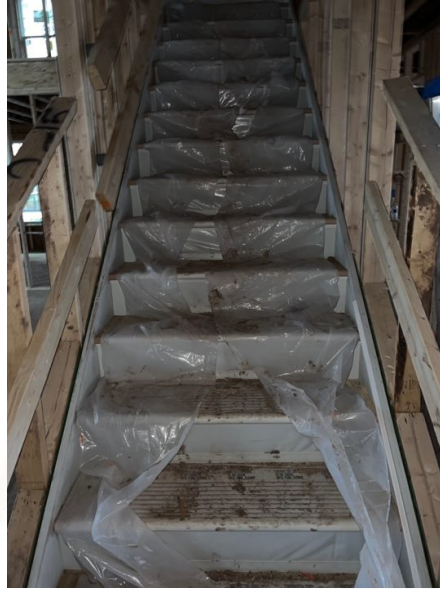
The stairs are prefabricated and comply with the PA UCC requirements for stairs.

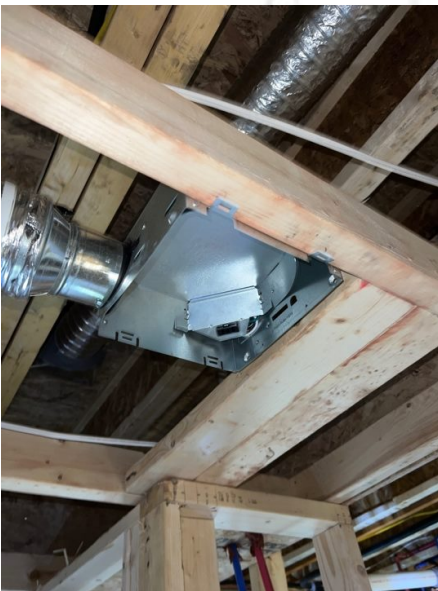
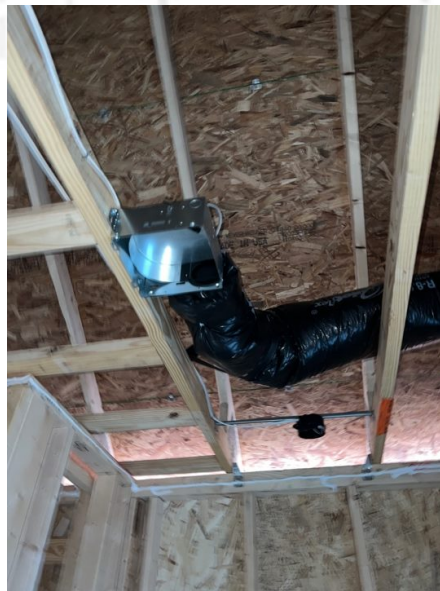
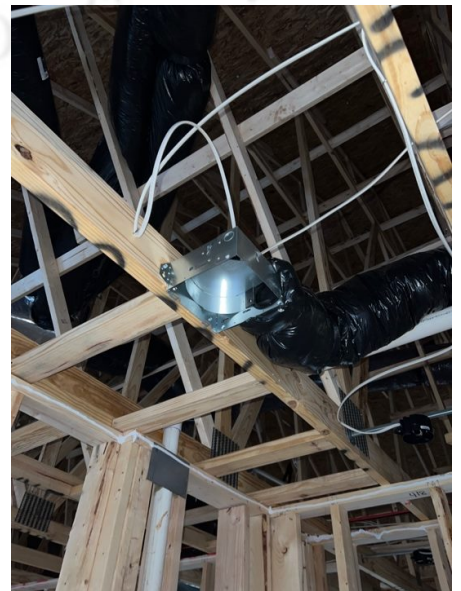
The bath fans are exhausting to the exterior as required. .

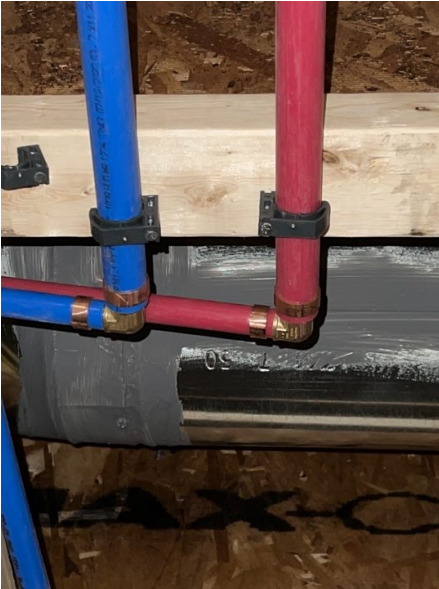
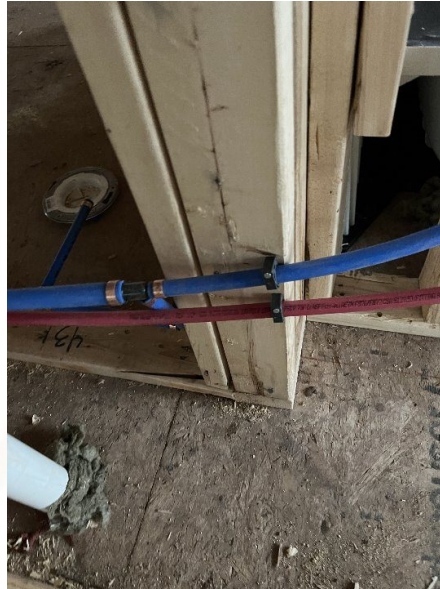
**C** Unprotected water lines were noted in the second floor back right bedroom. When water lines are installed through studs, joists, or rafters and are closer than 1 1/4 inch from the edge of the framing member they need to be protected by steel plates to prevent possible damage from fasteners that may be installed in the wall.

**C 12:** Unprotected water lines were noted in the second floor back right bedroom. When water lines are installed through studs, joists, or rafters and are closer than 1 1/4 inch from the edge of the framing member they need to be protected by steel plates to prevent possible damage from fasteners that may be installed in the wall.

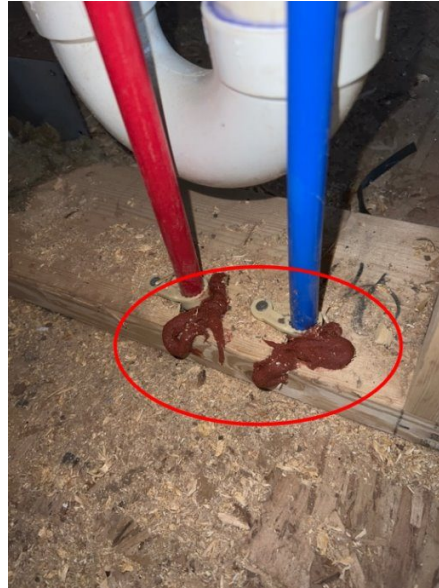
Laundry room

**C** Unprotected water lines were noted in the laundry room. When water lines are installed through studs, joists, or rafters and are closer than 1 1/4 inch from the edge of the framing member they need to be protected by steel plates to prevent possible damage from fasteners that may be installed in the wall.

**C 13:** Unprotected water lines were noted in the laundry room. When water lines are installed through studs, joists, or rafters and are closer than 1 1/4 inch from the edge of the framing member they need to be protected by steel plates to prevent possible damage from fasteners that may be installed in the wall.

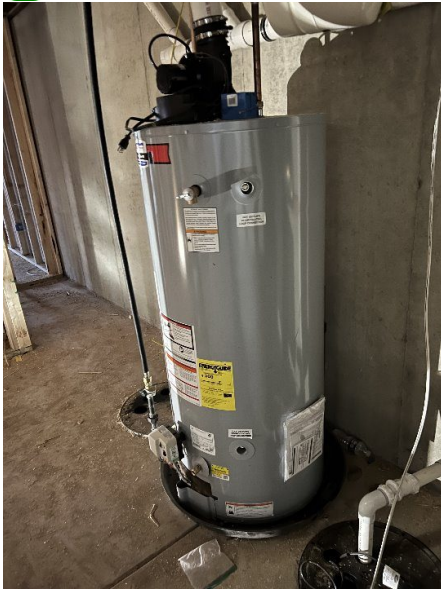
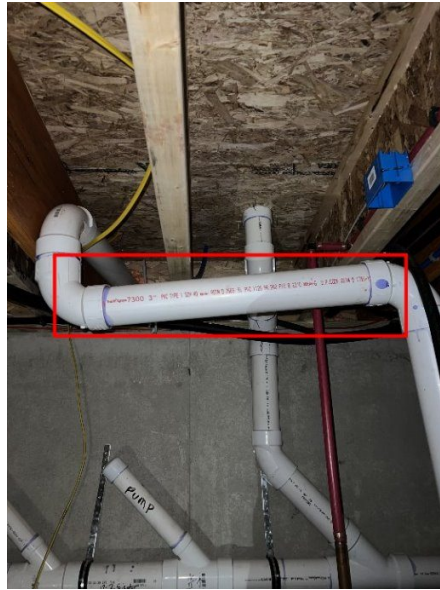
**C** The flue pipe for the water heater is sloped in the wrong direction. The flue pipe should slope upward.

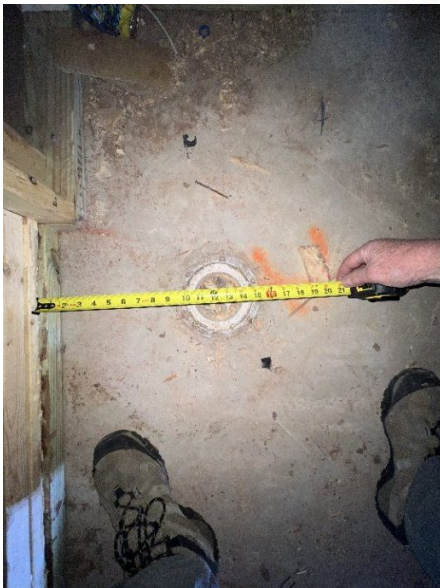
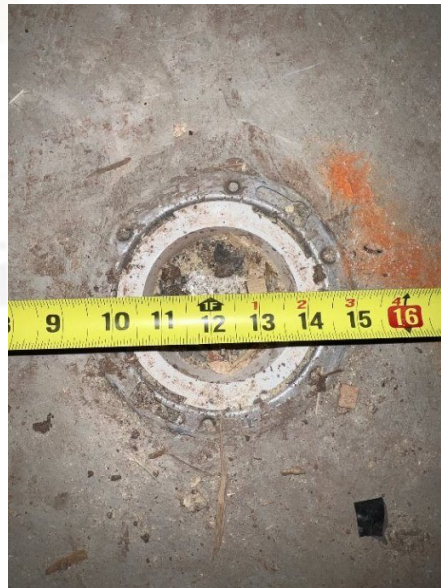
**C** The toilet planned for the basement bathroom is set to close to the shower wall. The center of the toilet plans should be 15 inches from the wall.

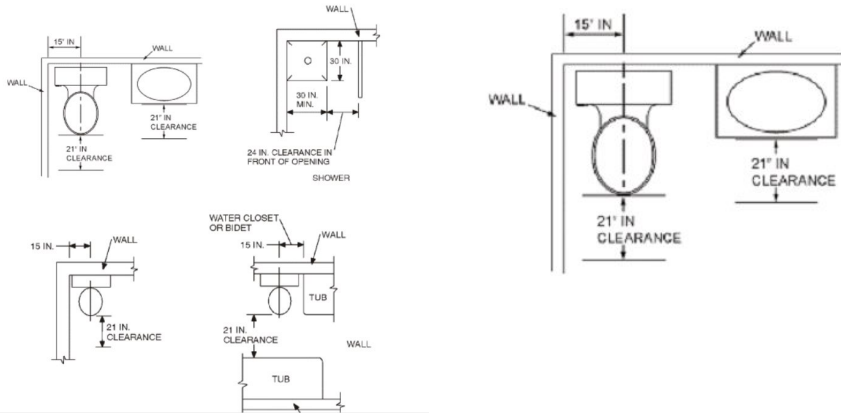
**R** Code Reference  
**R307.1 Space required**

Fixtures shall be spaced in accordance with figure R30 7.1 in accordance with the requirements of section P270 5.1

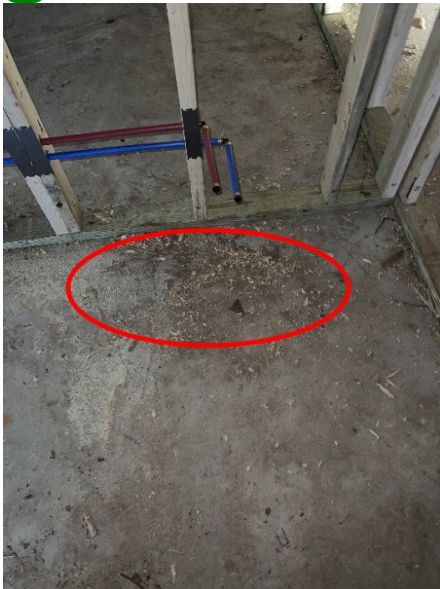
**C** The drainpipe for the basement bathroom sink does not line up with the bathroom layout.

no drainpipe for bathroom sink

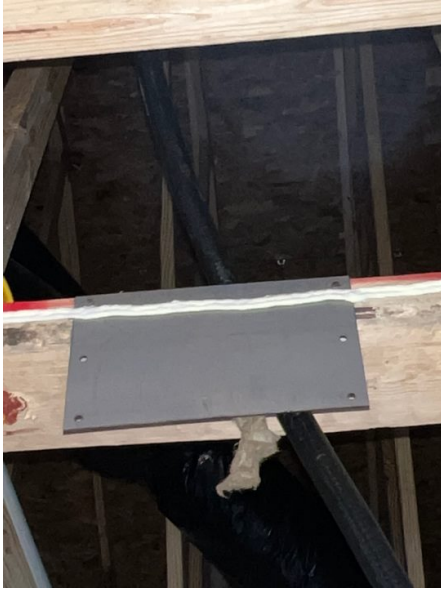
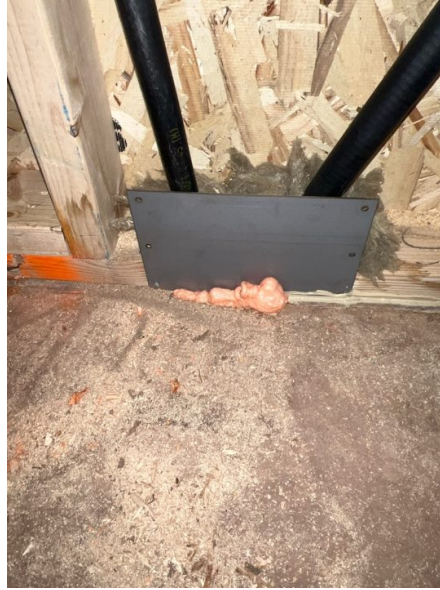
Steel plates protect the gas line where it passes through the framing, good.
